Final Field Report for Baseline Cultural Resources Surveys for the Sea Port in Yap, Federated States of Micronesia

Cardno GS – AECOM Pacific Joint Venture

October 2023

Project Name: Pacific Deterrence Initiative
Resource Surveys at Yap Port

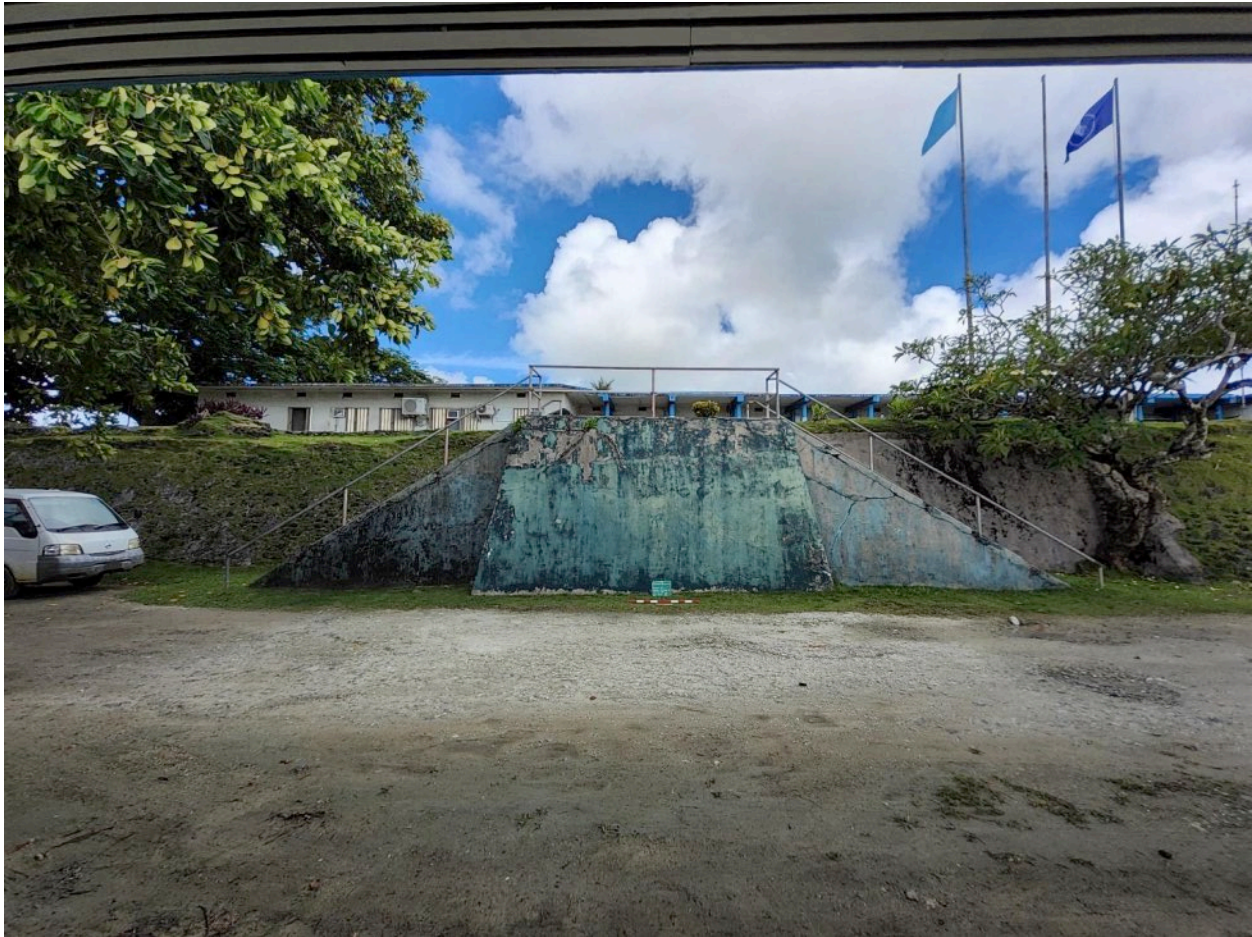
Feature 01 was a pair of concrete staircases leading to a common landing on the east side of the Spanish fort. It is approximately 43.6 feet (13.3 meters) long, 7.6 feet (2.3 meters) wide, and 9.8 feet (3.0 meters) tall (Figure 3-4 and Figure 3-5). The characteristics of the concrete were consistent with other Japanese administration buildings and structures, and local consultants identified Feature 01 as a Japanese modification to the site. A U.S. Coast and Geodetic Survey benchmark was installed on one of the stairs in 1951 (Figure 3-6). The condition of the stairs was good, but some cracks with vegetation were observed.

Figure 3-4 Feature 01 Overview, a Pair of Large Concrete Staircases Built along the East Side of the Spanish Fort during the Japanese Administration; View West; Staircases Built against Feature 06, the Spanish Colonial Earthen and Masonry Embankment

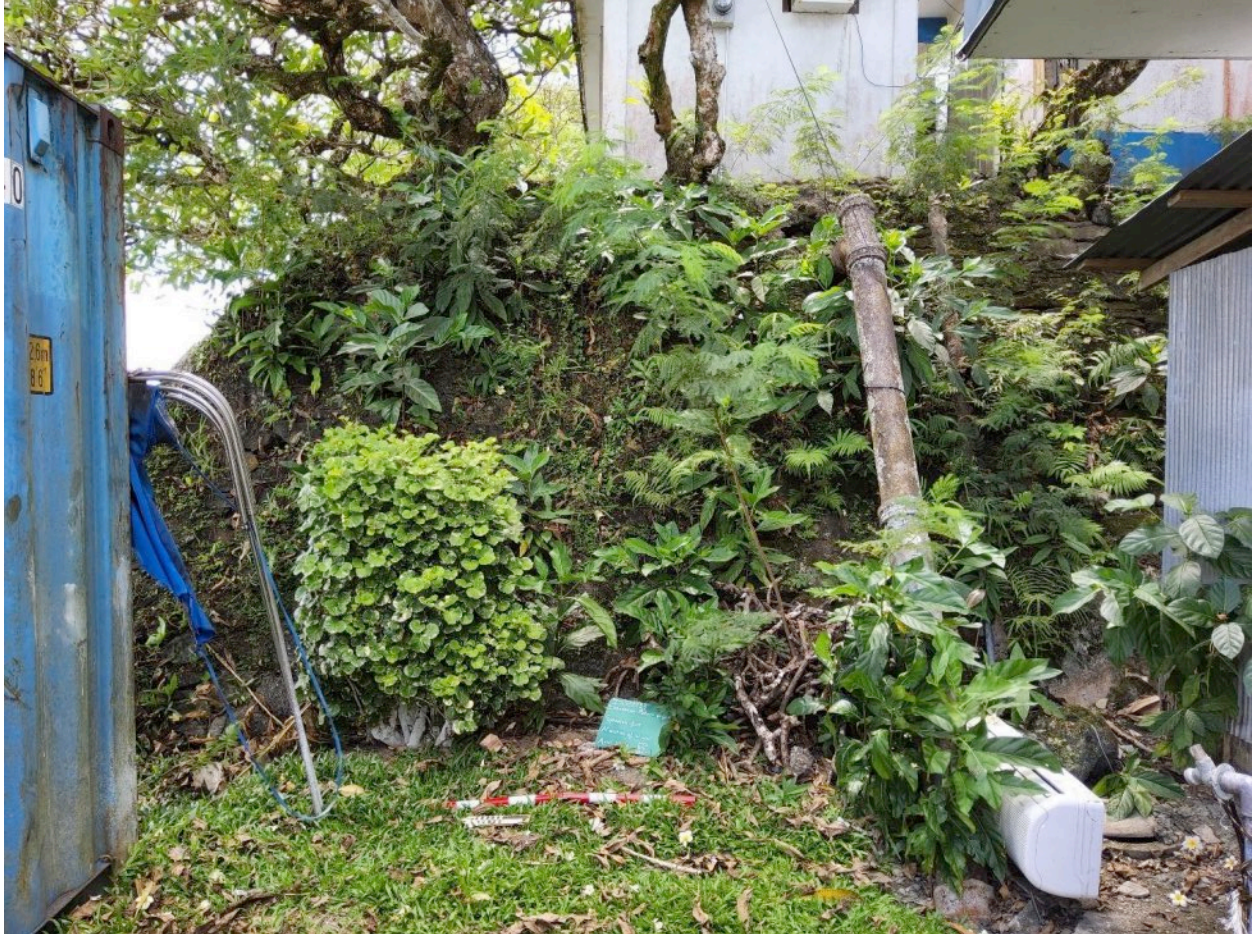
Feature 02 was a drainage or sewer pipe at the northwest corner of the Spanish fort (Figure 3-7). The pipe extended from the top of the Spanish colonial embankment and mound to the exterior grade. It likely originated from the Japanese hospital. The condition of the pipe was fair to good.

Figure 3-7 Feature 02, a Japanese Administration Drainage or Sewer Pipe at the Northwest Corner of the Site

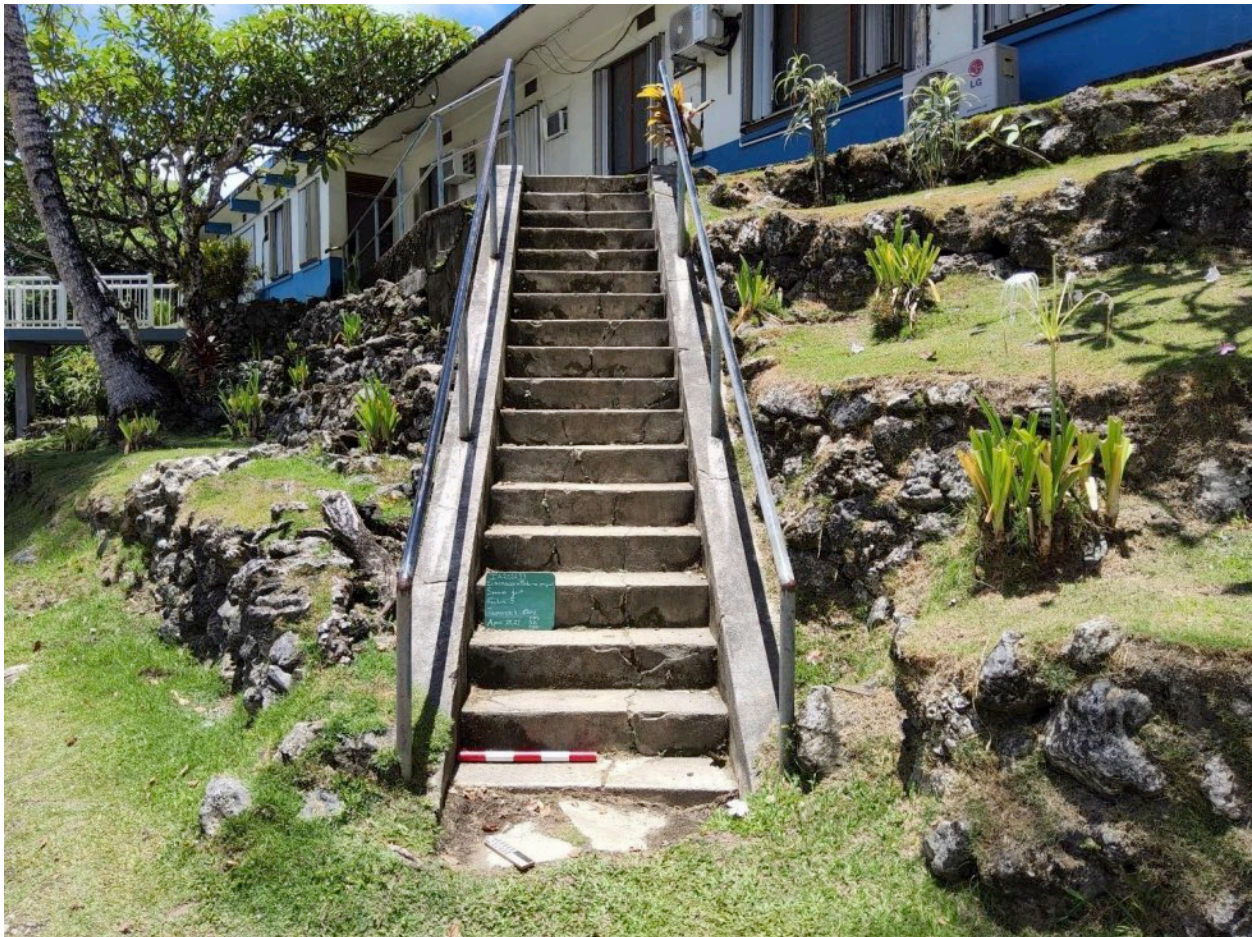
Feature 05 was a concrete staircase along the west side of the Spanish colonial embankment and mound (Feature 06) (Figure 3-13). The staircase was smaller and narrower than the double staircase on the east side of the site (Feature 01). The characteristics of the staircase suggested it was constructed during the Japanese administration. The condition was fair to poor as most of the steps had large cracks.

Figure 3-13 Feature 05, Japanese Staircase on the West Side of the Site; View Northeast

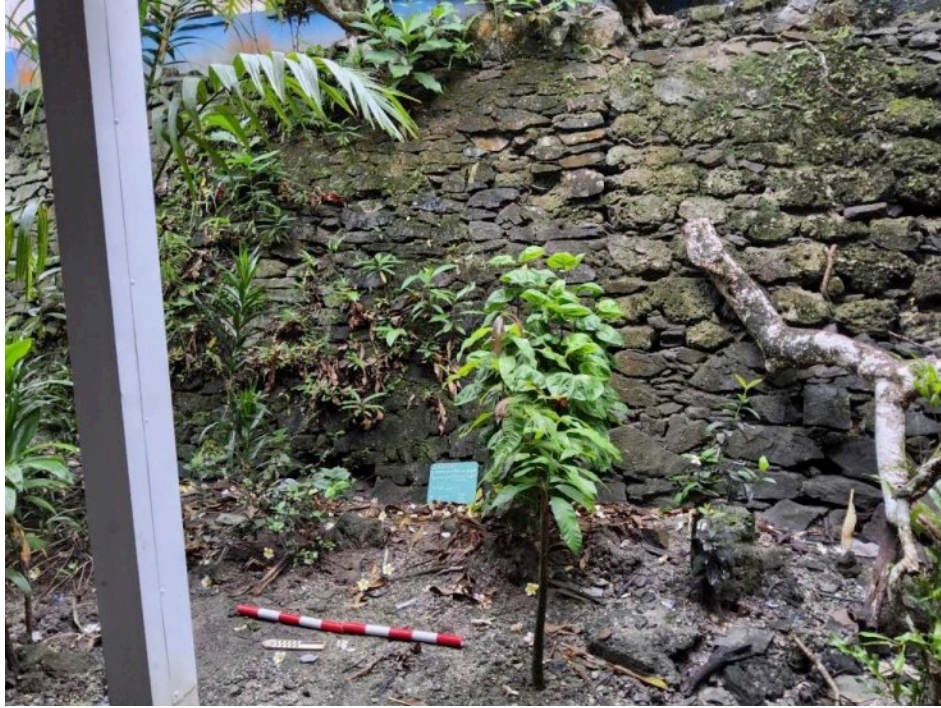
A section of the west foundation wall appeared to have been modified or rebuilt in a more recent construction episode. The stones were smaller, less weathered, and dry stacked, which is more consistent for *chamog* (Figure 3-21). Utility lines have been installed through this section of the embankment, and modification may be associated with these more recent installations. More extensive damage was observed on the south wall, which showed rebuilding using recycled fragments of stone and brick (Figure 3-22).

Figure 3-21 Feature 06, Section of the West Wall Revealing a Modification Reminiscent of Traditional Yapese Masonry; View East-northeast

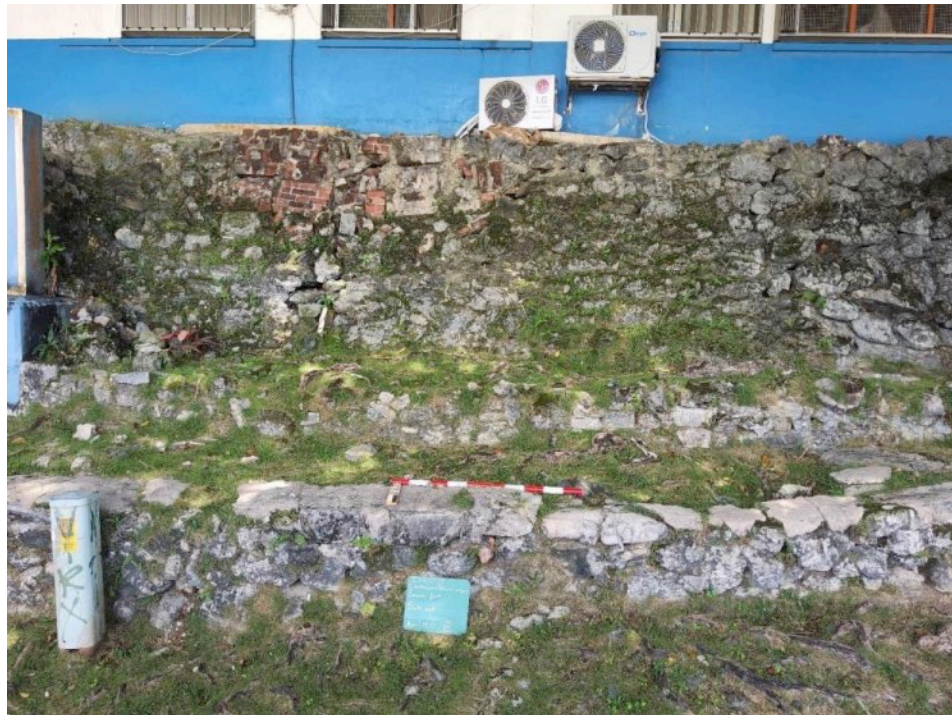
Figure 3-22 Feature 06, Section of the South Wall Damaged and Rebuilt Using Original Spanish Brickwork Fragments; View North

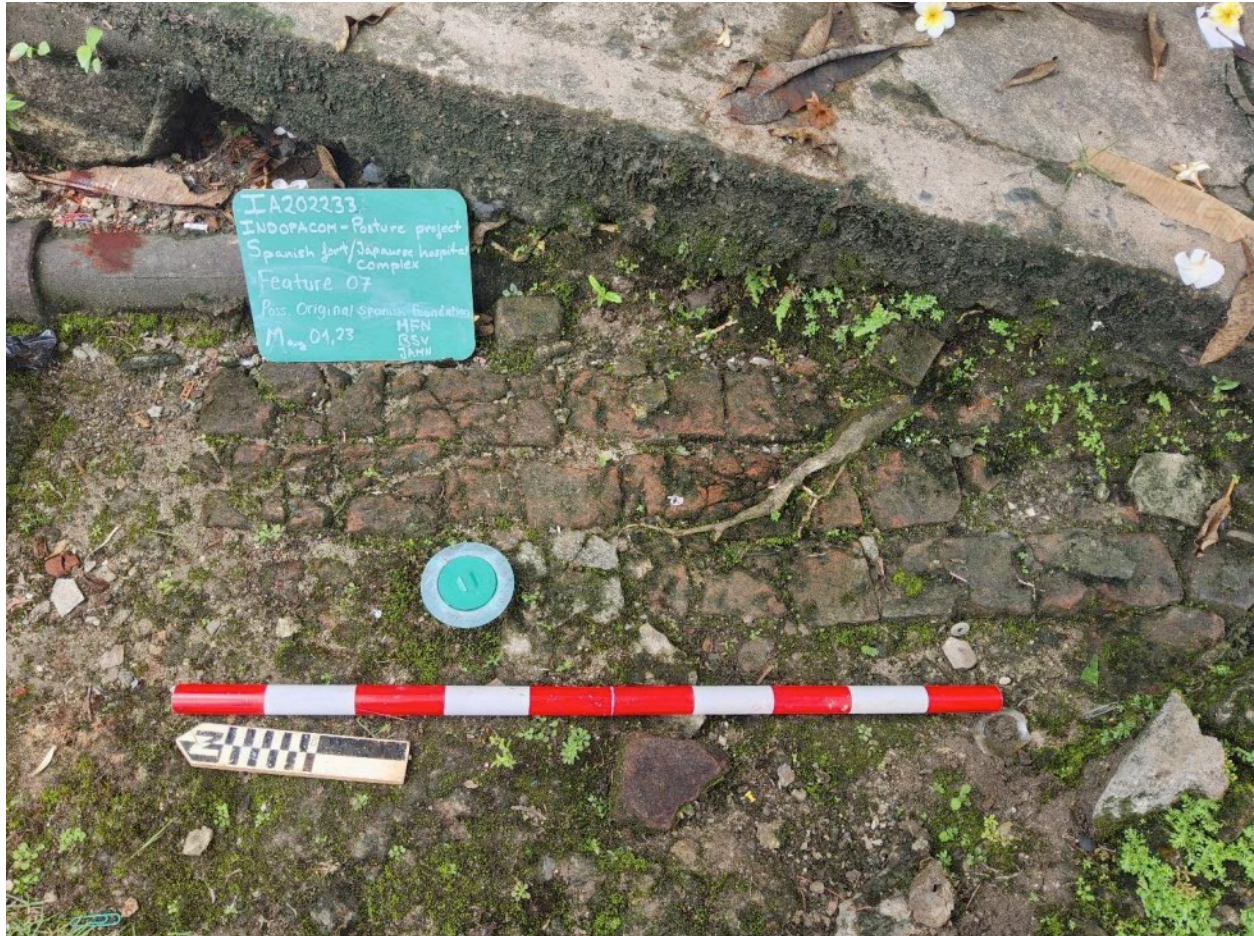
Feature 07 was a short section of Spanish brick inset into the top of the earthen mound (Feature 06) (Figure 3-23). The concrete foundation of the Japanese hospital overlaid a portion of the brickwork, and its full extent was unknown. Based on its location, it is possible that Feature 07 was the remnants of a Spanish colonial building, particularly one of the brick columns (*pilotes*) for the infantry quarters noted in historical documents. The condition was fair because of 20th-century modifications above and around the brickwork.

Figure 3-23 Feature 07, a Small Section of Spanish Brickwork That May Be a Remnant Foundation of a Former Building or Structure

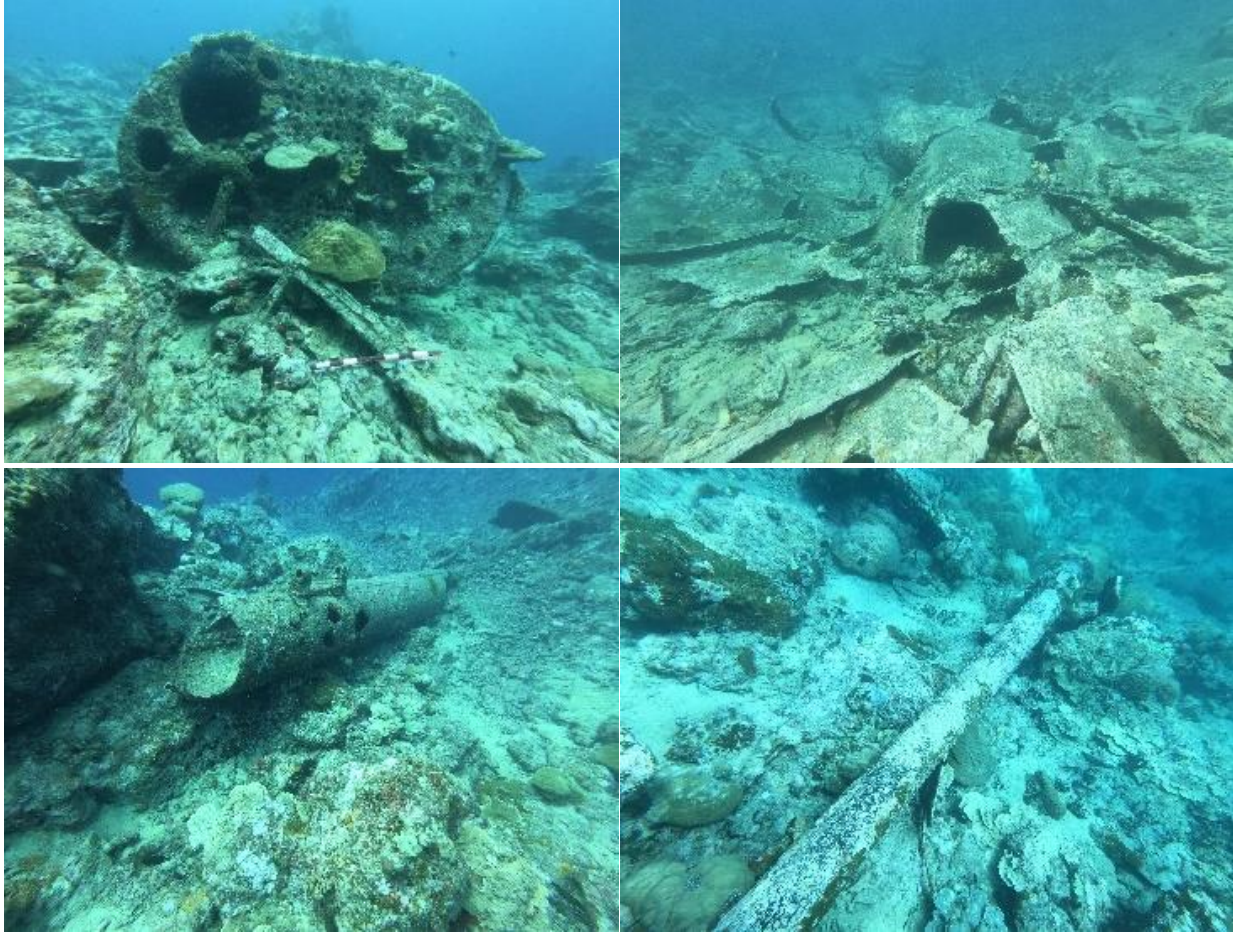
Divers spent 185 minutes investigating Target 24 within water depths approved for diving, while drop camera footage was collected in depths beyond approved diving limits. Target 24 consisted of several ship construction elements including a Scotch boiler, which dates to the mid-19th to early 20th century, a smokestack, and a mast (Figure 3-43). Other ship construction elements included a windlass, metal framing, and exterior hull sheeting with window ports (Figure 3-44). Various sizes of chains were strewn about the site. Archaeologists noted two anchors, with the smaller one resembling a Rodger-style anchor, which dates to the mid- to late 19th century. The larger anchor had a single fluke and portion of the stock visible and exposed portions resemble an admiralty anchor (Figure 3-45).

Figure 3-43 Target 24 Scotch Boiler (Top Left), Metal Sheeting (Top Right), Smokestack (Bottom Left), and Mast (Bottom Right) (Photos by AECOM)

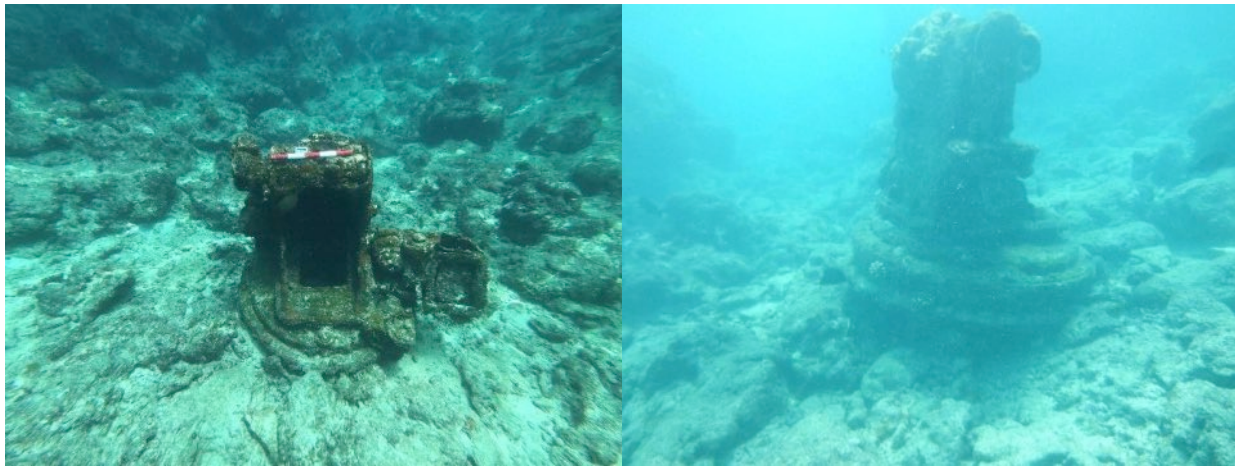
Target 20 was located in Tamil Channel Entrance (West) (Survey Area 3) in 15 feet (5 meters) of water and near Targets 23 and 24. Target 20 was an isolated object measuring 8 feet (2.5 meters) by 6.5 feet (2 meters) (Figure 3-51). Target 20 is an unknown piece of machinery that may be associated with Targets 23 or 24 or may be an isolated find. It is possible that Target 20 may have associated buried material. Based on observed characteristics and available data, Target 20 may be related to Target 23 or 24 and, as such, may retain the potential to yield important information regarding maritime shipping and industry practices significant to Yap and the FSM's history. Due to its potential association with Target 23 or 24, it is recommended treating Target 20 as eligible for listing in the NRHP pending additional information. Target 20 was encompassed within the recommended avoidance zone of Target 24 and may be related; therefore, an additional avoidance buffer for Target 20 is not currently recommended.

Figure 3-51 Target 20 (Photos by AECOM)

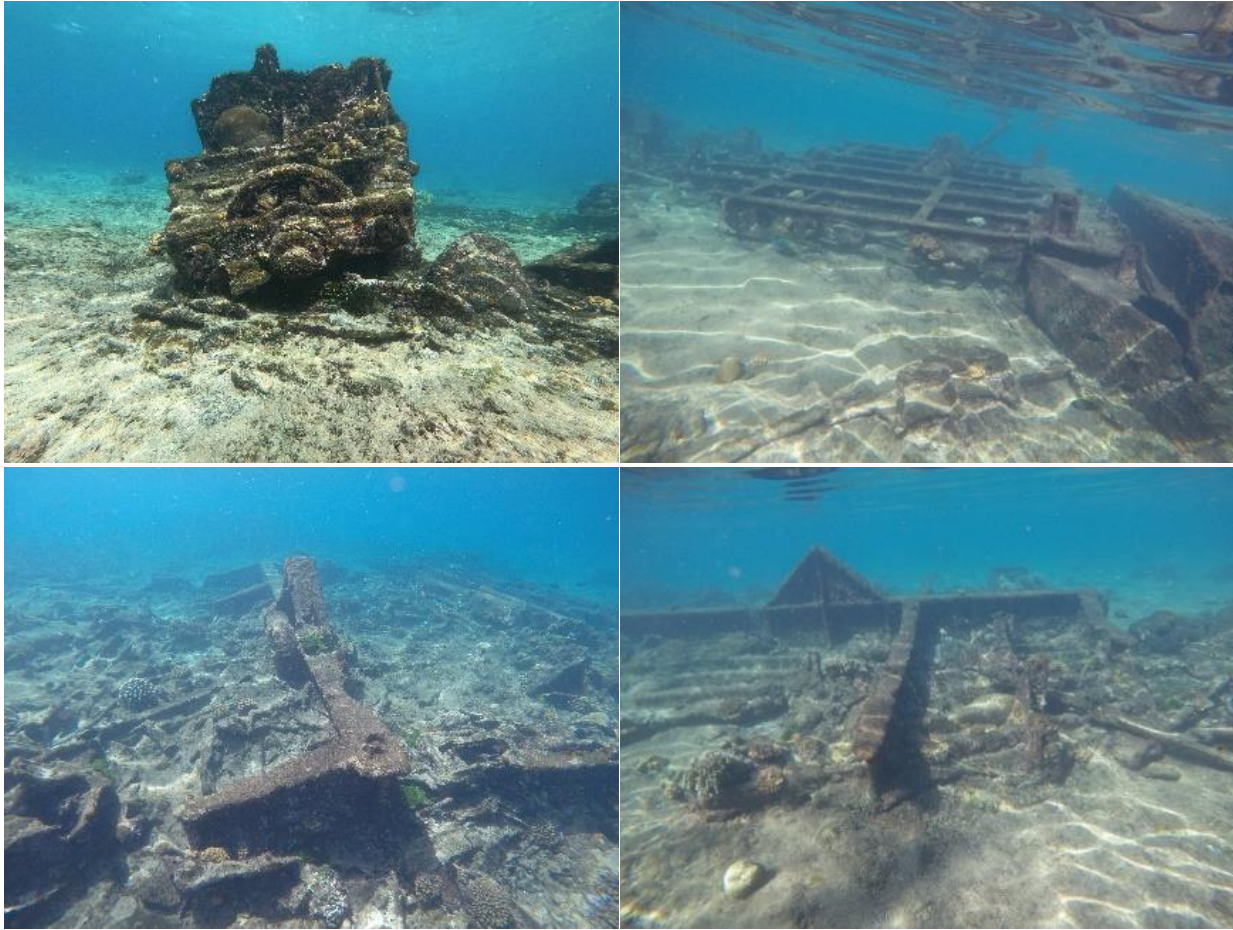
Target 23 was located near Tamil Channel Entrance (West) (Survey Area 3) in approximately 14 feet (4 meters) of water. Target 23 was denoted as kml_76 in the NOAA ENC shipwrecks database as always dry. Target 23 rests along the edge of the outer reef and, while investigating the target, archaeologists noted that during low tide sections of the wreck became exposed. Divers spent 146 minutes investigating Target 23 and identified the source as a large, early- to mid-20th century wreck. Target 23 was approximately 400 feet (122 meters) long by 100 feet (30 meters) wide and consisted of an early- to mid-20th-century ship with construction features including large engine pieces that may be from an internal combustion engine, large metal frames and outer hull plating, and a reinforced keelson with triangular supports (Figure 3-52). Target 23 also consisted of two propellers, the blades each measuring 3 feet (1 meters) long and 2 feet (0.5 meters) wide, prop shafts, and two propulsion engines (Figure 3-53). Two large anchors that stylistically resemble a Danforth anchor were located near the propeller shafts (Figure 3-54). Additional details were documented, such as a partial serial number on a fitting, two rectangular metal radiator-like objects, and a large variety of cupreous artifacts (Figure 3-55). Observed construction elements such as engine and prop shafts appear to reflect its historic design prior to the wrecking event. Due to heavy amounts of surge and shallow water, the entirety of Target 23 was not observed during diver investigations. Strong surge and waves, as well as tropical weather, may have dispersed the site onto the reef. The wreck is depicted on the U.S. Navy Hydrographic Office (1944) map. Based on the observed construction elements, Target 23 is likely an early- to mid-20th-century vessel. Based on observed characteristics and available data, Target 23 may retain the potential to yield significant information about early- to mid-20th-century shipping and site formation processes. It is recommended treating Target 23 as eligible for listing in the NRHP with an avoidance buffer of 328 feet (100 meters) from the defined site extents, pending additional information.

Figure 3-52 Probable Diesel Engine (Upper Left) and Large Metal Frames and Hull Sections (Remainder) (Photos by AECOM)

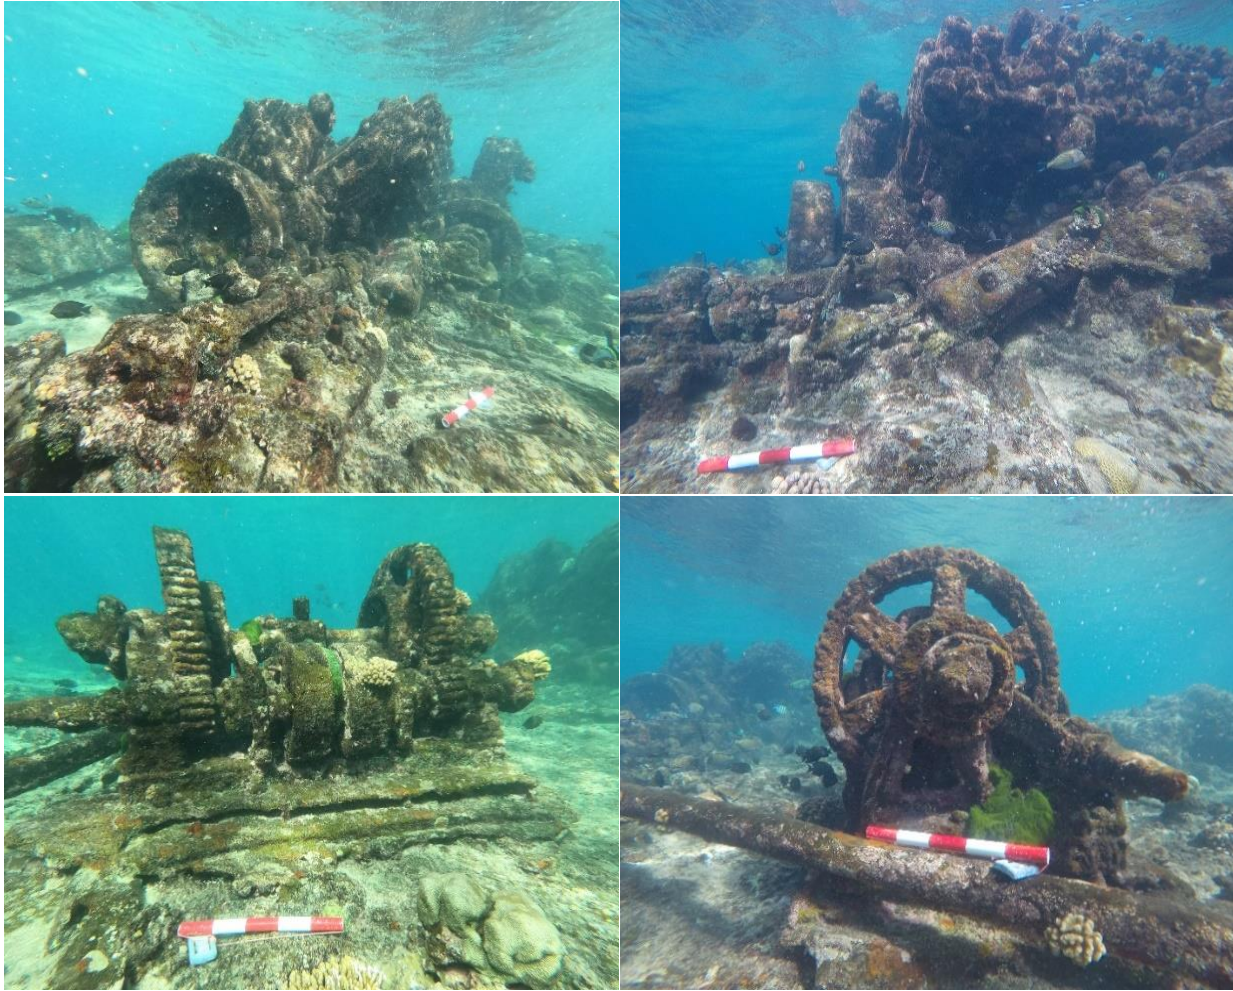
Target 26 was located near Offshore Mooring (Survey Area 1) in approximately 10 feet (3 meters) of water along the edge of a reef. Target 26 was denoted as kml_77 in the NOAA ENC shipwreck database as a visible shipwreck, always dry. Target 26 rests along the outer edge of the reef and, while investigating the target, archaeologists noted that during low tide sections of the wreck became exposed. Divers spent 34 minutes investigating Target 26 and identified the source as having elements consistent with late-19th-century to early-20th-century ships with construction features including large machinery, such as an engine and a large windlass (Figure 3-56). Target 26 also consisted of two partially buried propellers, the blades each measuring 2 feet (0.5 meters) long and 1 foot (0.4 meters) wide, and prop shafts (Figure 3-57). Two Rodger- or kedge-Admiralty-style anchors, typical of the 19th century, were located near the propellers (Figure 3-58). Archaeologists observed a large gouge in the seabed that led up to the shipwreck, implying the ship ran into the reef during the wrecking event (Figure 3-59). Observed construction elements such as engine and prop shafts appear to reflect its historic design prior to the wrecking event. Due to heavy amounts of surge and shallow water, the entirety of Target 26 was not observed during diver investigation. Strong surge and waves, as well as tropical weather, may have dispersed the site onto the reef. Based on the observed construction elements, Target 26 is likely a late-19th-century to early-20th-century vessel. Based on observed characteristics and available data, Target 26 may retain the potential to yield significant information about late-19th-century to early-20th-century shipping and site formation processes. It is recommended treating Target 26 as eligible for listing in the NRHP with an avoidance buffer of 328 feet (100 meters) from the defined site extents, pending additional information.

Figure 3-56 Propulsion Engine (Top Left and Top Right) and Windlass (Bottom Left and Bottom Right) (Photos by AECOM)

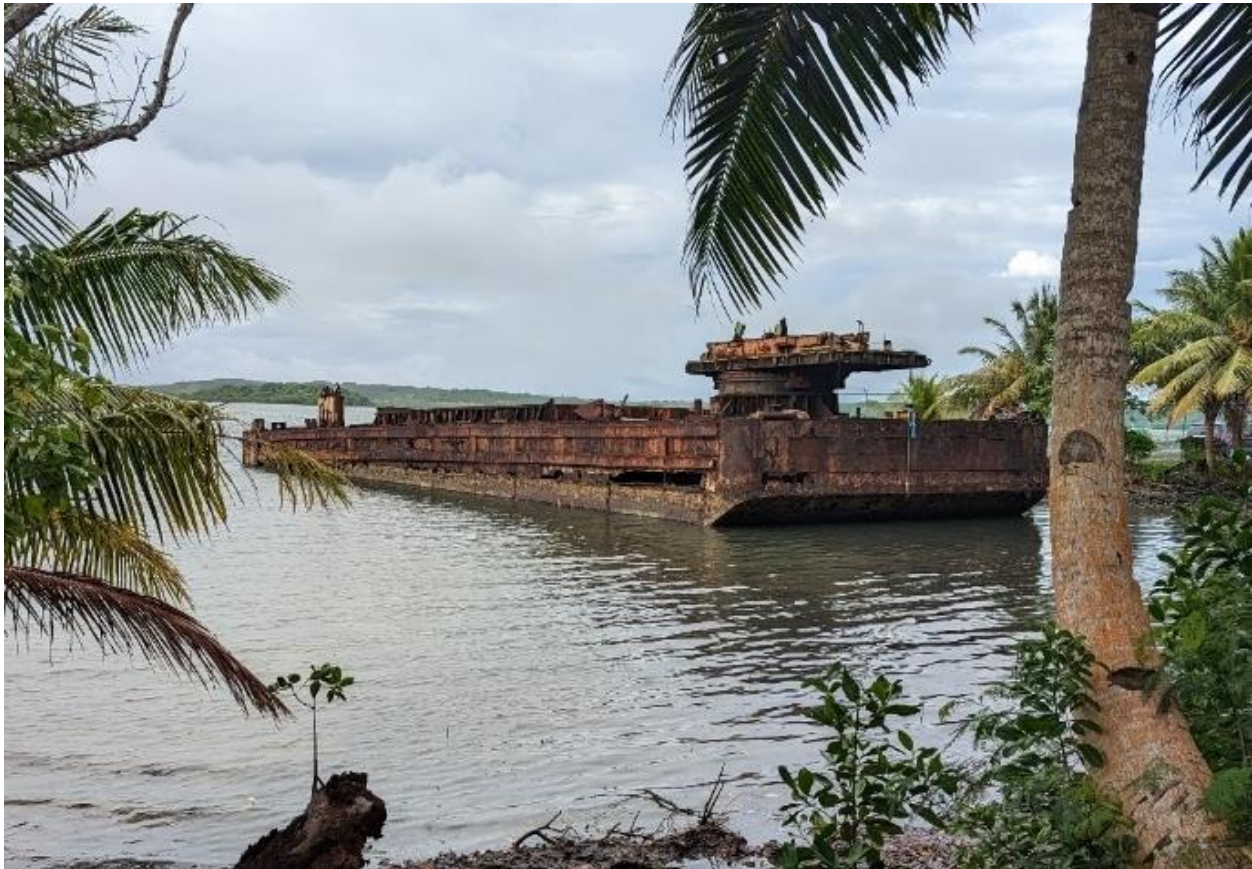
Target 06 was located in Yap Port (Survey Area 4) (Figure 3-82). Target 06 was identified as an unknown contact partially exposed in aerial imagery measuring 120 feet (36 meters) long and 45 feet (14 meters) wide. Target 06 first appeared on aerial imagery in 2013 but was not visible in 2008 aerial imagery (Figure 3-83). Archaeologists conducted a pedestrian survey at low tide and surveyed from a boat at high tide, with access around a majority of the target. Archaeologists identified Target 06 as a rectangular crane barge and observed multiple ship construction elements, including welded deck plating, mooring bitts—some with dock line still threaded—and a large support for a mounted crane. Target 06 was partially salvaged with evidence that the crane and boom have been removed. Archaeologists could not locate an identifying name or nameplate, and attempts to identify the vessel in ship registries were unsuccessful; however, observed construction elements are consistent with late-20th-century crane barge construction methodologies. Based on observed construction elements and vessel size, Target 06 was likely a crane barge. Based on observed characteristics and available data, Target 06 may retain the potential to yield important information regarding maritime shipping and industry practices significant to Yap and the FSM's history. It is recommended treating Target 06 as eligible for listing in the NRHP with an avoidance buffer of 164 feet (50 meters) from the defined site extents, pending additional information.

Figure 3-82 Target 06 (Photo by AECOM)

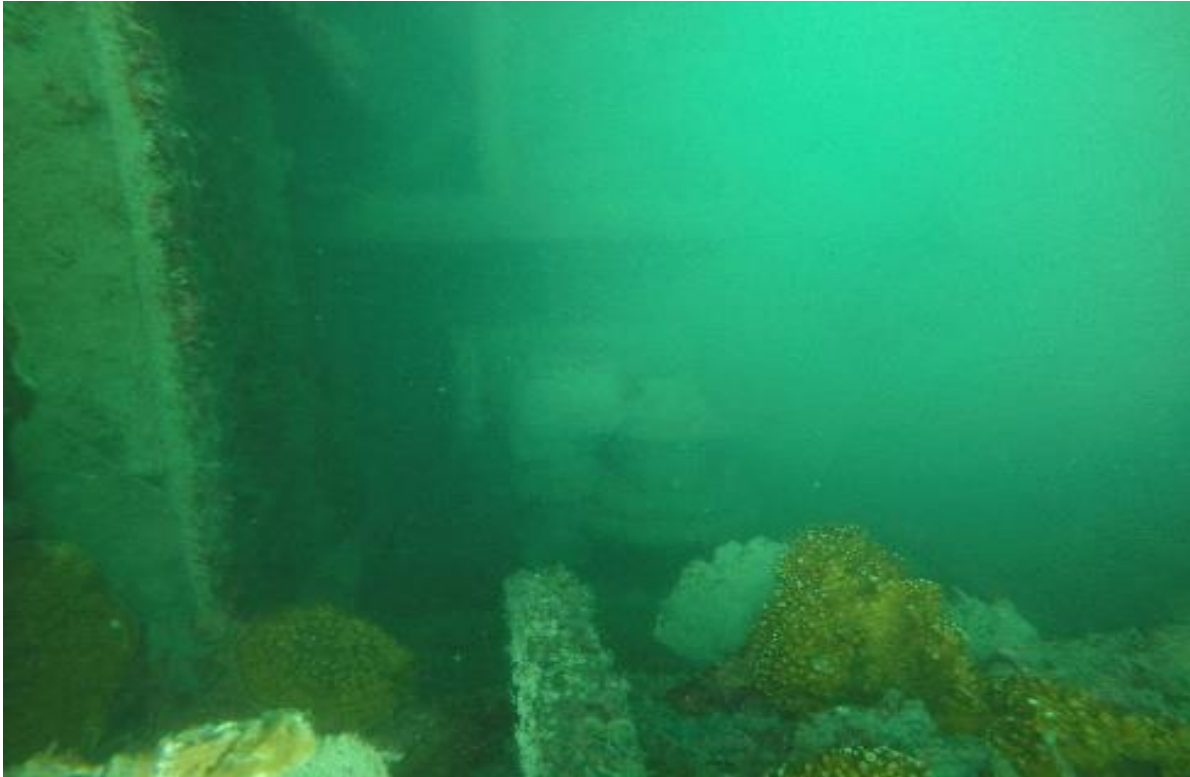
Figure 3-109 Missing Deck Plating, Exposed Engine Parts on Target 16 (Photo by AECOM)

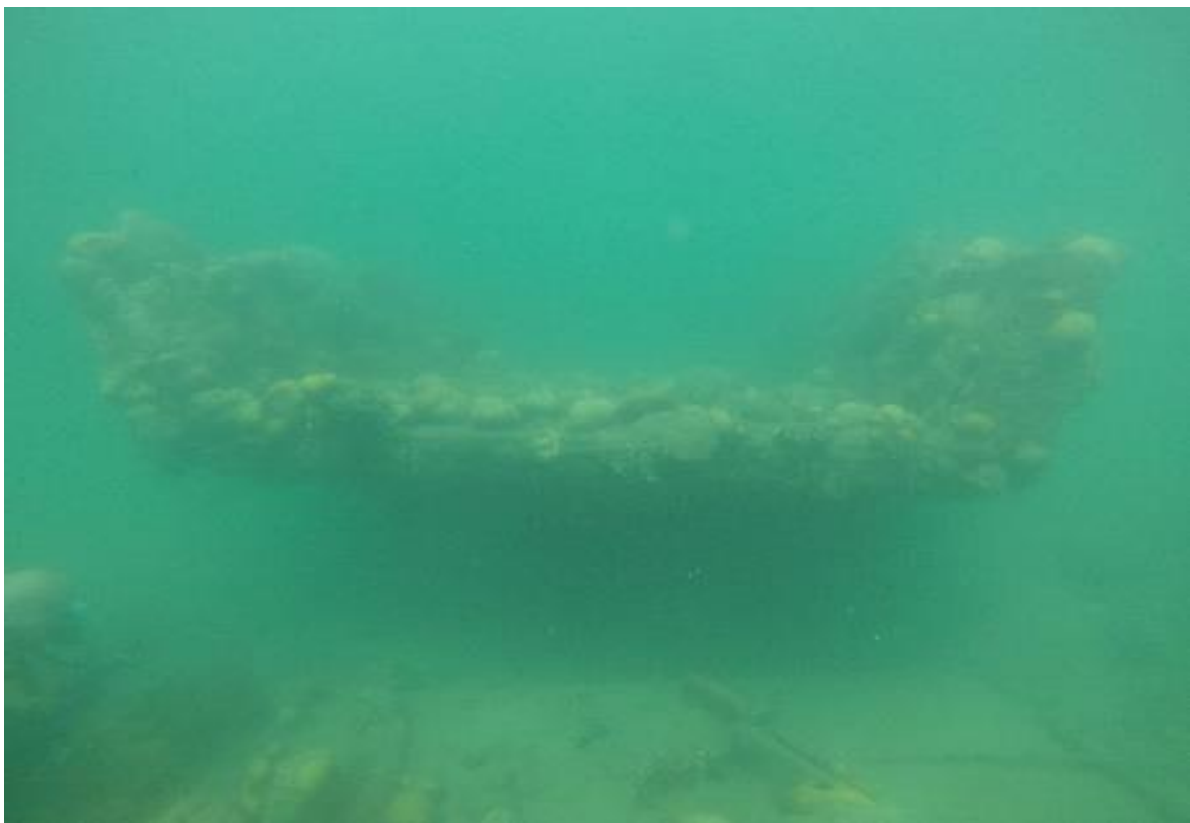
Figure 3-110 Detached Ramp of Target 16 (Photo by AECOM)
