**Phase I Environmental Site**

**Assessment**

**Yap Seaport**

**May 2024**

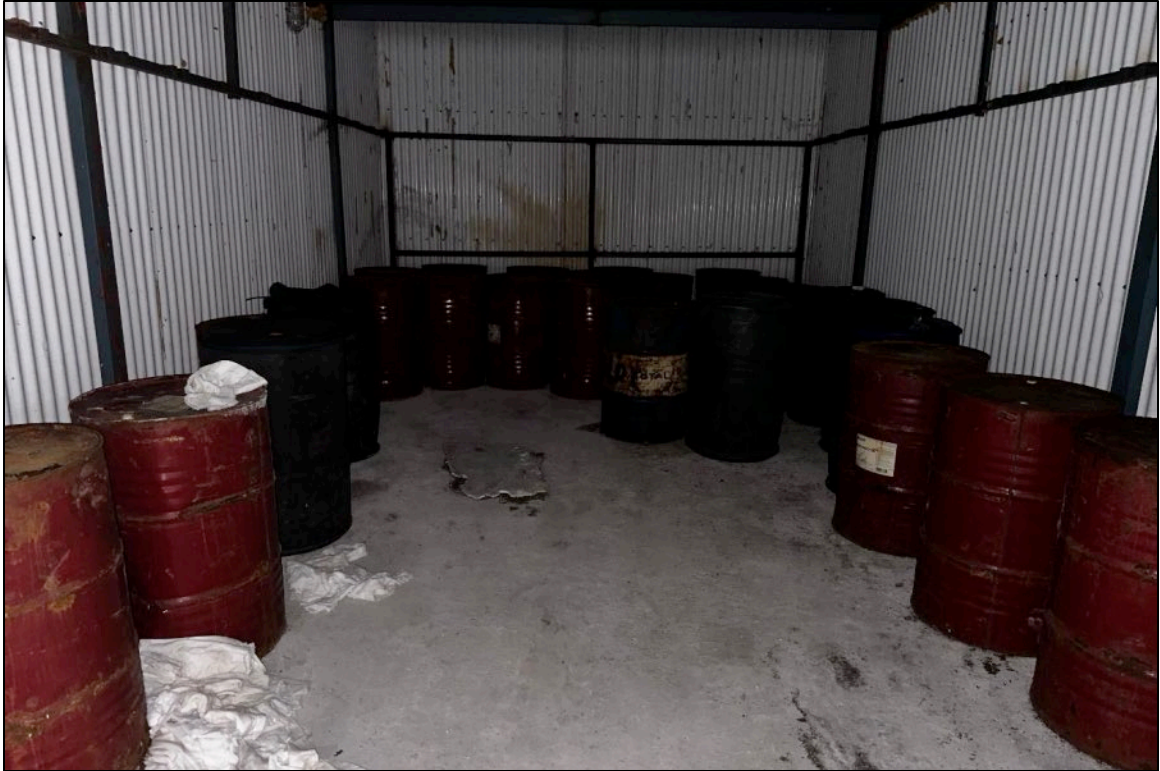
- Sixty-seven 55-gallon drums at the former tuna processing facility. Thirty-eight of the 55-gallon drums were observed in an enclosed room on a concrete floor, lacking spill pallets (Appendix A, Photos 1 and 2). Two 55-gallon metal drums were observed with corrosion and a dark colored oily substance present at their base. Only 10 of the 55-gallon drums contained labeling—Mobil Gard 525, 412, ADL 40, and 300 C—indicative of diesel engine oil. Based on gently touching each drum, it was suspected that all 38 drums in the room contained some amount of fluid (i.e., none were suspected to be empty).

Photo 1: Thirty-eight 55-gallon metal drums observed in a room near the side entrance of the former tuna canning facility.

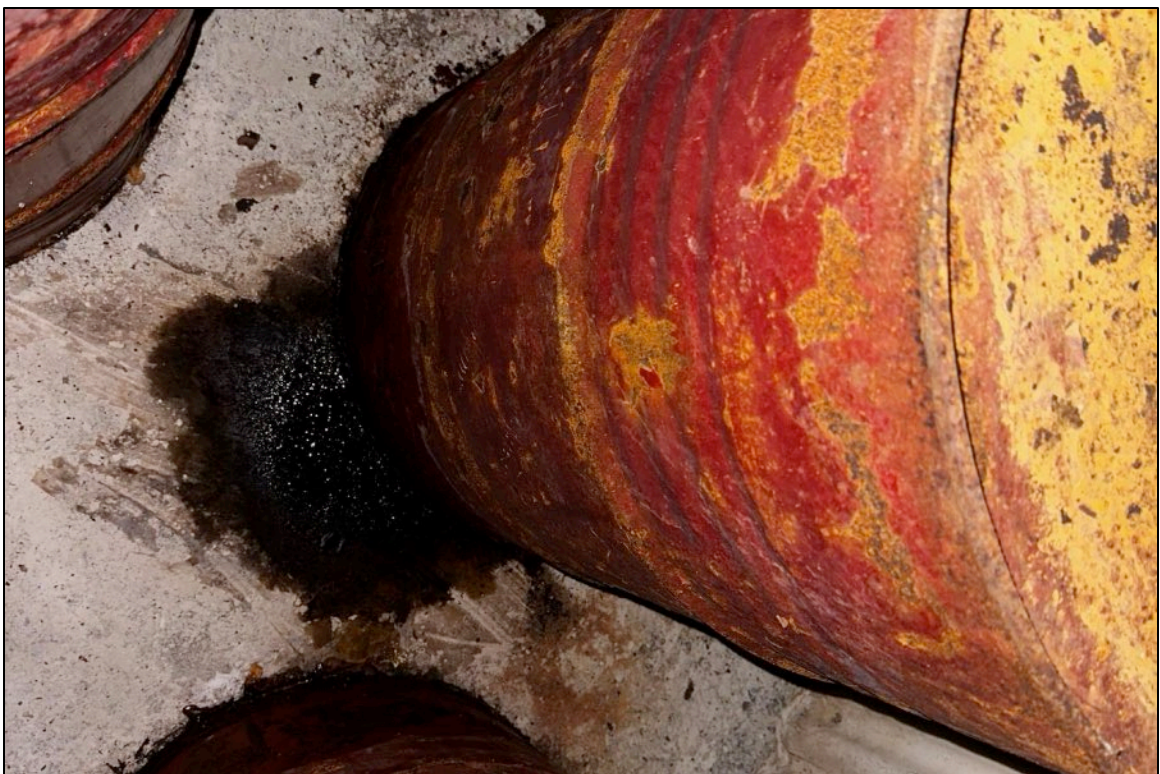
Photo 2: Close-up view of one of the drums leaking de minimis amounts of oily substance on the concrete floor.

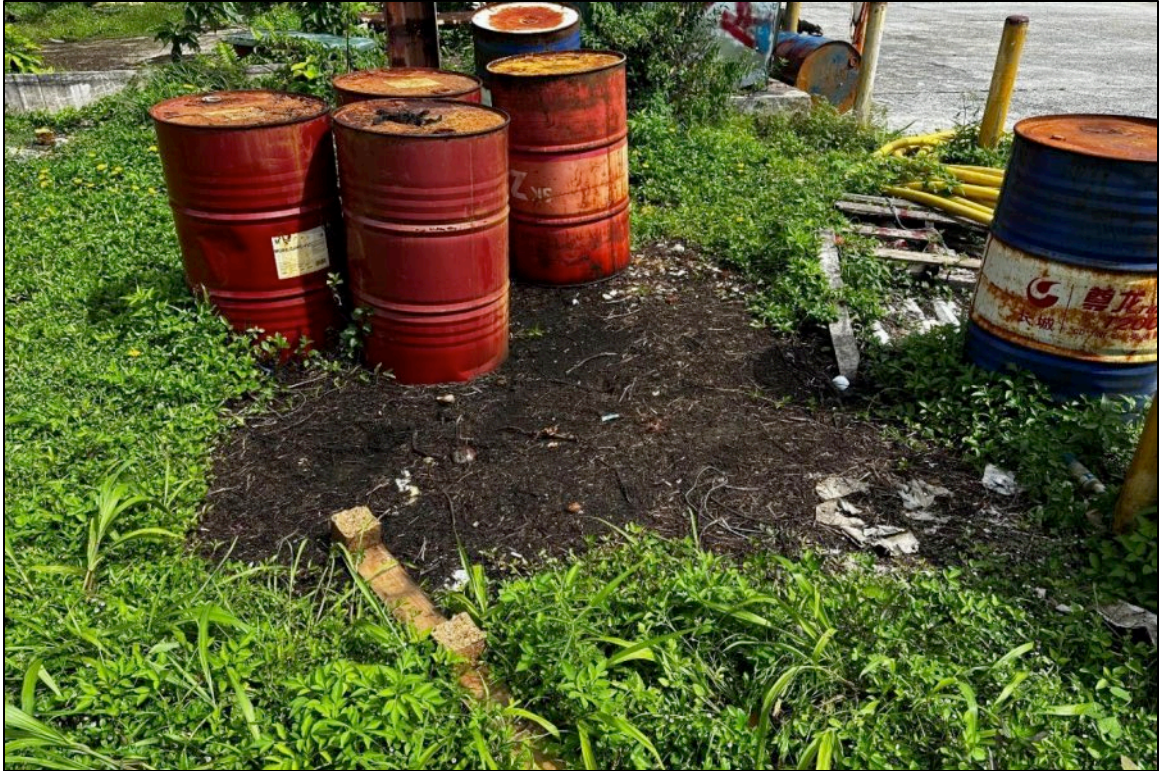
- The release of a suspected petroleum substance from four empty and unlabeled 55-gallon drums near the former tuna processing facility building is a REC, in AECOM's opinion. The approximately 20 square-foot stained area had a petroleum odor, and no vegetation was growing within the staining. Furthermore, the empty drums suggest that a significant volume of product may have leaked.

Photo 3: Four empty 55-gallon metal drums observed near the northeastern corner of the former tuna canning facility. Note stressed vegetation surrounding the drums. Photo is looking northwest.

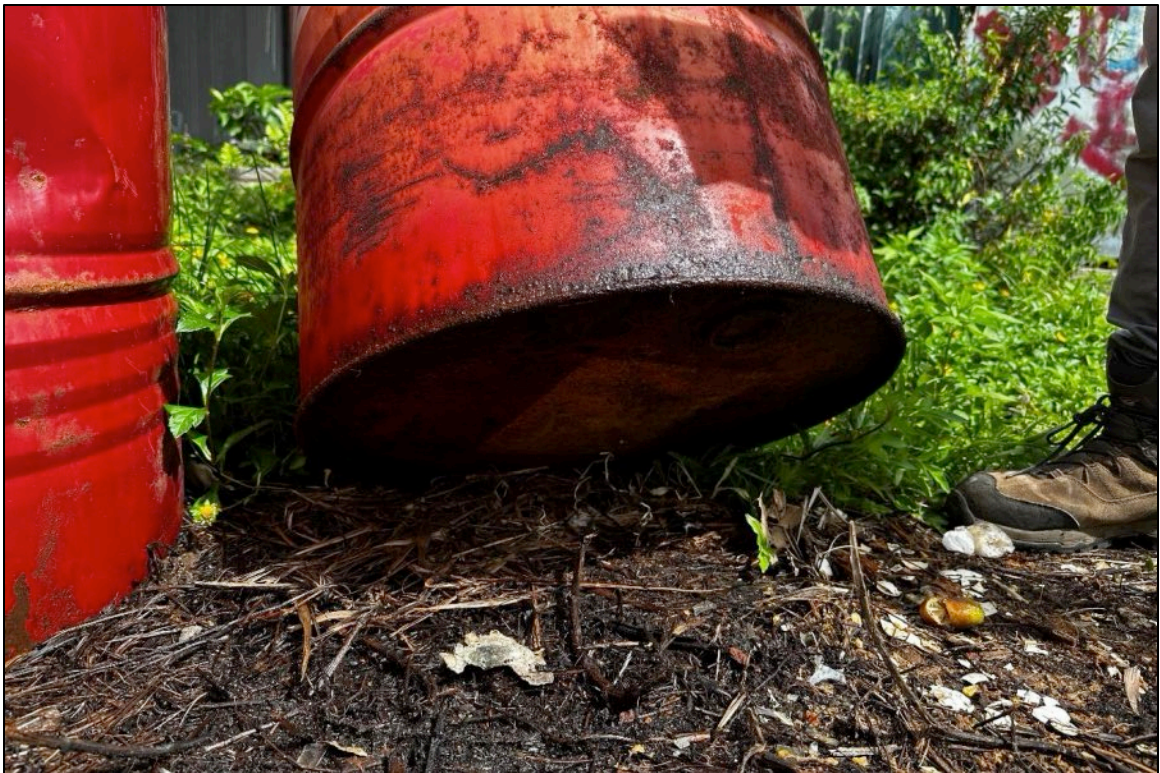
Photo 4: Close-up view of one of the four drums suspected to have leaked oily contents. Distinct petroleum odor noted emanating from dark and moist soil.

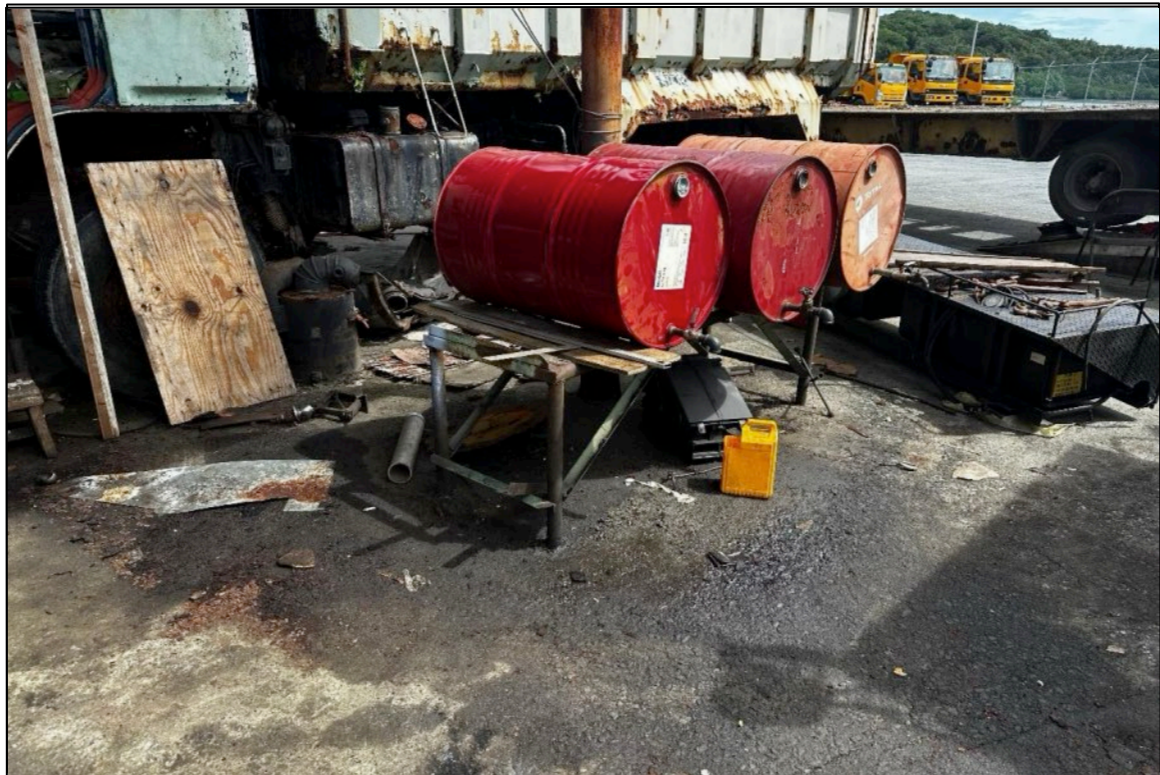
- Extensive oil staining at the Division of Sea Transportation maintenance shop, encompassing an area of approximately 200 square feet, is considered a REC, in AECOM's opinion. Petroleum hydrocarbons have likely leached to underlying soil and entered floor and trench drains.

Photo 6: Closer look at three 55-gallon drums containing hydraulic oil. Note: Extensive staining observed on the concrete surface. This type of staining was observed throughout the premises. Photo is looking north.

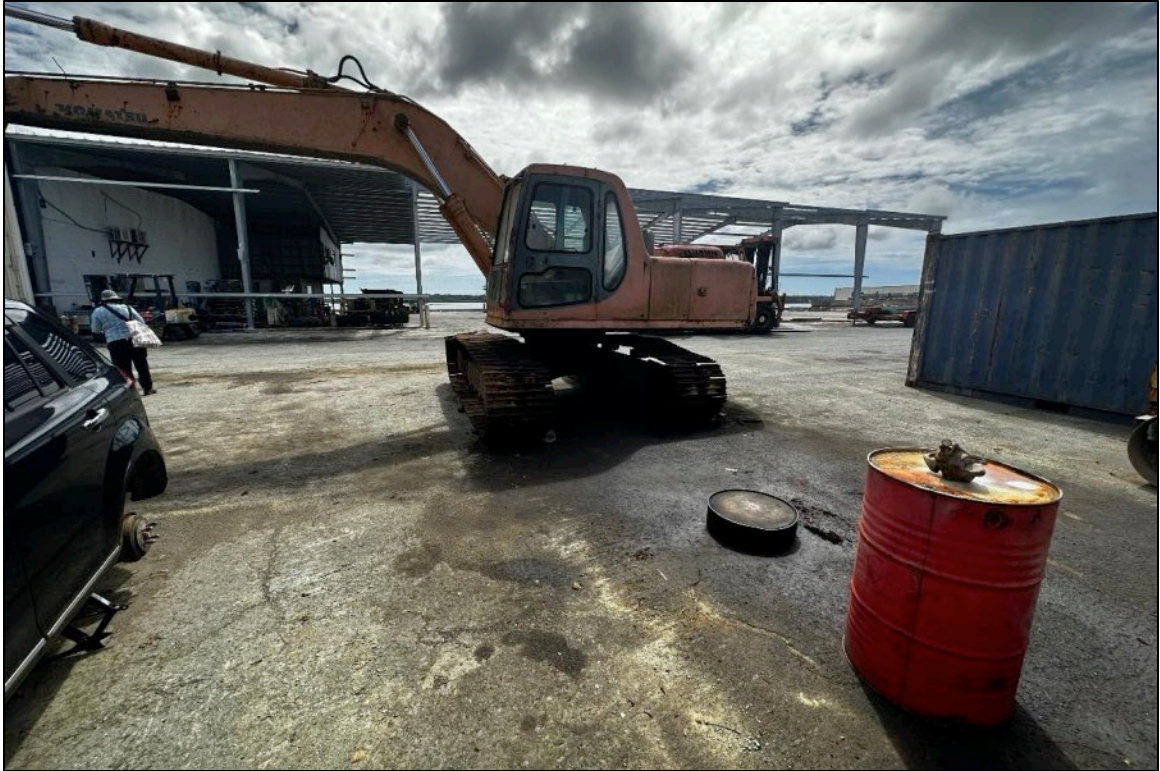
Photo 7: Closer look at other area within the main port maintenance shop displaying concrete staining. Photo is looking northeast.

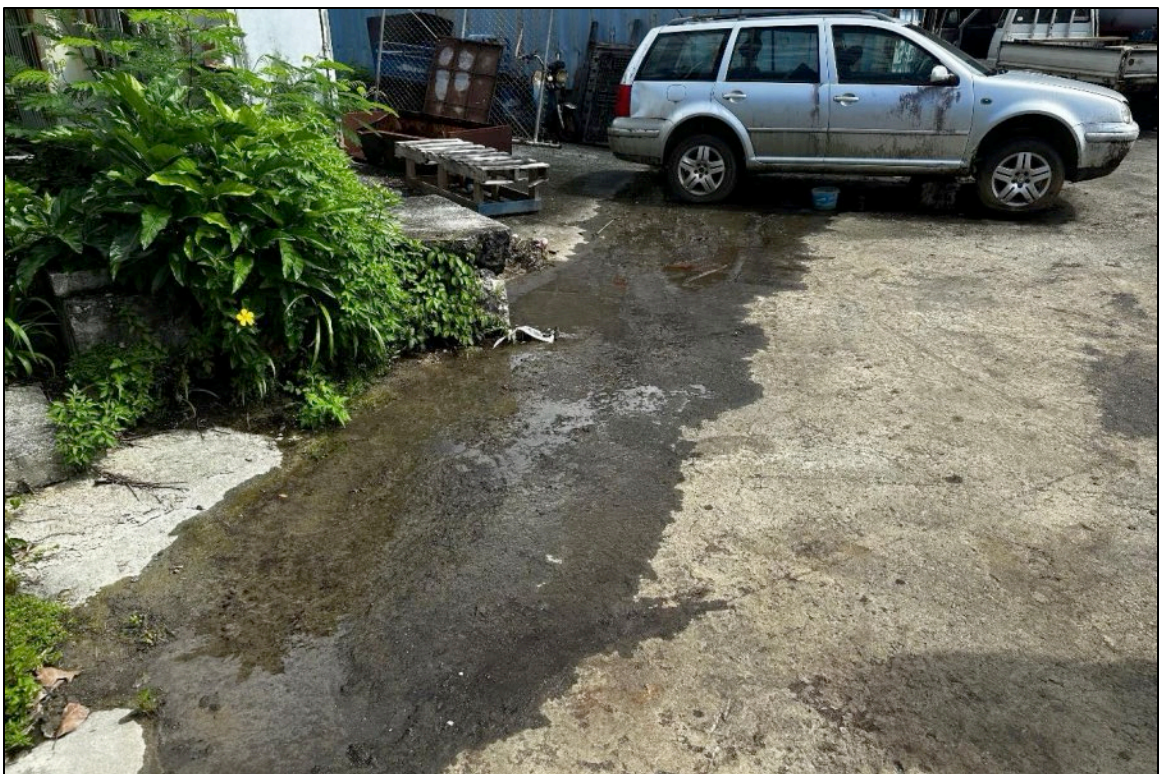
Photo 8: Runoff from washing activities at the maintenance shop heading toward a drainage channel nearby. Photo is looking northwest.

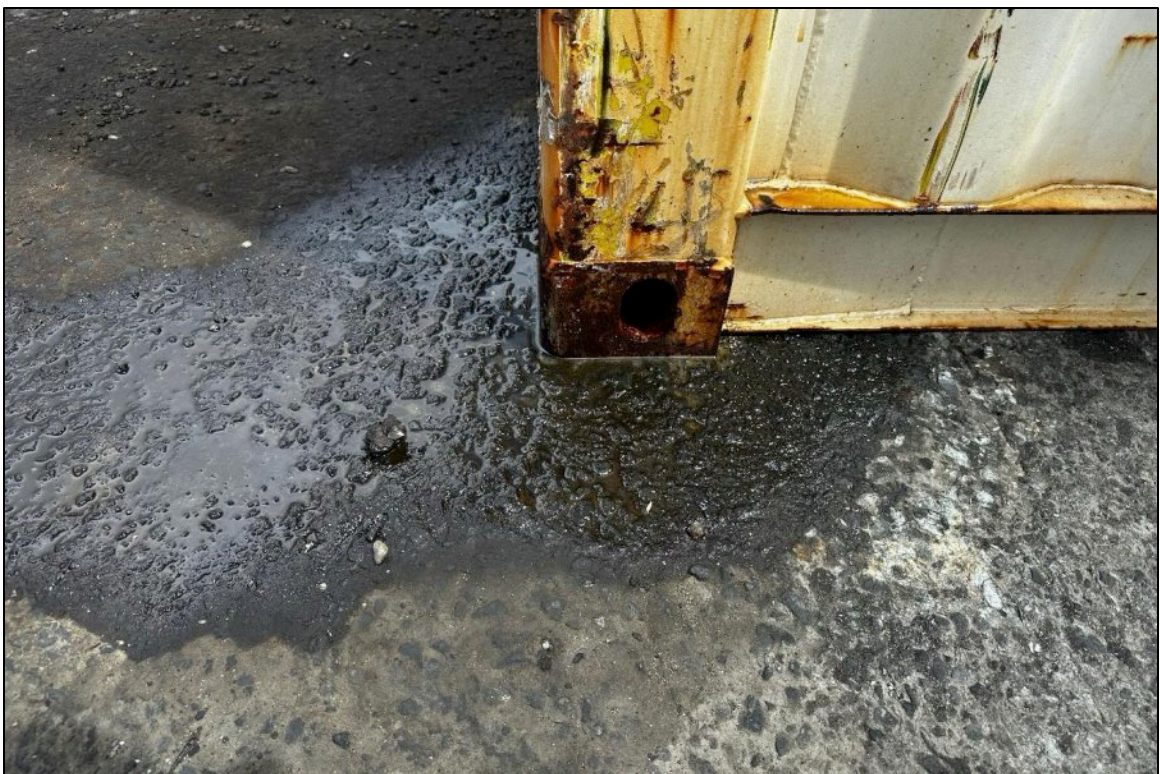
- A shipping container managed by Waab Transportation Company of unknown origin was observed leaking small quantities of a viscous, yellowish substance. The Port Officer at the Division of Sea Transportation Office was not aware of the contents of the container; however, due to the localized nature of the release, AECOM considers this staining a DMC.
- Four small oil stains (less than 2 square feet each) observed at the Yap Fishing Authority maintenance shop. Given the localized nature, AECOM considers this staining a DMC.

Photo 10: Close-up view of shipping container managed by Waab Transportation Company of unknown origin observed leaking small quantities of a viscous, yellowish substance.

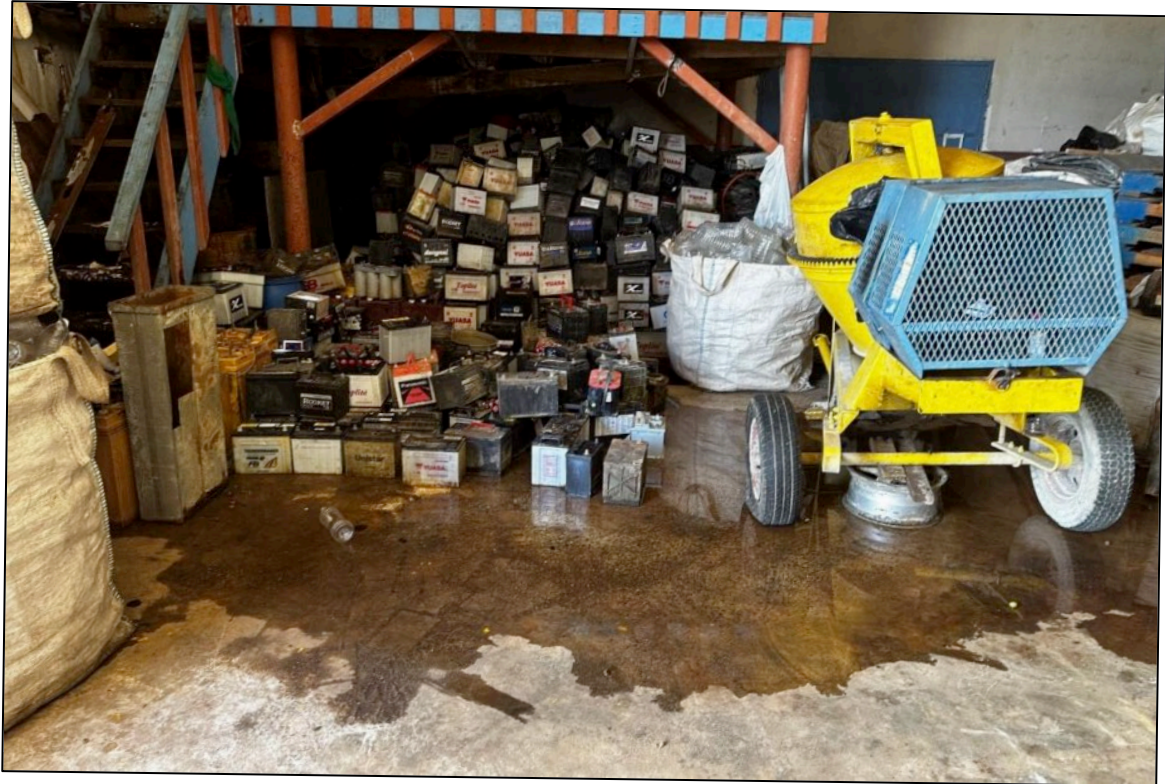
- A stockpile of automobile and other equipment batteries at the Recycling Center is a REC, in AECOM's opinion. These batteries were situated on a concrete floor atop a substantial pool of liquid, reportedly identified as rainwater by personnel on site. Although no significant floor cracks were observed, various floor drains were observed in the vicinity of the batteries.

Photo 15: Overview of a lead-acid battery pile located inside the Recycling Center observed sitting on a large puddle of rainwater. Approximately 200–300 batteries were estimated. Photo taken standing on top of floor drain.

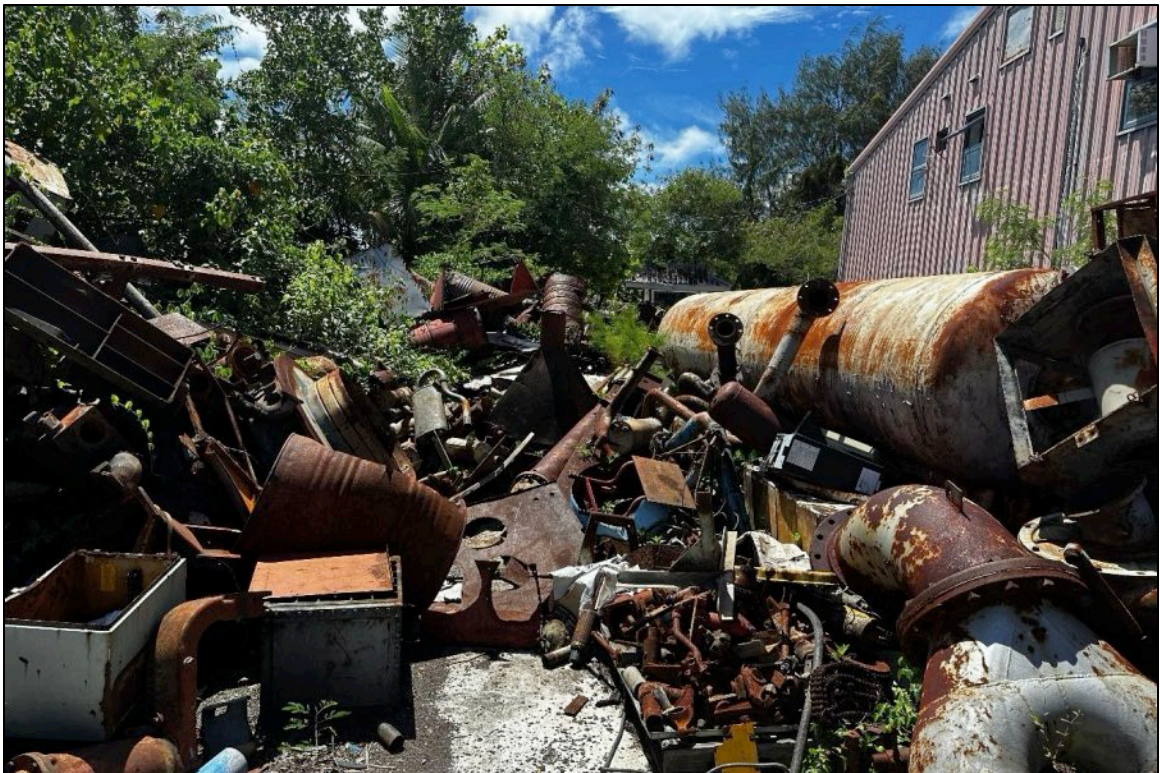
Photo 18: Overview of an approximately 1,500-square-foot scrap metal pile located adjacent to the Recycling Center. Photo is looking east.

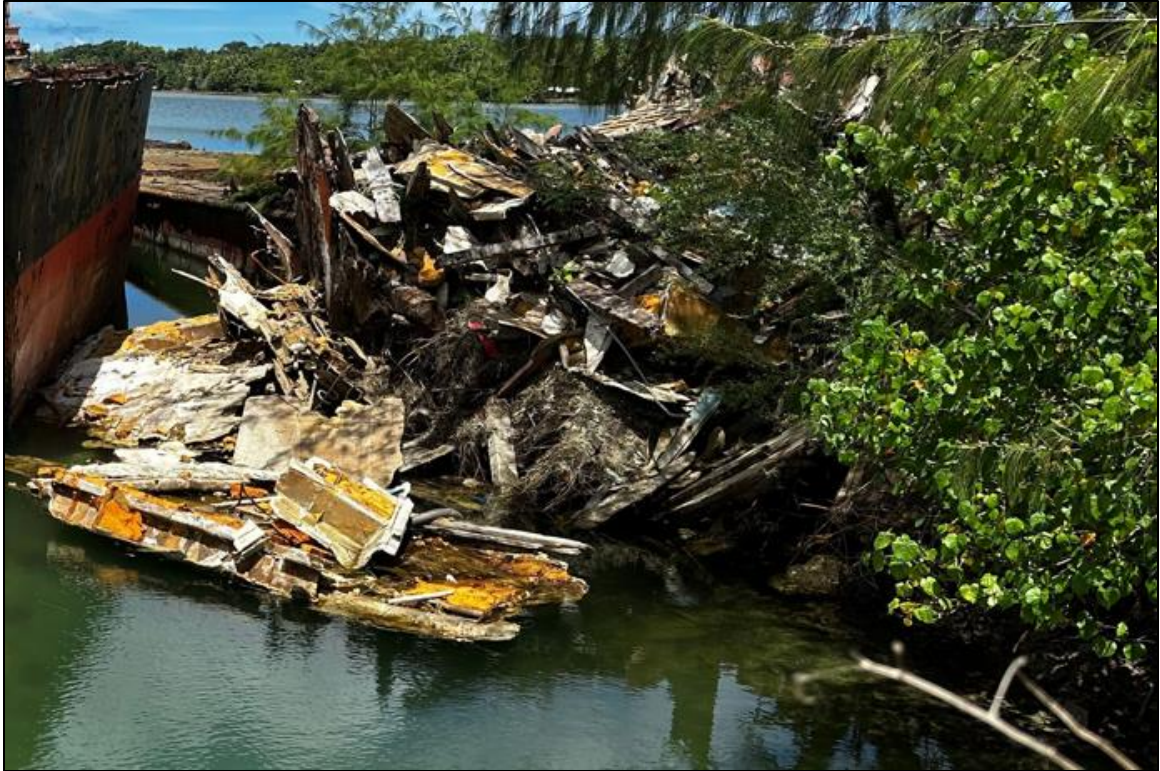
Photo 19: Overview of demolition debris mound located in the southeasternmost point of the subject property. A portion of the mound was observed eroding into the ocean. Photo is looking southeast.

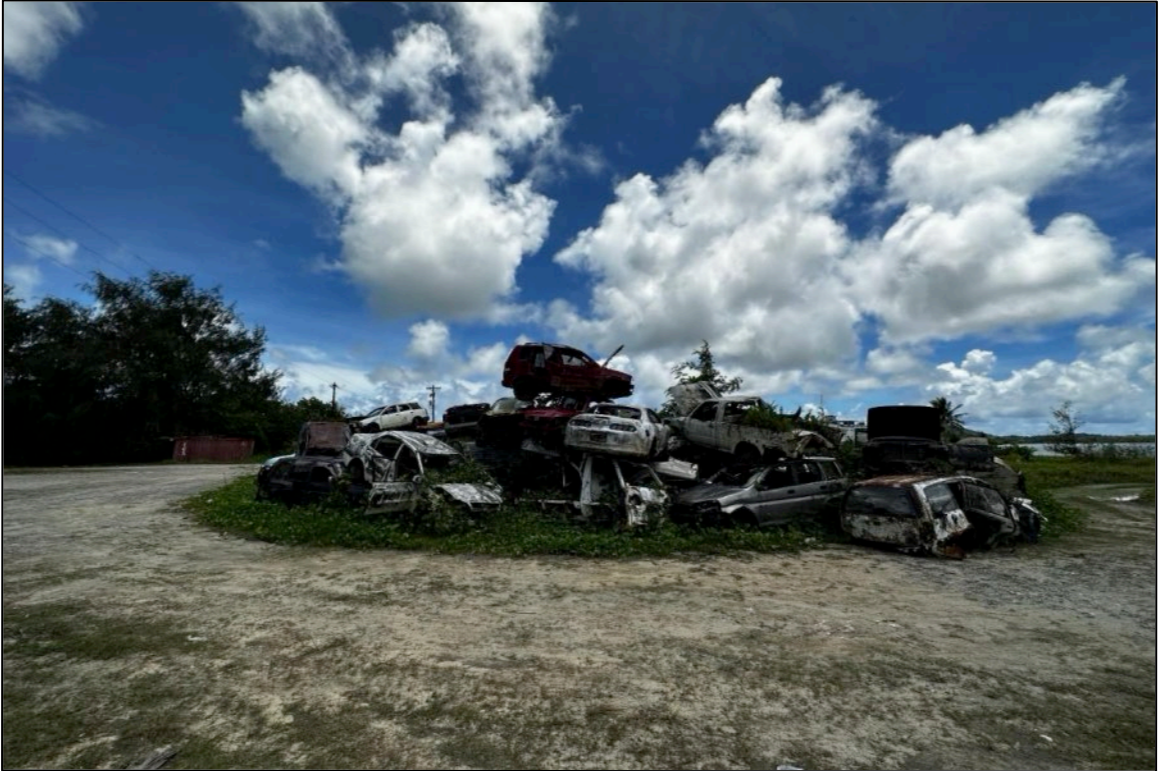
- Three piles of metal debris, primarily consisting of abandoned automobiles and automotive parts are present in the salvage yard within the subject property. The piles measured approximately 7,000, 1,500, and 1,300 square feet. In addition, a deteriorated 20-foot metallic tank marked as "unleaded gas," was identified and exhibited substantial corrosion and perforations. The condition of such an abandoned tank may indicate a release of hazardous substances or petroleum products into the surrounding environment. The piles have not been previously investigated, and it is unknown whether metals or other contaminants are present at concentrations that represent a hazard to human or ecological health; therefore, this finding is considered a REC in AECOM's opinion.

Photo 21: Overview of one of the three non-contiguous abandoned vehicle piles. Photo is looking north.

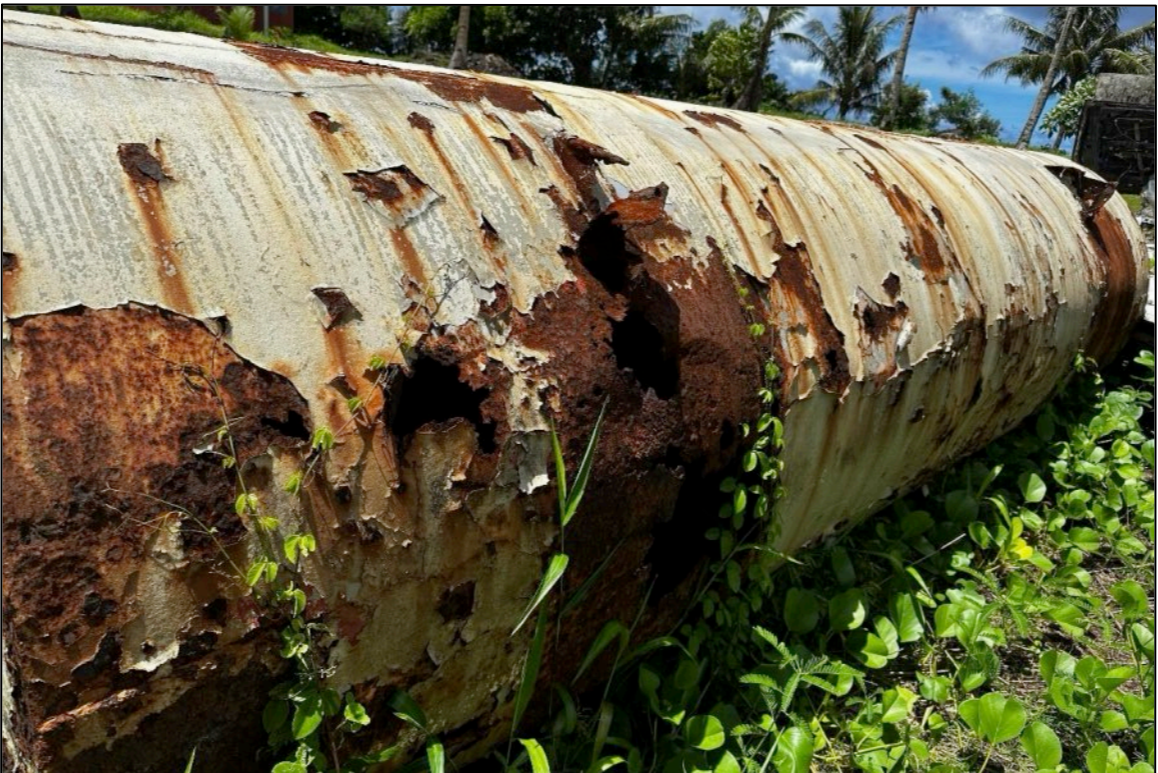
Photo 22: Close-up view of empty, deteriorated AST observed adjacent to the abandoned vehicle piles. Photo is looking west.

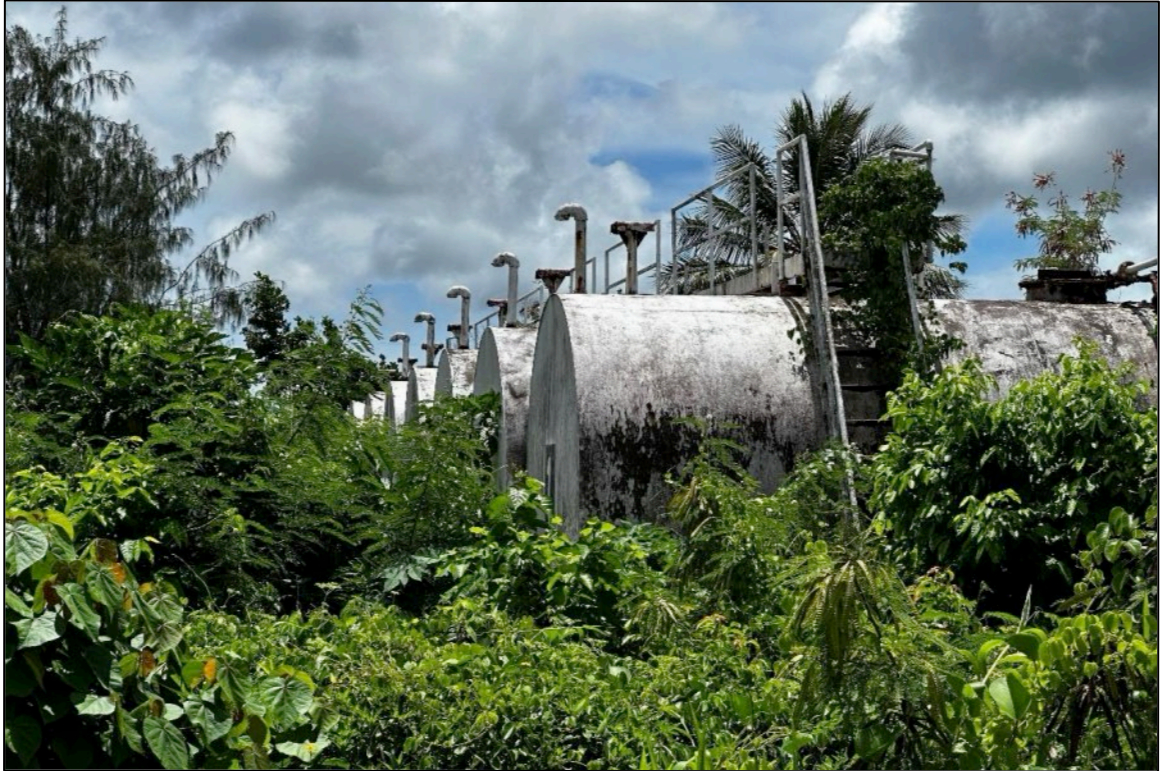
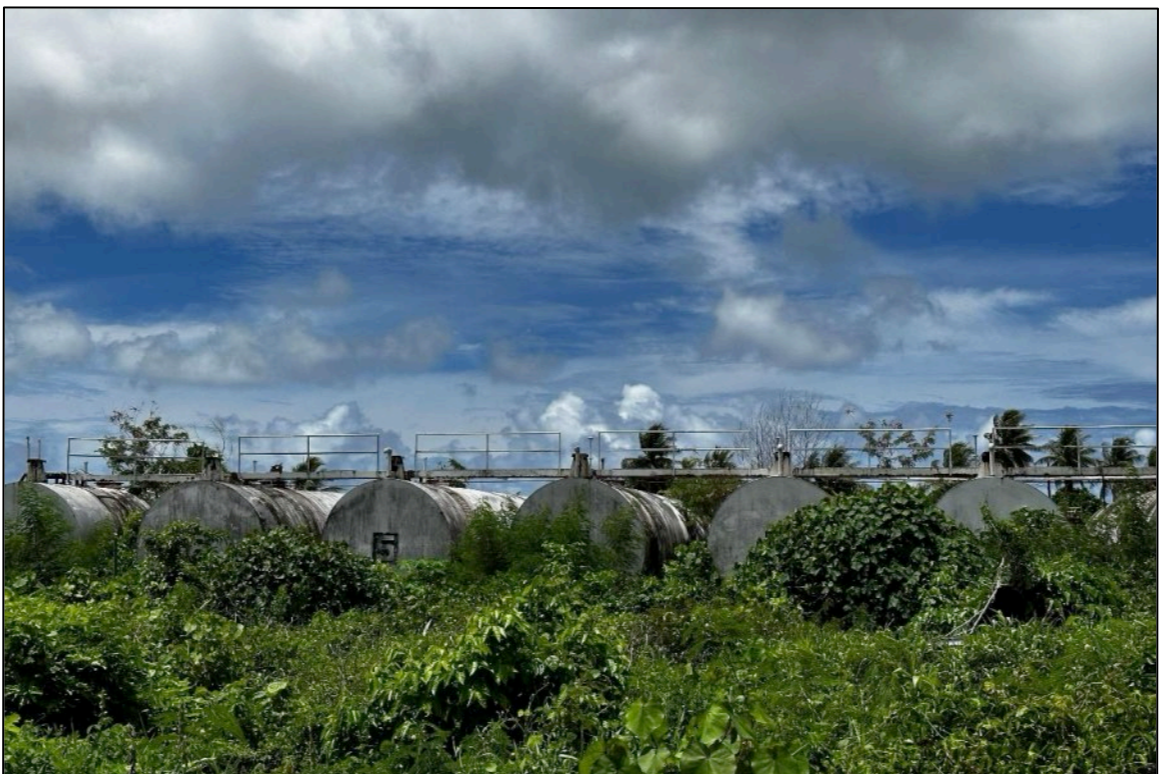
- Seven fuel tanks previously utilized by the U.S. Coast Guard on the subject property are considered a REC, in AECOM's opinion. The ASTs could only be observed from a distance during the site visit because of overgrown dense vegetation and the surrounding terrain; however, they appeared to be slightly corroding. It was not ascertainable from interviews whether any fuel remains in the ASTs and abandonment documentation was not available.

- AECOM was unable to observe seven abandoned fuel tanks on the subject property previously utilized by the U.S. Coast Guard. The ASTs could not be visually inspected up close due to the overgrown nature of the surrounding terrain; however, they appeared to be slightly corroded, yet no visible holes were observed in any of the ASTs from a distance. Precise abandonment dates and related abandonment documentation was not available. Based on the lack of documentation regarding the abandonment of such fuel tanks, the ASTs are considered a REC. Additional information would likely assist the environmental professional in determining whether a REC exists.

Photo 23: Zoomed-in photograph of the seven abandoned former U.S. Coast Guard fuel tanks. Photo is looking southeast.

Photo 24: Zoomed-in photograph of the seven abandoned former U.S. Coast Guard fuel tanks. Photo is looking west.

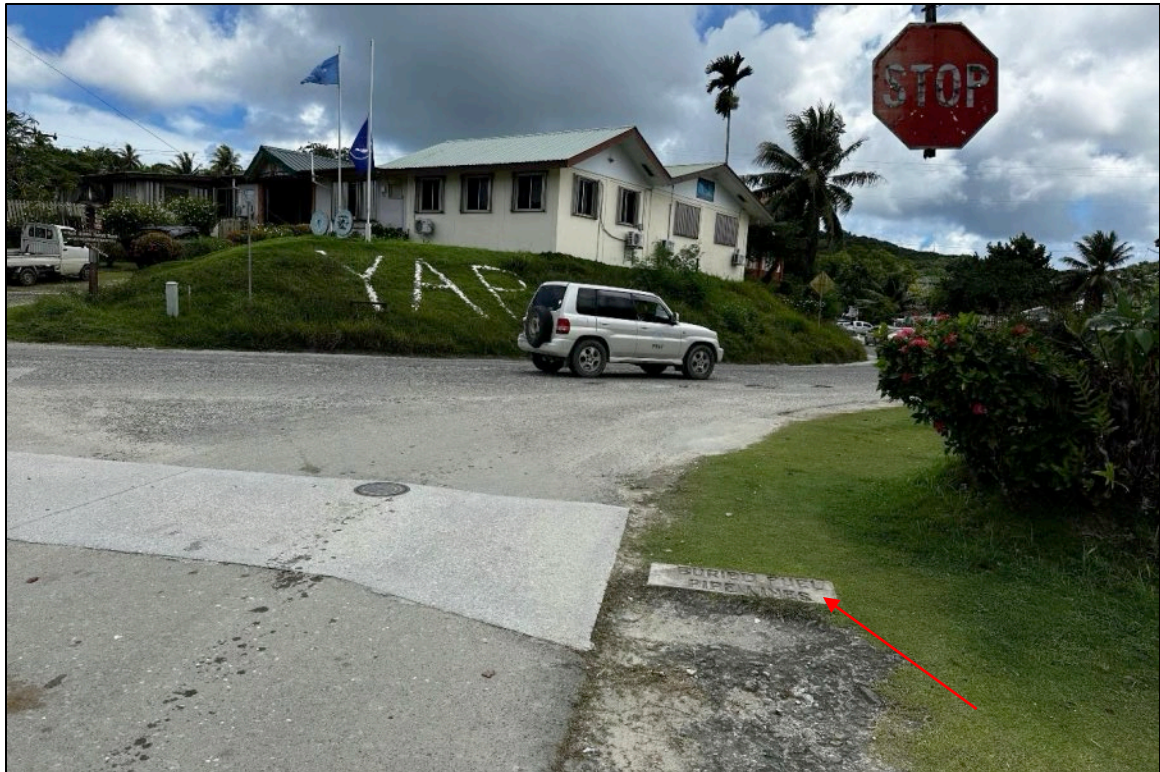
- The underground fuel pipeline that transports fuel from the PetroCorp fuel farm to the port is present throughout the subject property. It could not be determined during this Phase I ESA whether the pipeline is regularly leak tested, the leak testing methods, and testing results. Based on this lack of information, the pipeline represents a material threat of a potential future release and a REC, in AECOM's opinion.

Photo 25: Overview of the northern border of the subject property. Note: A buried fuel line marking exists on the street (denoted by red arrow). Photo is looking northwest.

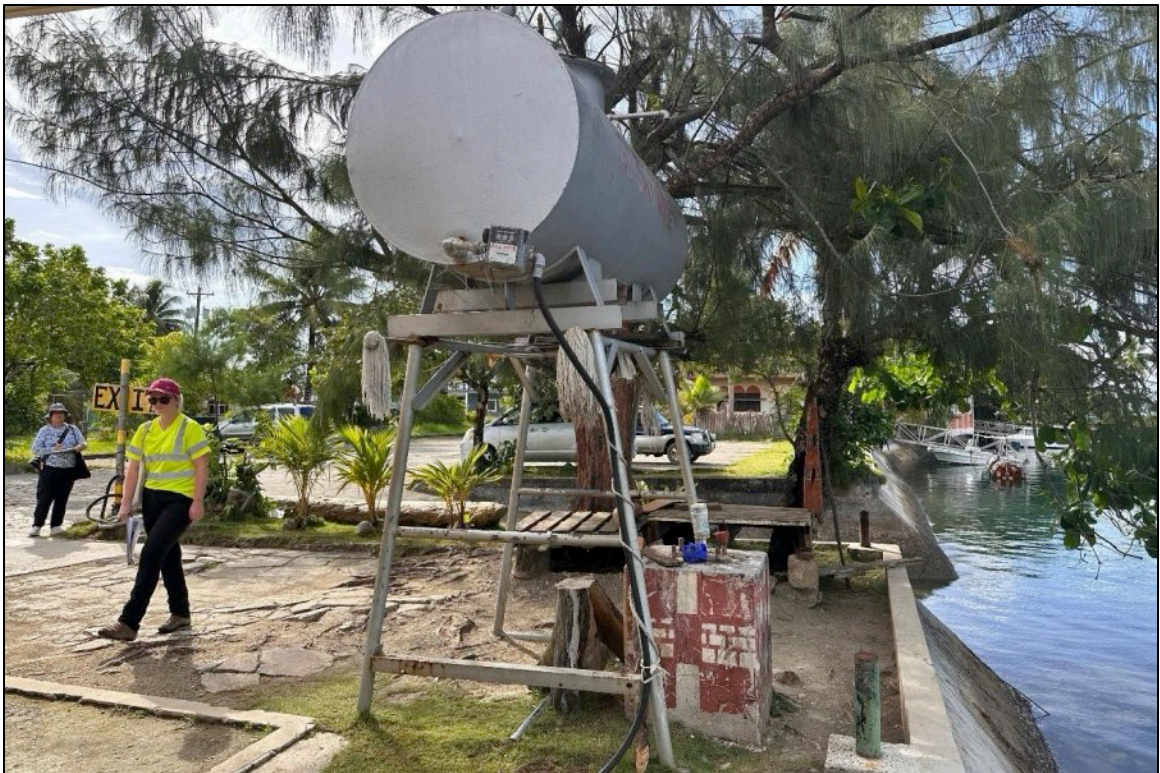
Photo 28: Overview of 320-gallon kerosene AST lacking secondary containment. Photo is looking east.
