**Naval Facilities Engineering Systems Command Pacific
JBPHH HI**

Phase I Environmental Site

Yap Seaport

ISLAND OF YAP FEDERATED STATES OF MICRONESIA

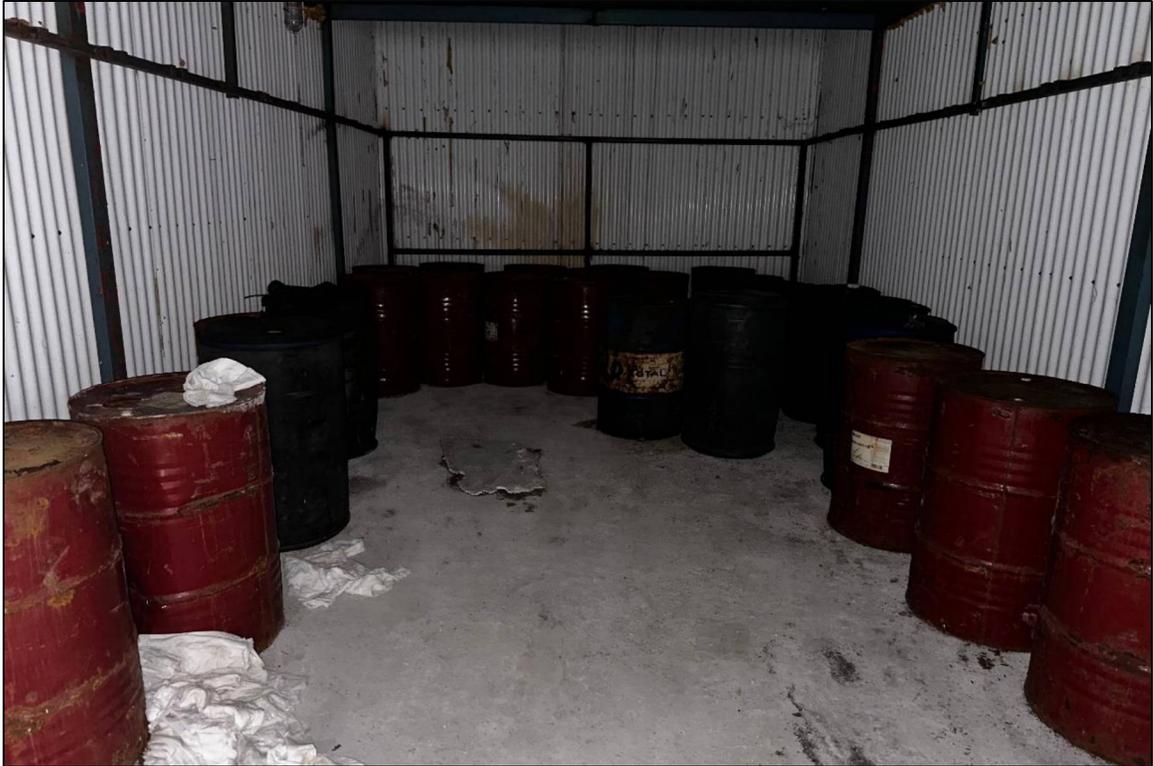
- Sixty-seven 55-gallon drums at the former tuna processing facility. Thirty-eight of the 55-gallon drums were observed in an enclosed room on a concrete floor, lacking spill pallets (Appendix A, Photos 1 and 2). Two 55-gallon metal drums were observed with corrosion and a dark colored oily substance present at their base. Only 10 of the 55-gallon drums contained labeling—Mobil Gard 525, 412, ADL 40, and 300 C—indicative of diesel engine oil. Based on gently touching each drum, it was suspected that all 38 drums in the room contained some amount of fluid (i.e., none were suspected to be empty).

Photo 1: Thirty-eight 55-gallon metal drums observed in a room near the side entrance of the former tuna canning facility.

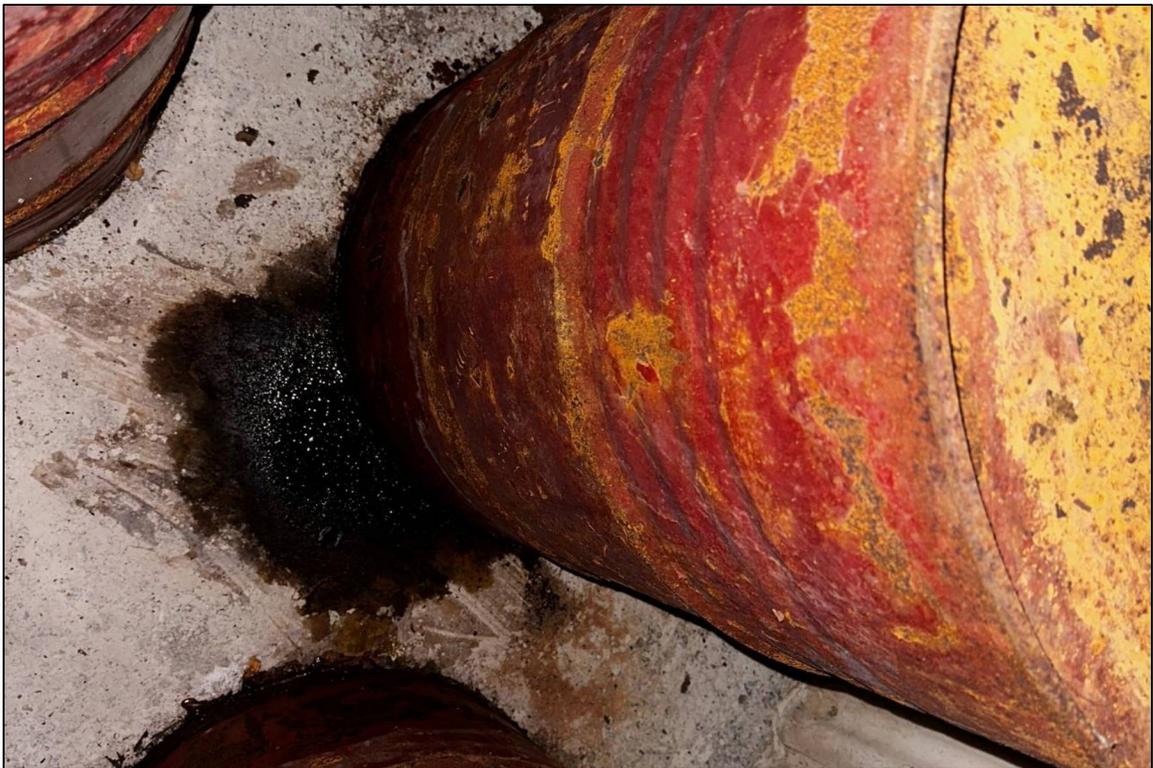
Photo 2: Close-up view of one of the drums leaking de minimis amounts of oily substance on the concrete floor.

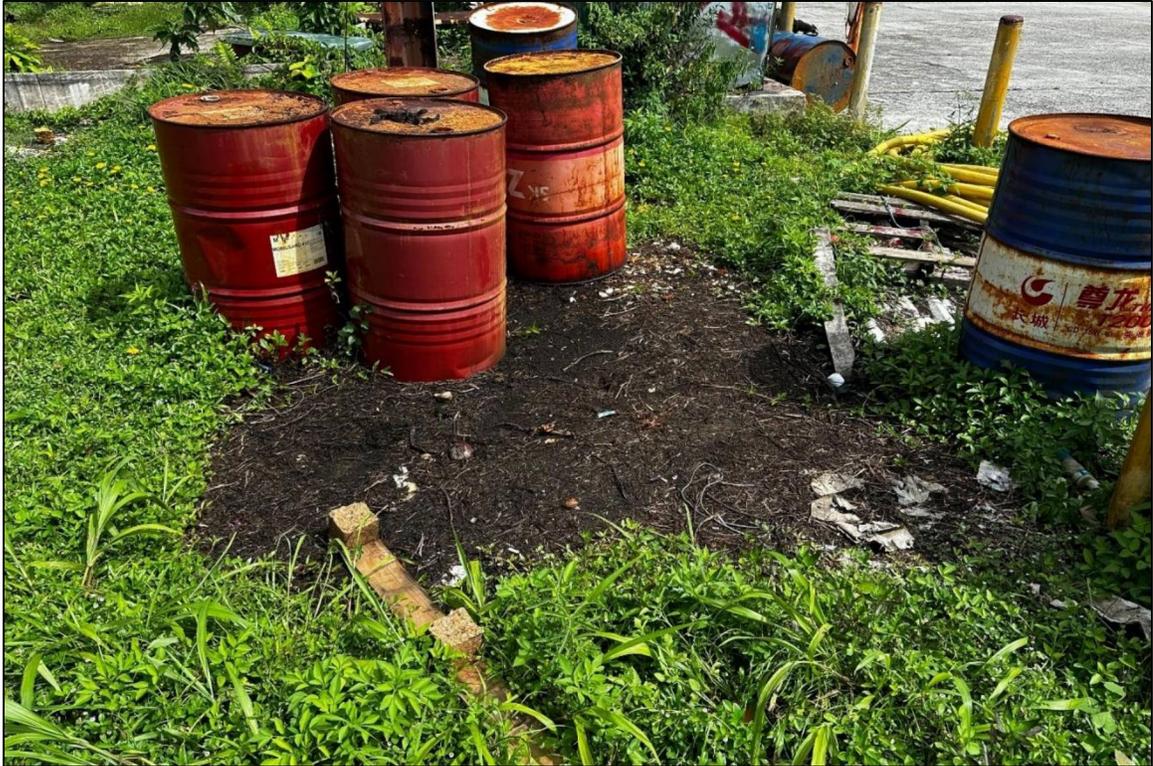
- The release of a suspected petroleum substance from four empty and unlabeled 55-gallon drums near the former tuna processing facility building is a REC, in AECOM's opinion. The approximately 20 square-foot stained area had a petroleum odor, and no vegetation was growing within the staining. Furthermore, the empty drums suggest that a significant volume of product may have leaked.

Photo 3: Four empty 55-gallon metal drums observed near the northeastern corner of the former tuna canning facility. Note stressed vegetation surrounding the drums. Photo is looking northwest.

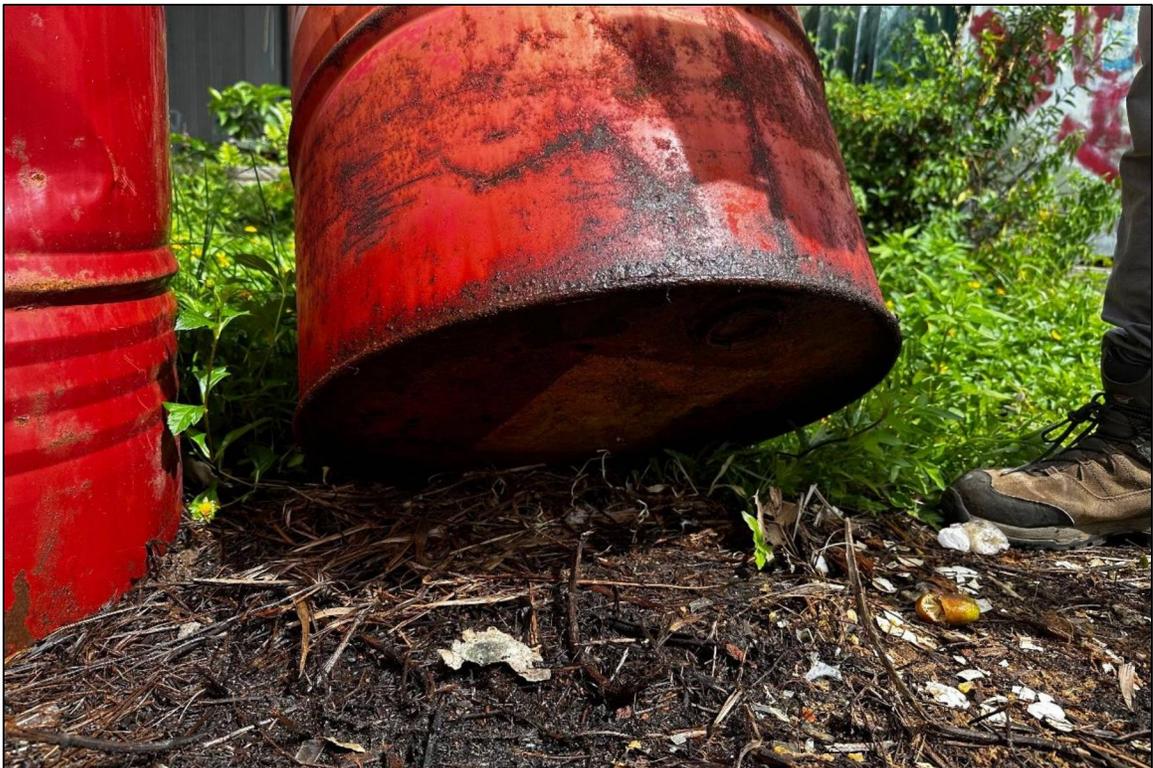
Photo 4: Close-up view of one of the four drums suspected to have leaked oily contents. Distinct petroleum odor noted emanating from dark and moist soil.

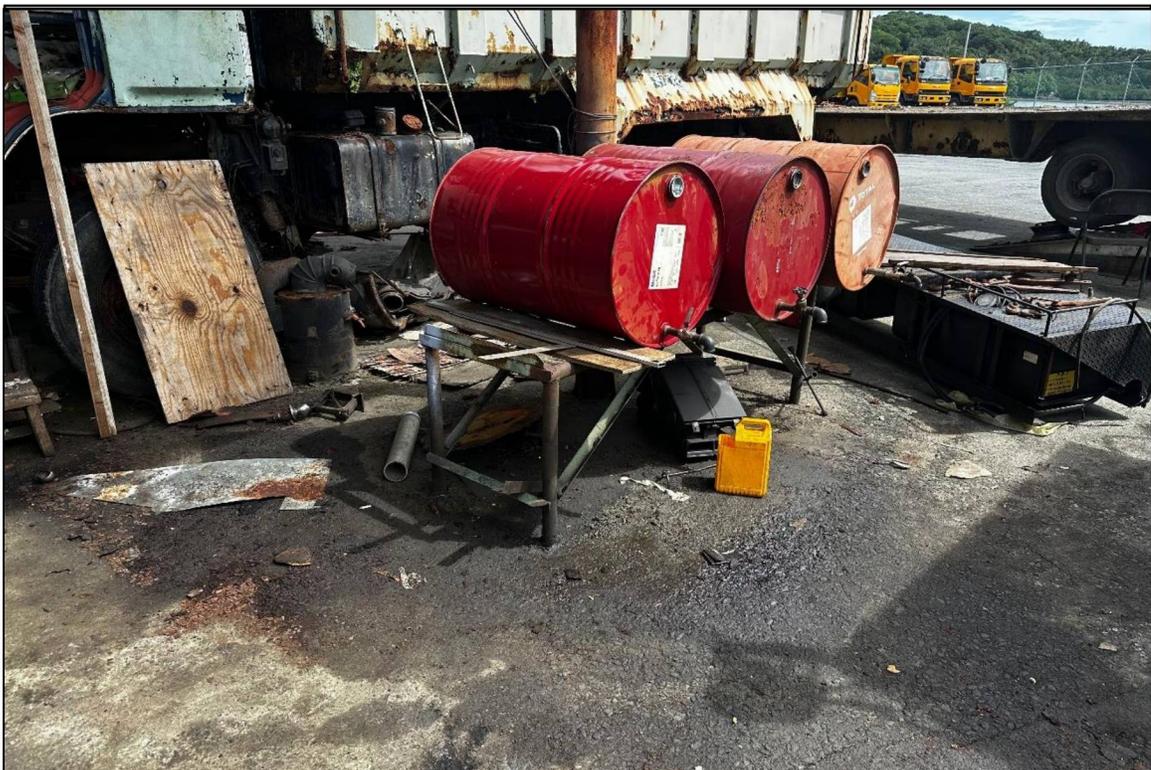
- Extensive oil staining at the Division of Sea Transportation maintenance shop, encompassing an area of approximately 200 square feet, is considered a REC, in AECOM's opinion. Petroleum hydrocarbons have likely leached to underlying soil and entered floor and trench drains.

Photo 6: Closer look at three 55-gallon drums containing hydraulic oil. Note: Extensive staining observed on the concrete surface. This type of staining was observed throughout the premises. Photo is looking north.

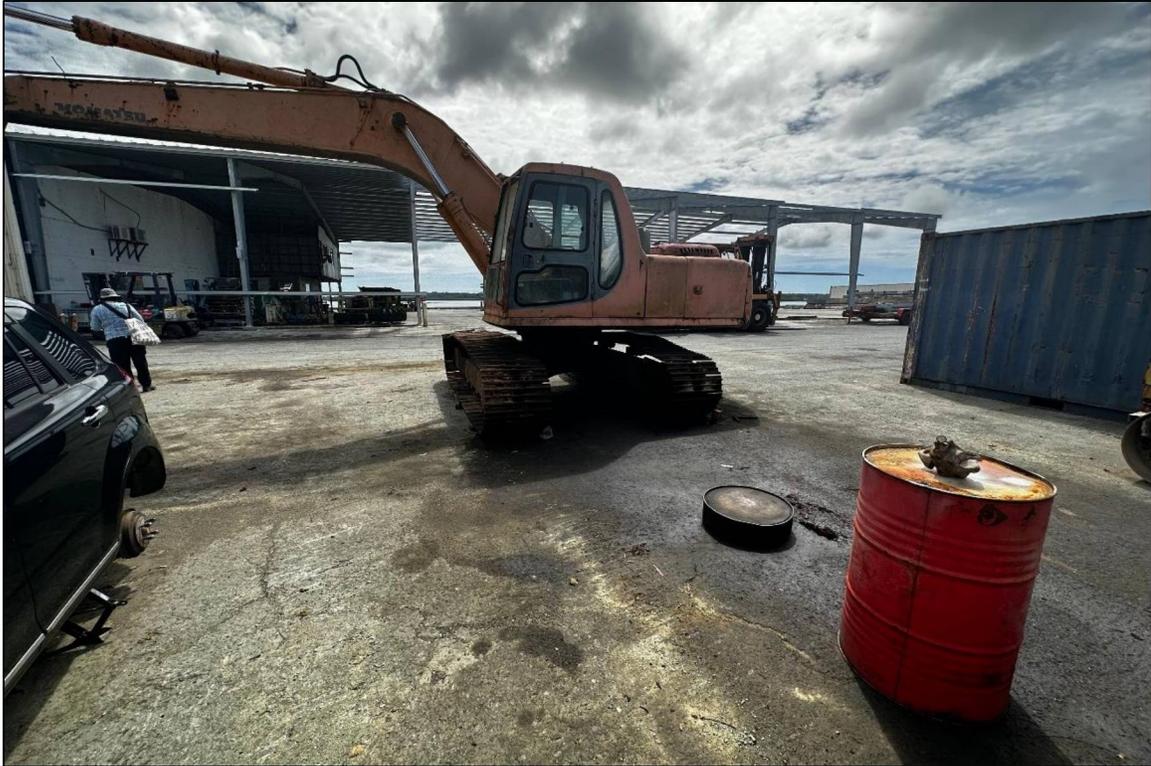
Photo 7: Closer look at other area within the main port maintenance shop displaying concrete staining. Photo is looking northeast.

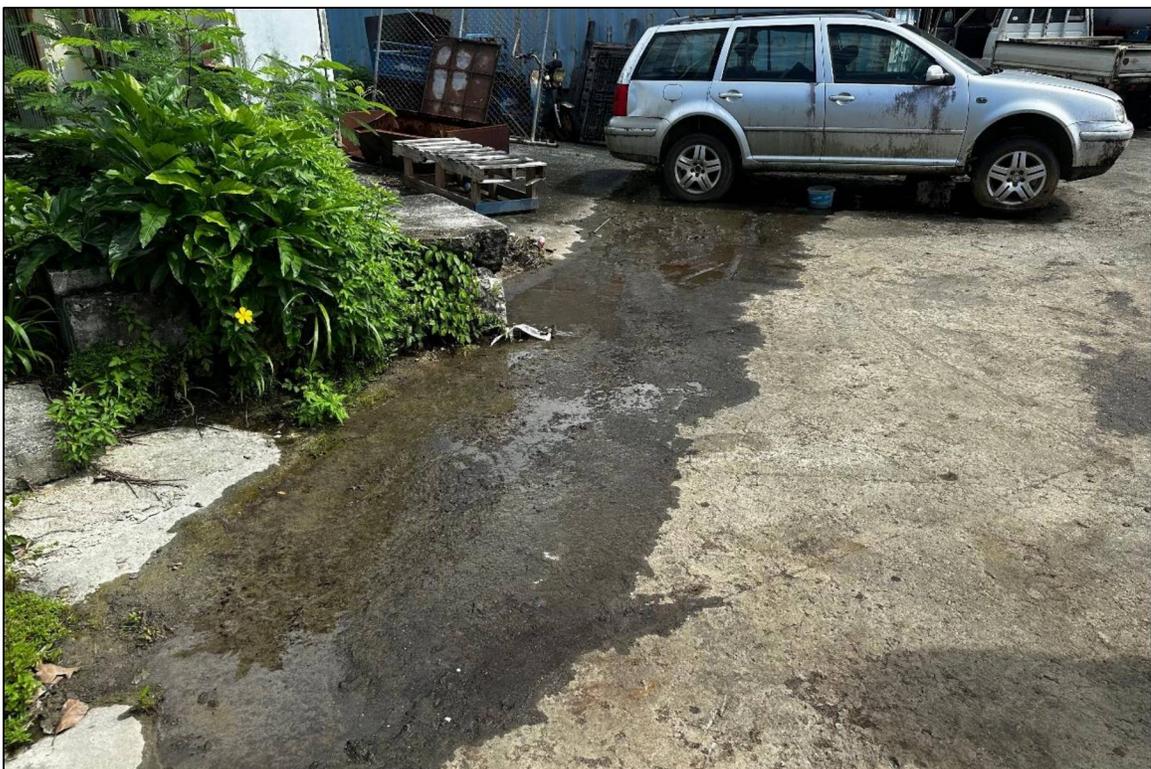
Photo 8: Runoff from washing activities at the maintenance shop heading toward a drainage channel nearby. Photo is looking northwest.

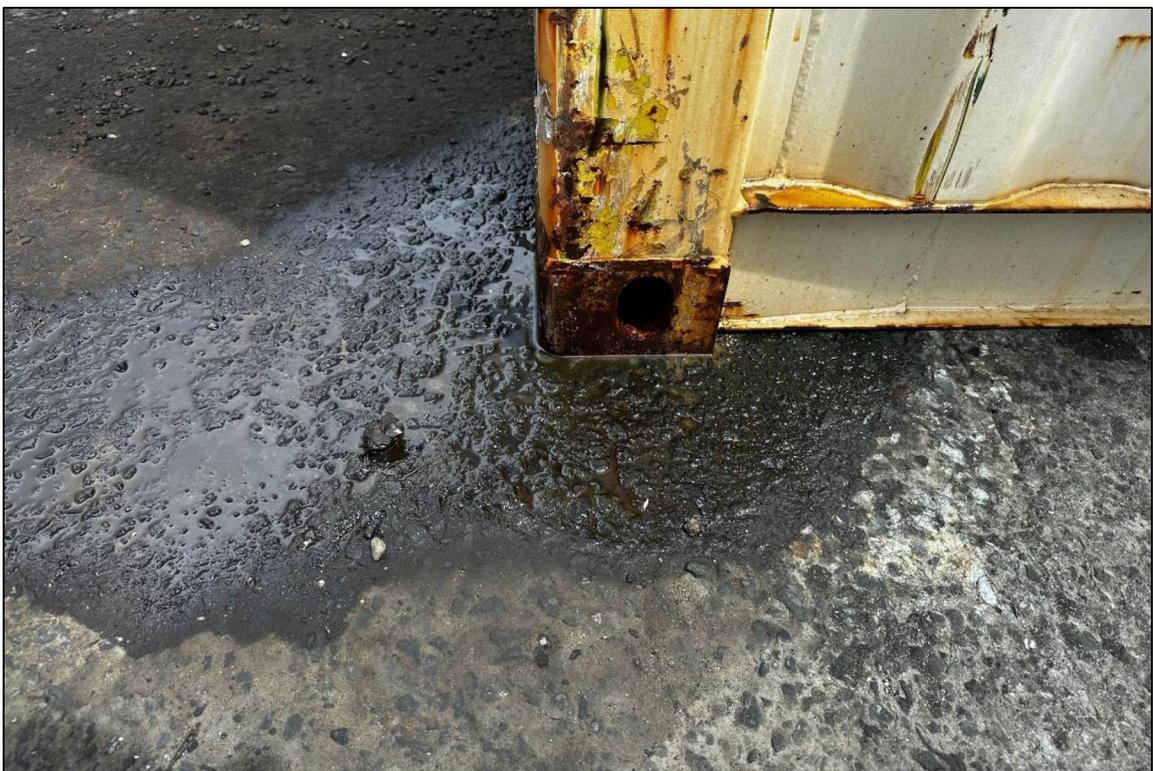
- A shipping container managed by Waab Transportation Company of unknown origin was observed leaking small quantities of a viscous, yellowish substance. The Port Officer at the Division of Sea Transportation Office was not aware of the contents of the container; however, due to the localized nature of the release, AECOM considers this staining a DMC.
- Four small oil stains (less than 2 square feet each) observed at the Yap Fishing Authority maintenance shop. Given the localized nature, AECOM considers this staining a DMC.

Photo 10: Close-up view of shipping container managed by Waab Transportation Company of unknown origin observed leaking small quantities of a viscous, yellowish substance.

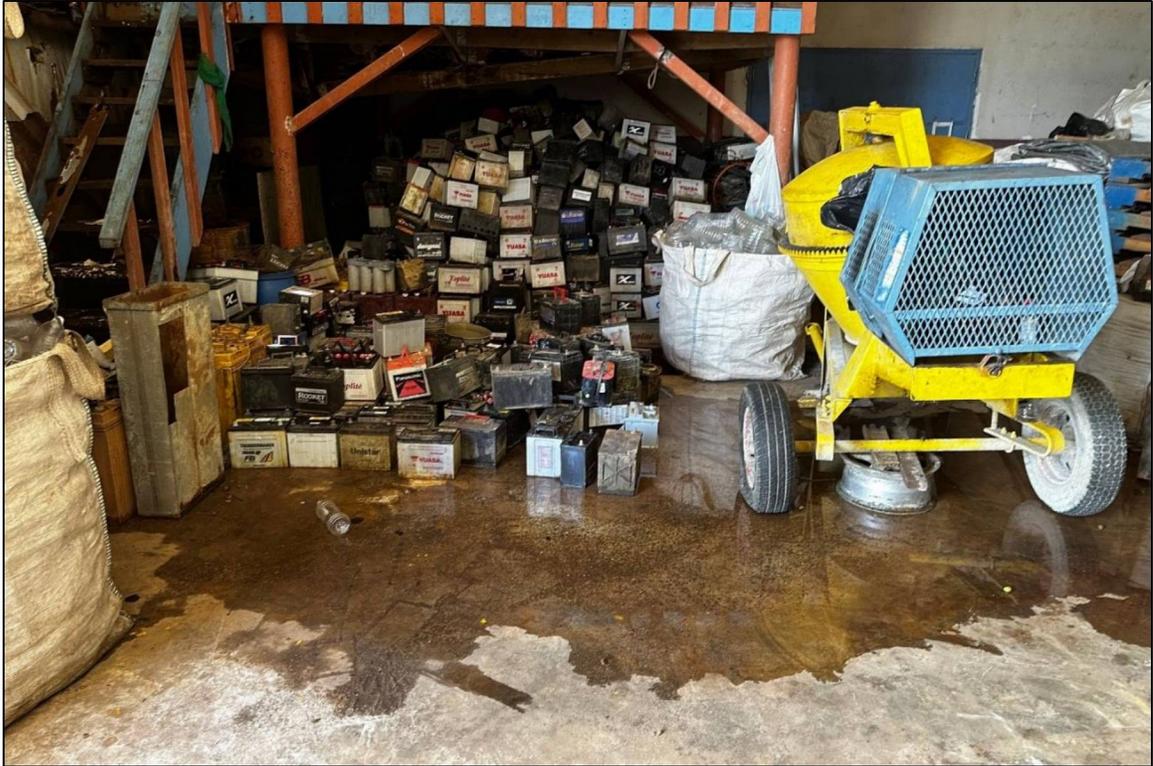
- A stockpile of automobile and other equipment batteries at the Recycling Center is a REC, in AECOM's opinion. These batteries were situated on a concrete floor atop a substantial pool of liquid, reportedly identified as rainwater by personnel on site. Although no significant floor cracks were observed, various floor drains were observed in the vicinity of the batteries.

Photo 15: Overview of a lead-acid battery pile located inside the Recycling Center observed sitting on a large puddle of rainwater. Approximately 200–300 batteries were estimated. Photo taken standing on top of floor drain.

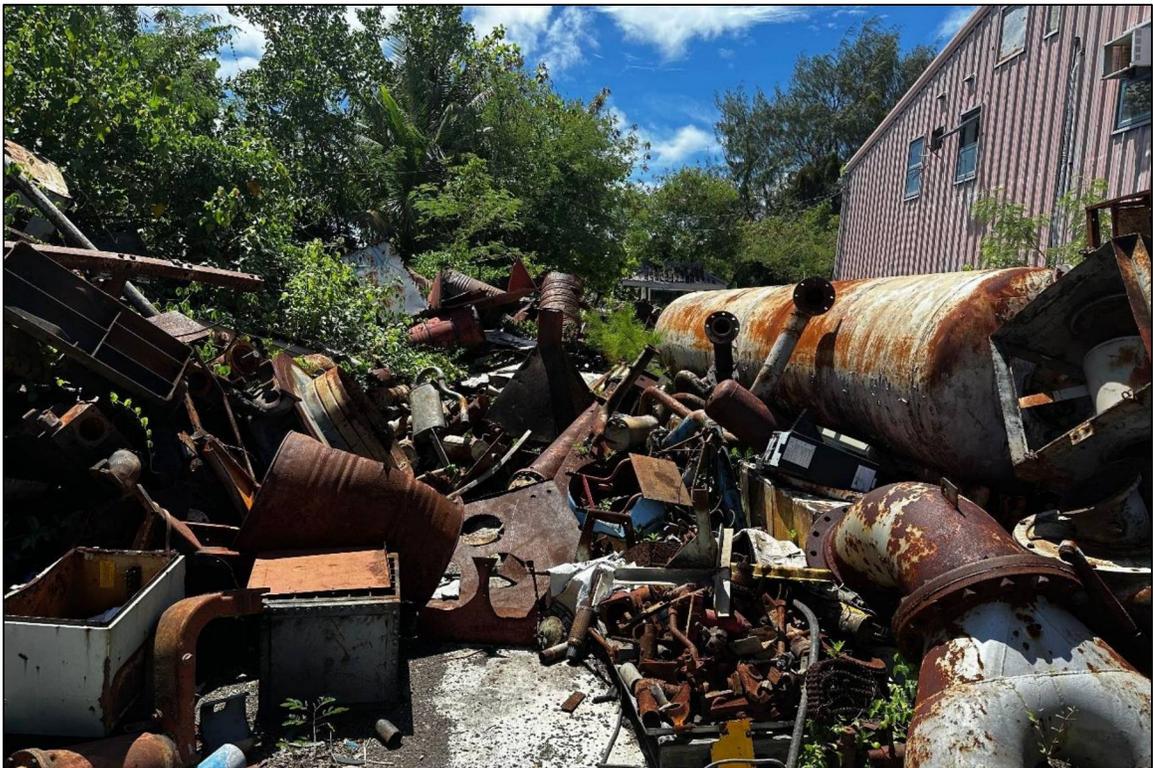
Photo 18: Overview of an approximately 1,500-square-foot scrap metal pile located adjacent to the Recycling Center. Photo is looking east.

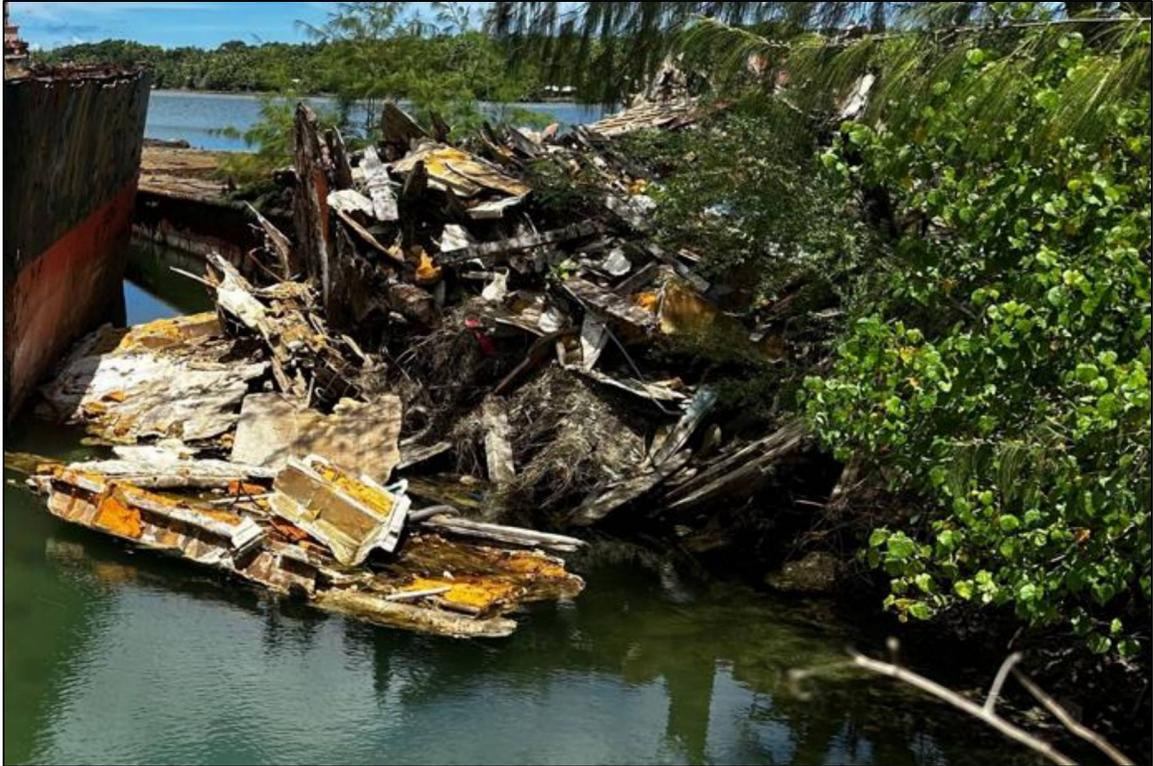
Photo 19: Overview of demolition debris mound located in the southeasternmost point of the subject property. A portion of the mound was observed eroding into the ocean. Photo is looking southeast.

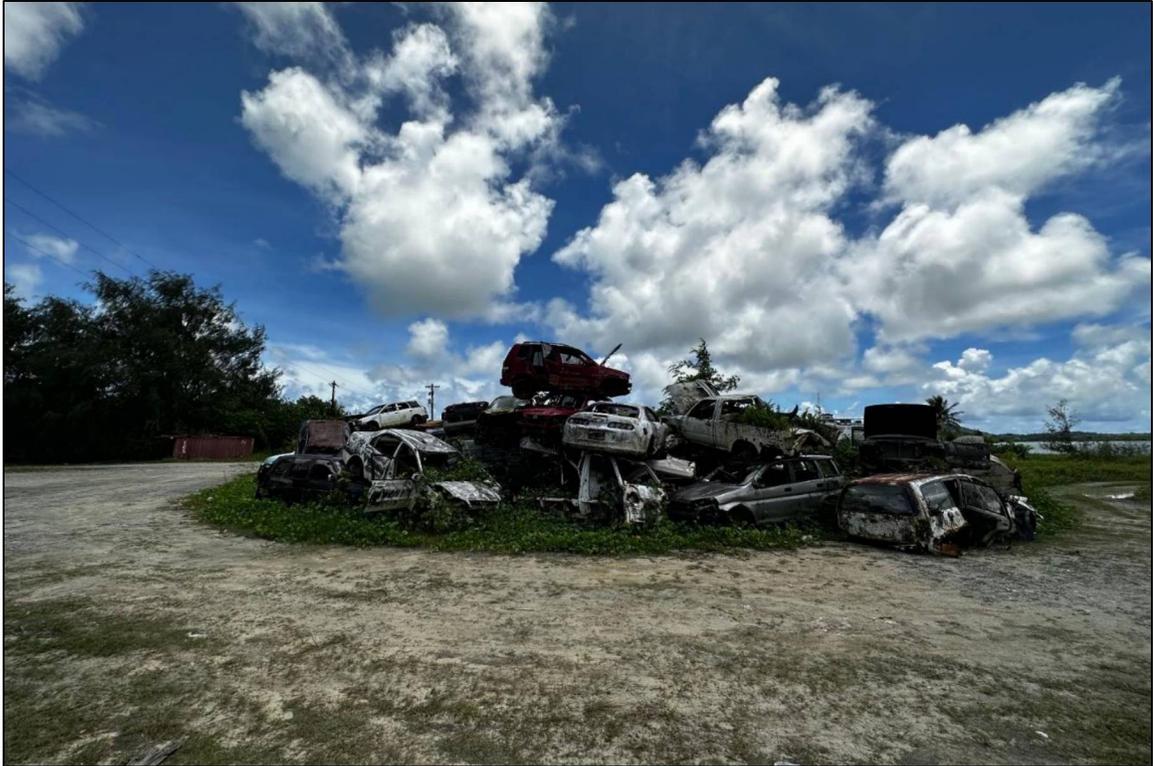
- Three piles of metal debris, primarily consisting of abandoned automobiles and automotive parts are present in the salvage yard within the subject property. The piles measured approximately 7,000, 1,500, and 1,300 square feet. In addition, a deteriorated 20-foot metallic tank marked as "unleaded gas," was identified and exhibited substantial corrosion and perforations. The condition of such an abandoned tank may indicate a release of hazardous substances or petroleum products into the surrounding environment. The piles have not been previously investigated, and it is unknown whether metals or other contaminants are present at concentrations that represent a hazard to human or ecological health; therefore, this finding is considered a REC in AECOM's opinion.

Photo 21: Overview of one of the three non-contiguous abandoned vehicle piles. Photo is looking north.

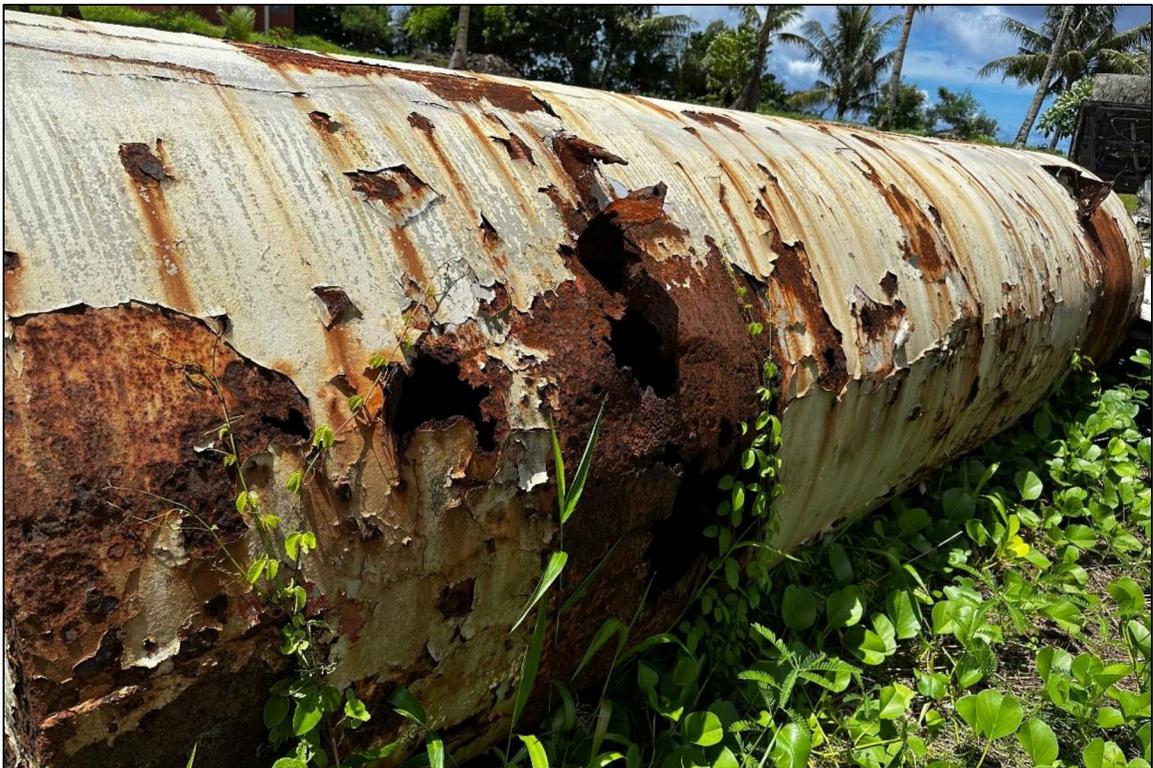
Photo 22: Close-up view of empty, deteriorated AST observed adjacent to the abandoned vehicle piles. Photo is looking west.

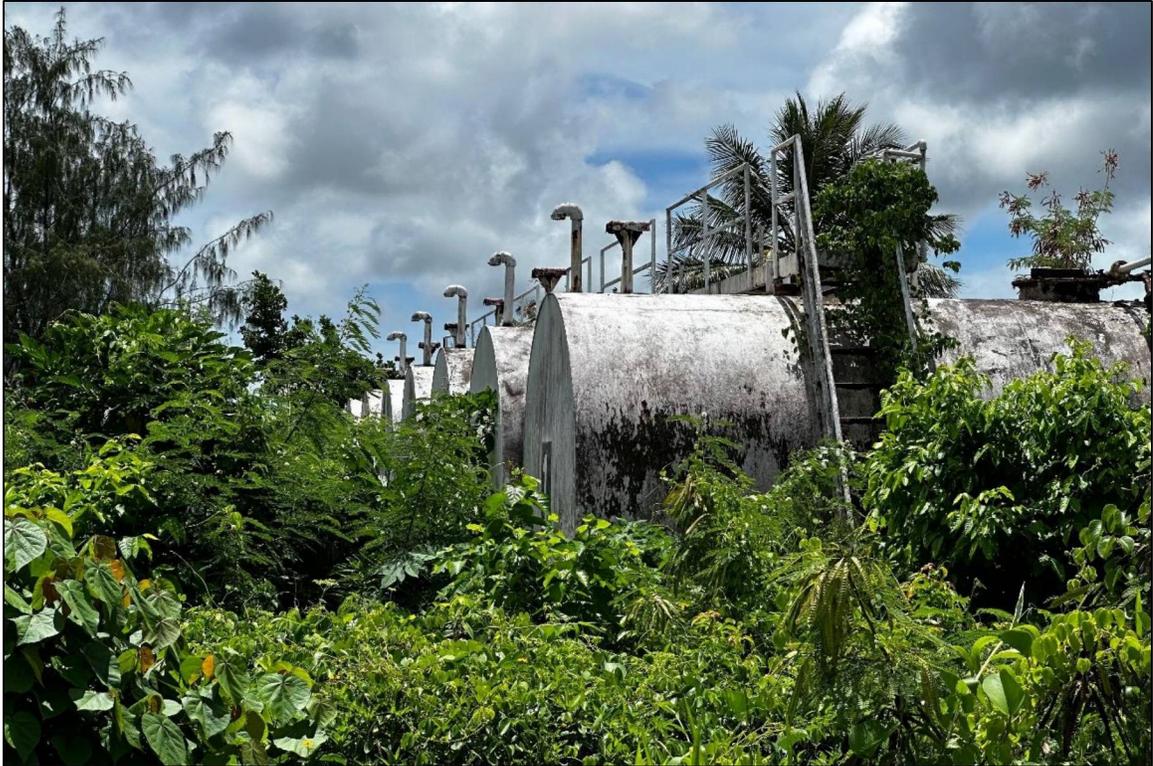
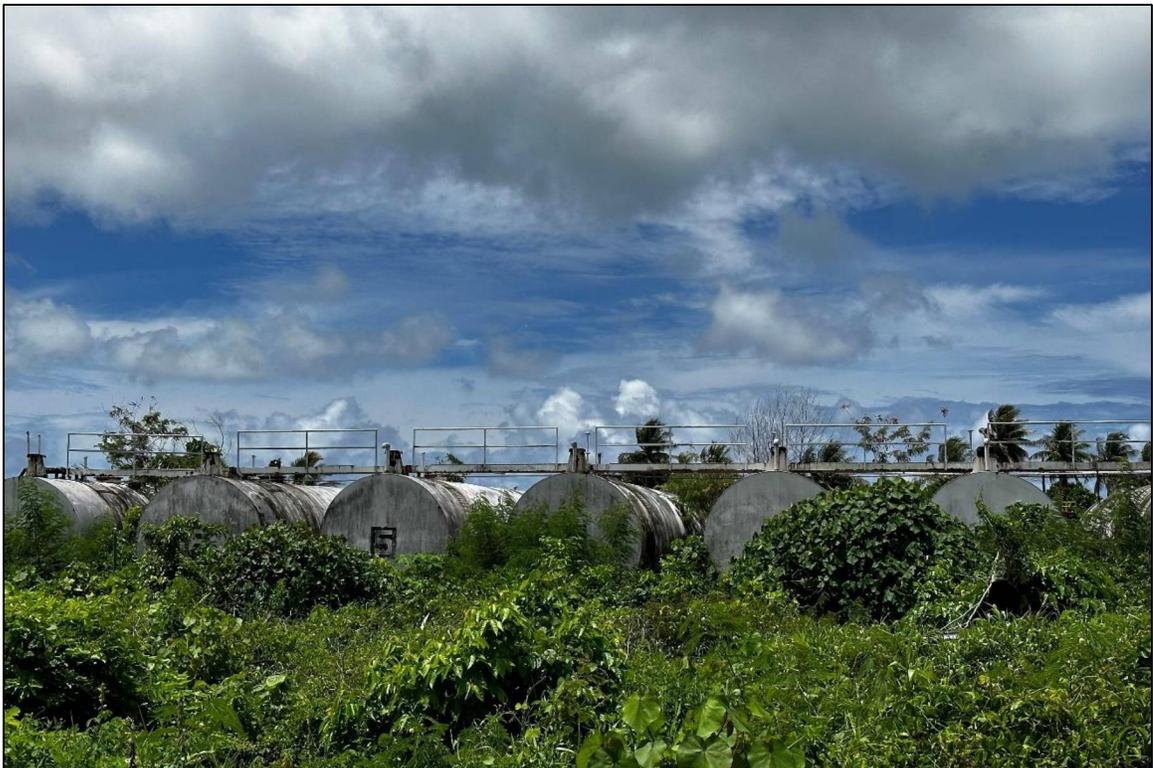
- Seven fuel tanks previously utilized by the U.S. Coast Guard on the subject property are considered a REC, in AECOM's opinion. The ASTs could only be observed from a distance during the site visit because of overgrown dense vegetation and the surrounding terrain; however, they appeared to be slightly corroding. It was not ascertainable from interviews whether any fuel remains in the ASTs and abandonment documentation was not available.

Photo 23: Zoomed-in photograph of the seven abandoned former U.S. Coast Guard fuel tanks. Photo is looking southeast.

Photo 24: Zoomed-in photograph of the seven abandoned former U.S. Coast Guard fuel tanks. Photo is looking west.

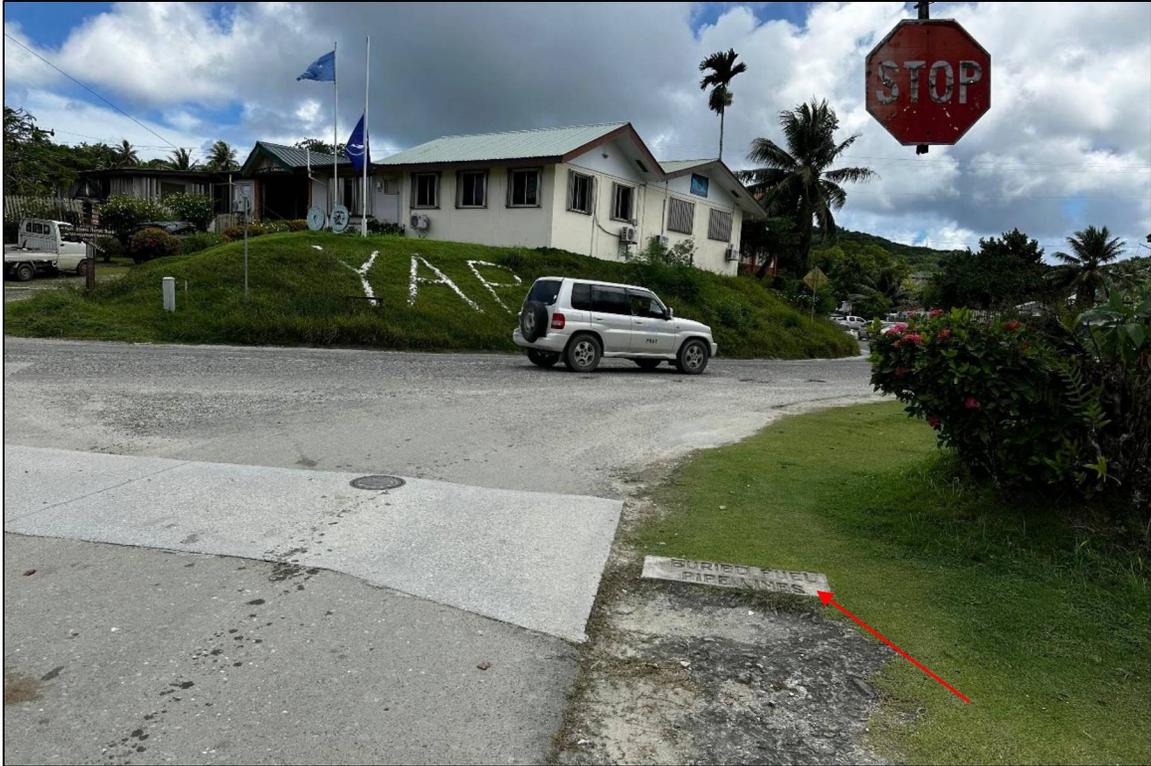
- The underground fuel pipeline that transports fuel from the PetroCorp fuel farm to the port is present throughout the subject property. It could not be determined during this Phase I ESA whether the pipeline is regularly leak tested, the leak testing methods, and testing results. Based on this lack of information, the pipeline represents a material threat of a potential future release and a REC, in AECOM's opinion.

Photo 25: Overview of the northern border of the subject property. Note: A buried fuel line marking exists on the street (denoted by red arrow). Photo is looking northwest.

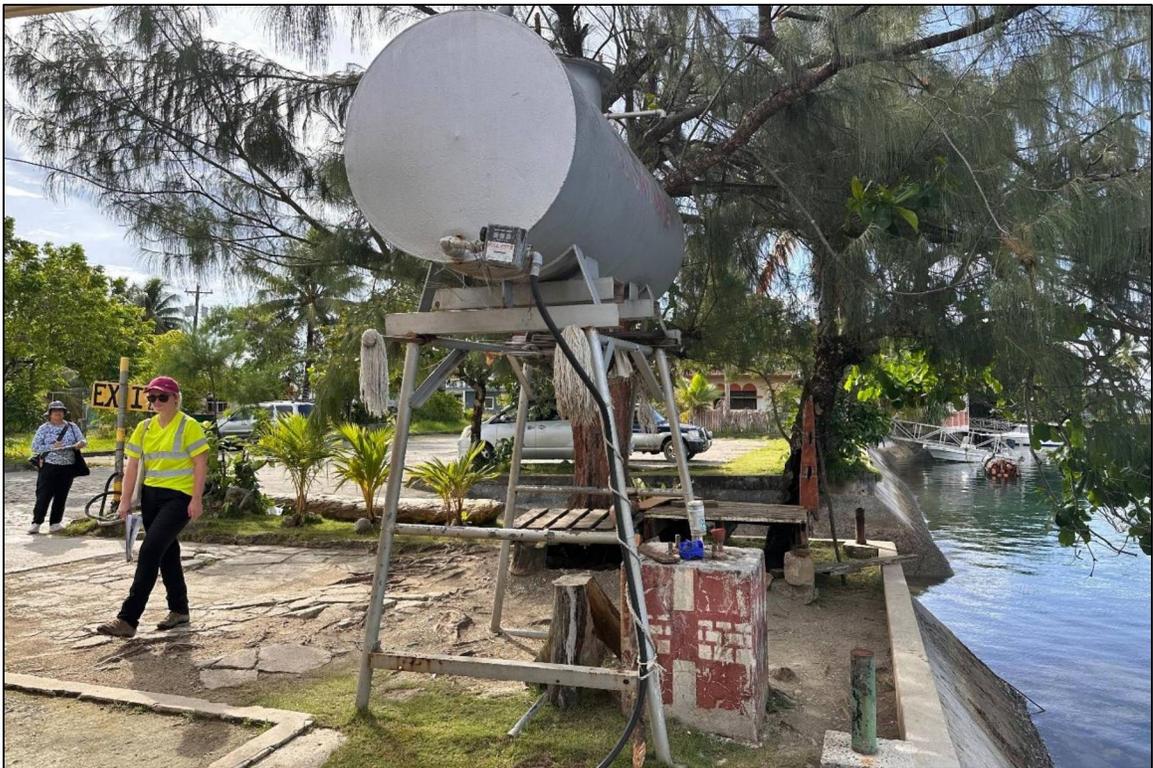
Photo 28: Overview of 320-gallon kerosene AST lacking secondary containment. Photo is looking east.
