Final Field Report for Baseline Cultural Resources Surveys for the Sea Port in Yap, Federated States of Micronesia

Cardno GS – AECOM Pacific Joint Venture

October 2023

Project Name: Pacific Deterrence Initiative
Resource Surveys at Yap Port

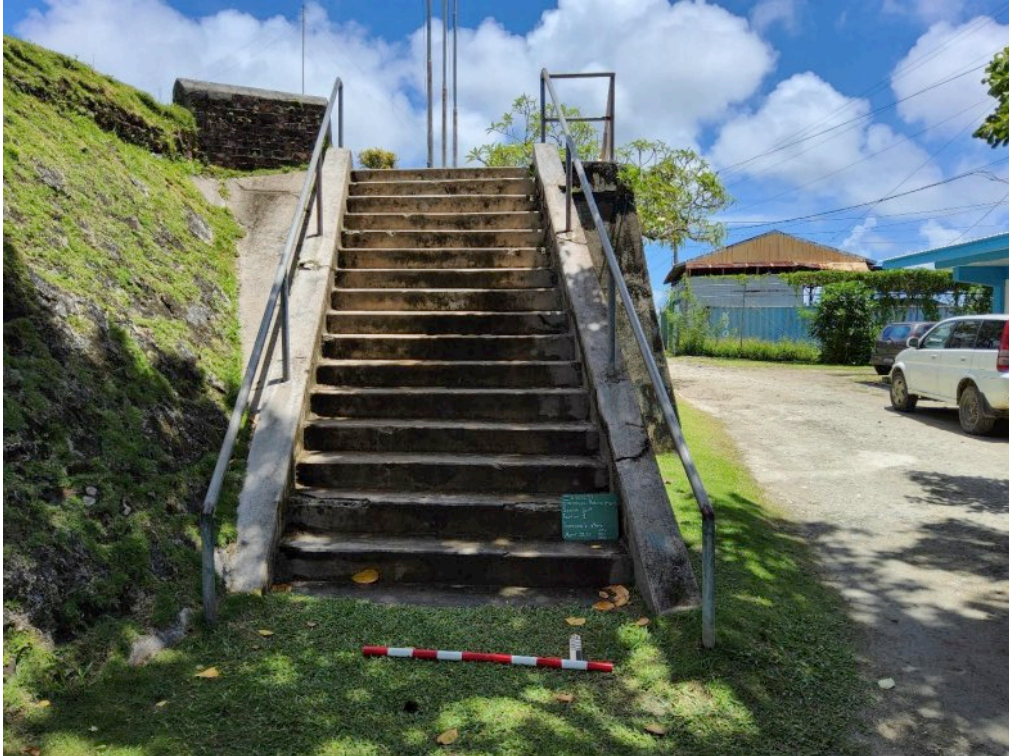
Feature 01 was a pair of concrete staircases leading to a common landing on the east side of the Spanish fort. It is approximately 43.6 feet (13.3 meters) long, 7.6 feet (2.3 meters) wide, and 9.8 feet (3.0 meters) tall (Figure 3-4 and Figure 3-5). The characteristics of the concrete were consistent with other Japanese administration buildings and structures, and local consultants identified Feature 01 as a Japanese modification to the site. A U.S. Coast and Geodetic Survey benchmark was installed on one of the stairs in 1951 (Figure 3-6). The condition of the stairs was good, but some cracks with vegetation were observed.

Figure 3-5 Feature 01, Close-up of One Flight of the Japanese Administration Stairs on the East Side of the Site; View North

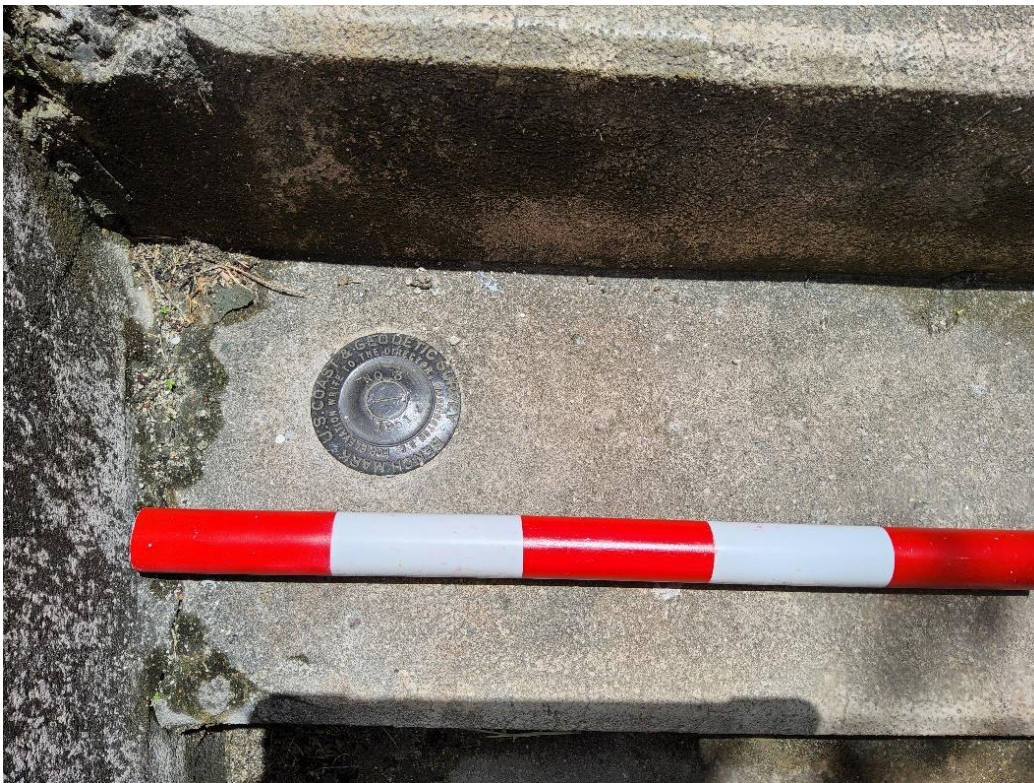
Figure 3-6 Feature 01, U.S. Coast and Geodetic Survey Benchmark, Installed in 1951, Embedded into One of the Steps of Feature 01

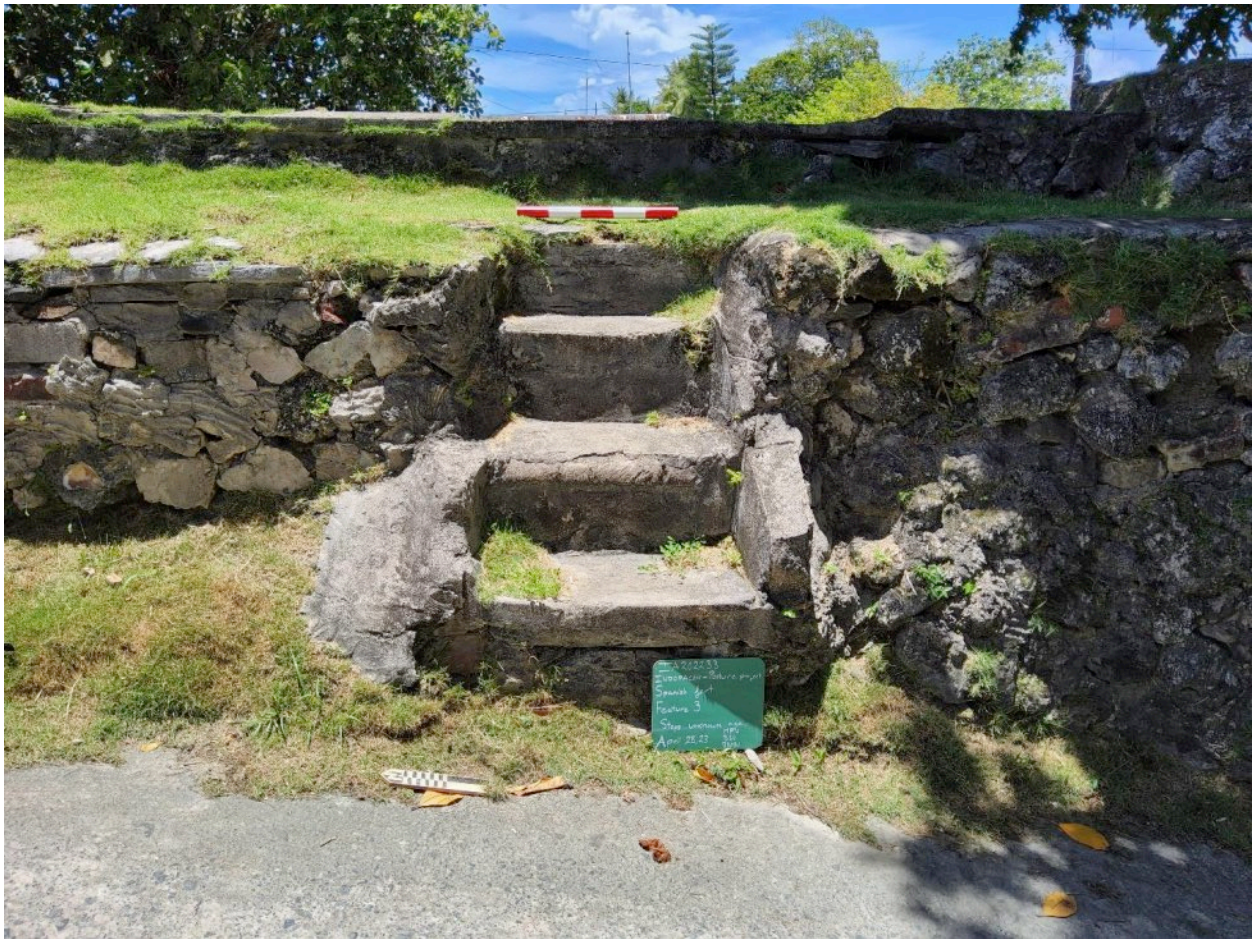
Feature 03 was a sitting area comprised of a staircase, a pair of terraces, and circular planters (Figure 3-8). It was adjacent to the driveway leading to the Japanese hospital (the driveway may be a modification of one of the two original Spanish access routes). The short staircase had three concrete steps that lead to a narrow, grass-covered terrace. Above the lower terrace was a second narrow terrace with two circular planters. The retaining walls for the terraces were constructed with stone, coral, concrete, and brick; the brick may be reused material from earlier Spanish colonial construction. The planters were made from concrete, stone, and coral. Vegetation covers some of the steps and the surface of the sitting area had some fractures, though overall, the area was maintained. Feature 03 was inferred to date to the Japanese administration based on the construction characteristics and spatial association with the driveway leading to the Japanese hospital (though it could have been a later modification). The condition was fair to good, and this area is still used as a sitting area.

Figure 3-8 Feature 03, Sitting Area Comprised of Stairs, a Level Area, a Terraced Sitting Area, and Planters; View East

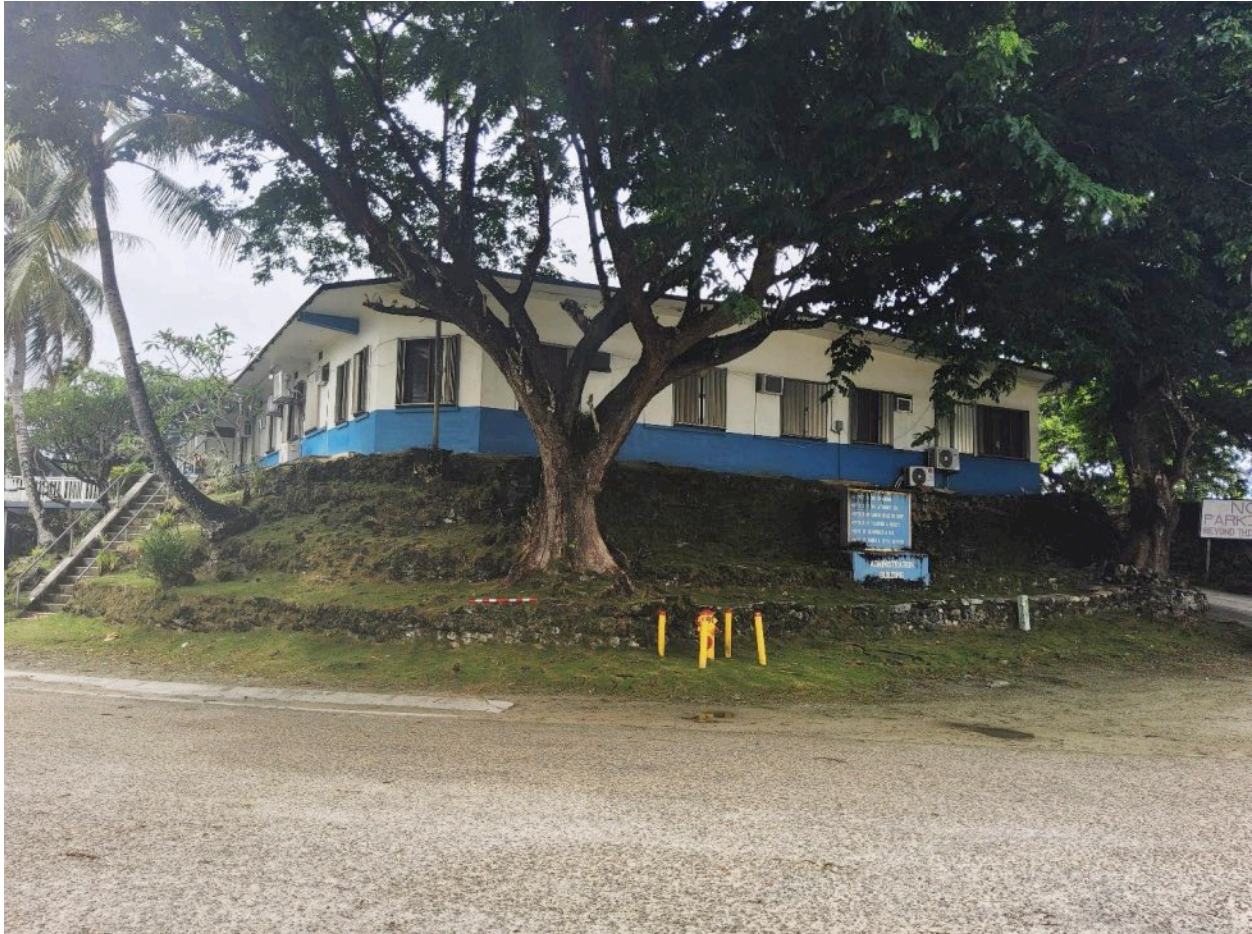
Feature 04 was a 20th-century Yapese terrace set built along the south and west sides of the embankment (Feature 06) (Figure 3-9 to Figure 3-12). Four terrace tiers were present, with the facings built of stone with some coral. The lowest terrace was the longest, with each successive terrace shorter in length; the uppermost tier was present along a short section on the west side of Feature 06. The terraces were built around a Japanese staircase on the west side (Feature 05). The surfaces of each terrace were covered with grass and ornamental plants. The terrace set is inferred to be a 20th-century Yapese addition based on construction characteristics and its placement around the pre-existing Japanese staircase.

Figure 3-9 Feature 04, Traditionally Constructed Yapese Terraces Built along the South and West Sides of the Spanish Colonial Embankment and Mound (Feature 06); View Northeast; the Building is the Former Japanese Hospital

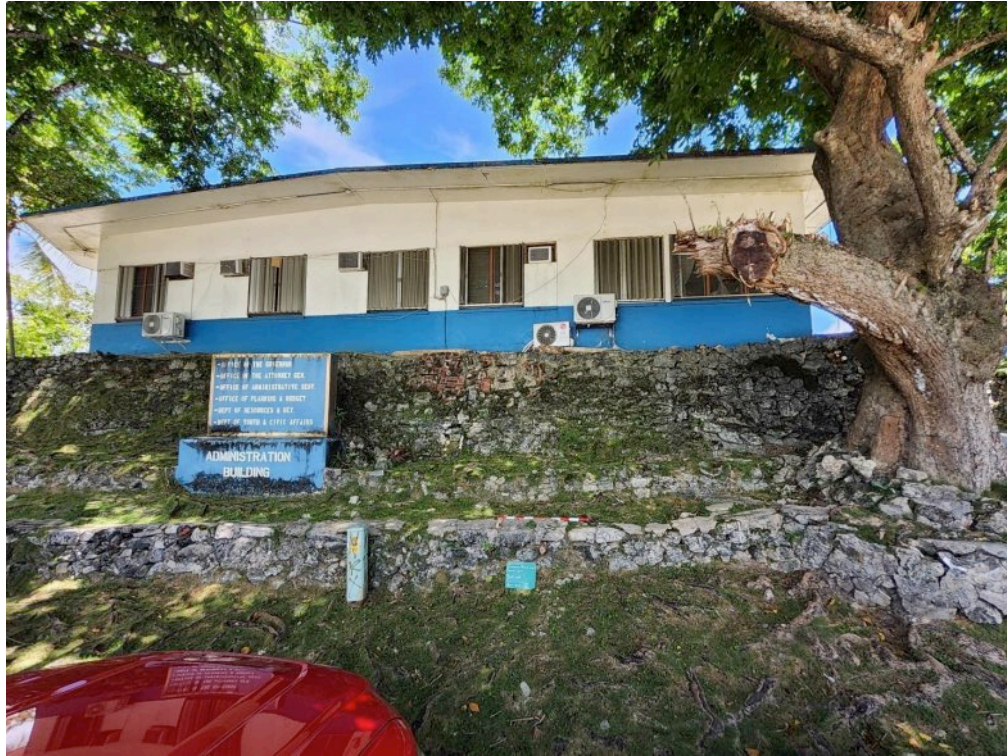
Figure 3-10 Feature 04, Traditionally Constructed Yapese Terrace Set along the South Side of Feature 06; View North

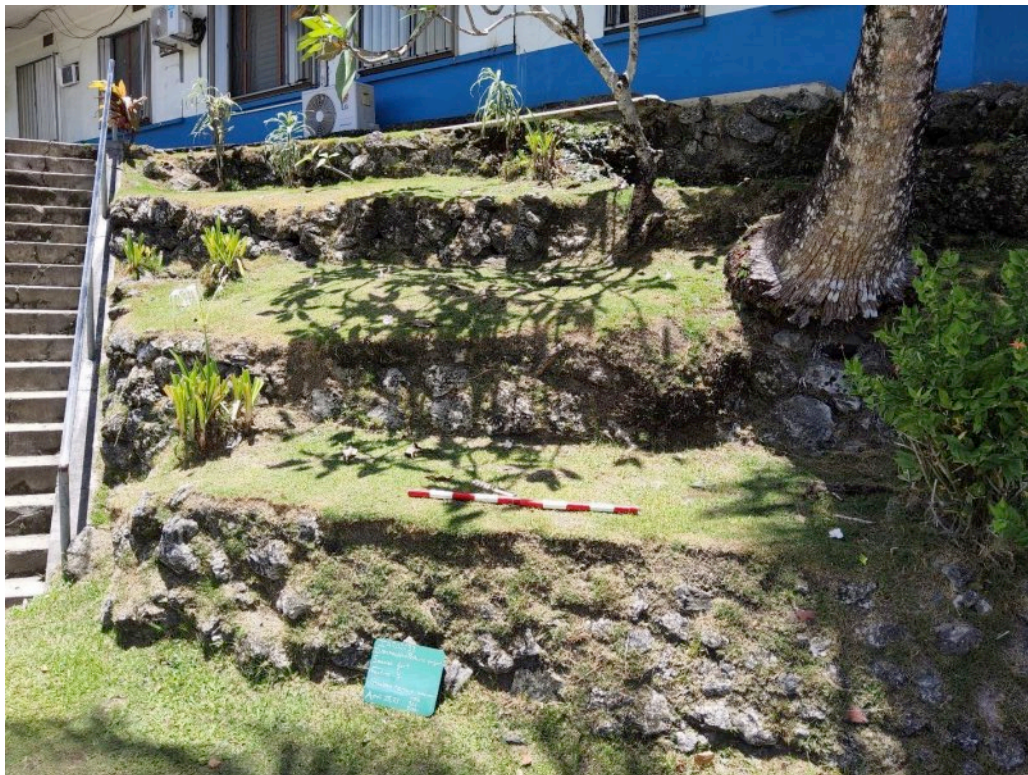
Figure 3-11 Feature 04, Traditionally Constructed Yapese Terrace Set near the Southwest Corner of Feature 06; View Northeast

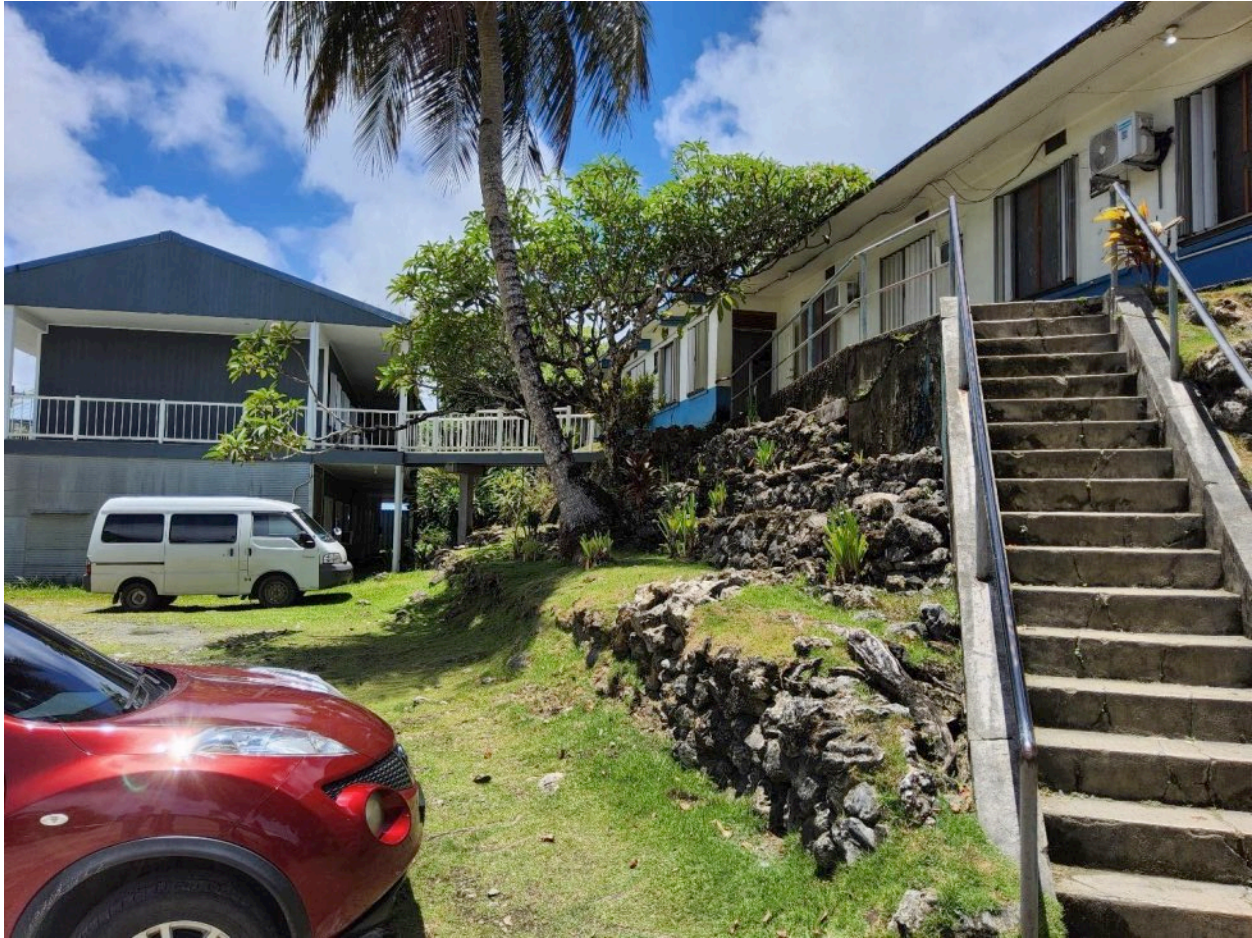
Figure 3-12 Feature 04, Traditionally Constructed Yapese Terrace Set on the West Side of Feature 06; View North-northeast; Feature 05, Japanese Concrete Staircase, is in the Foreground

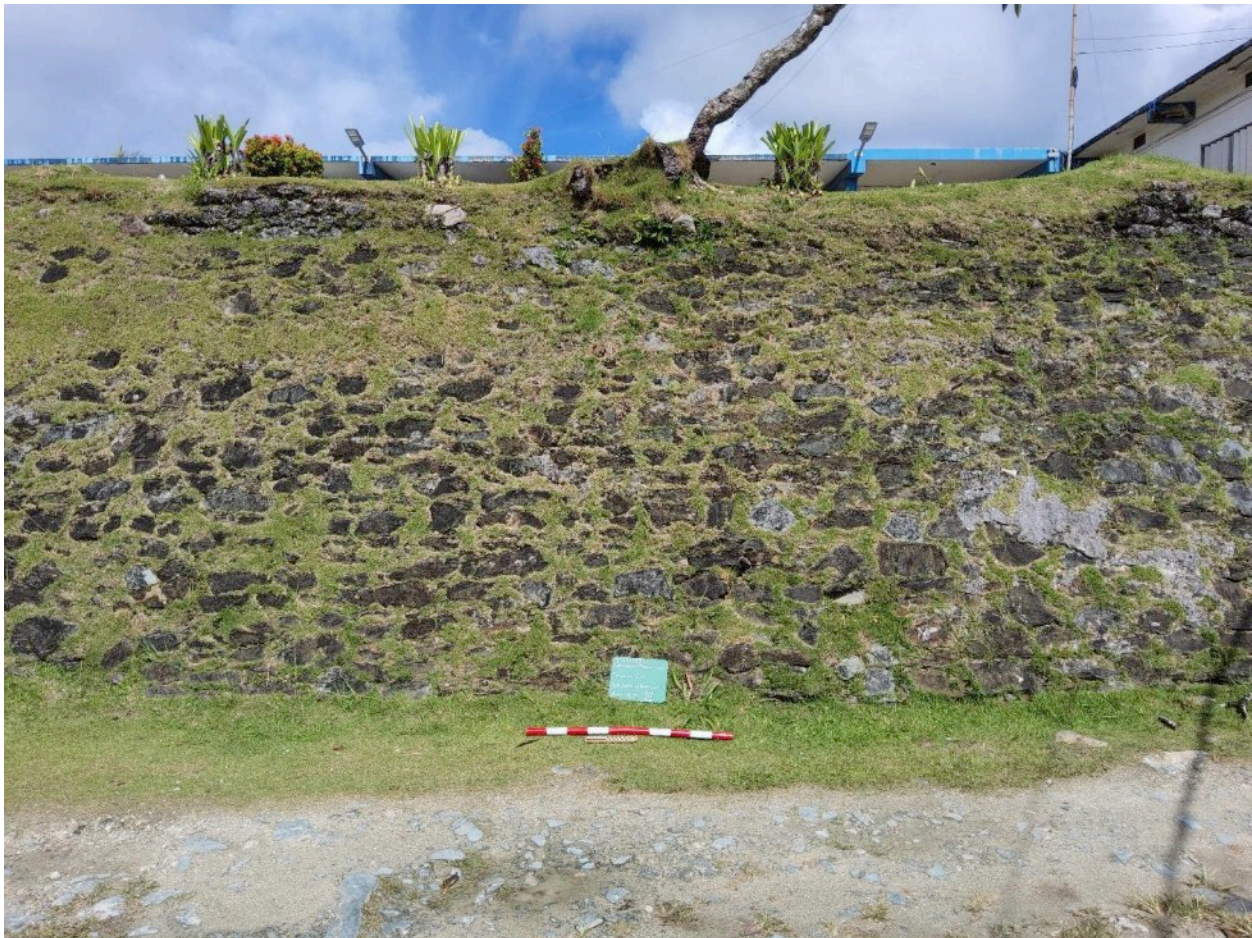
Masonry reinforcement included segments of square, hand-cut stone masonry or rough ashlar (also known as large square-cut stone) (*silleria*) (Figure 3-14) with mortared fired clay bricks and formed three of the extant corners (southeast, northeast, and northwest) (Figure 3-15 to Figure 3-20); the southwest corner was destroyed or removed and had a traditional Yapese terrace set (Feature 04). The southeast corner was an exemplar of the different masonry techniques that were applied. Coursed, mortared bricks form the bulk of the corner, including the exterior faces. Abutting the brickwork on the interior edge was *silleria*. This, in turn, was covered by mortared rubble masonry, which formed the interior surface of the embankment. The original masonry that was plastered though portions of this finish have since eroded.

Figure 3-14 Feature 06, North Section of the East Spanish Colonial Embankment and Mound Exhibiting *Silleria* Masonry; View West

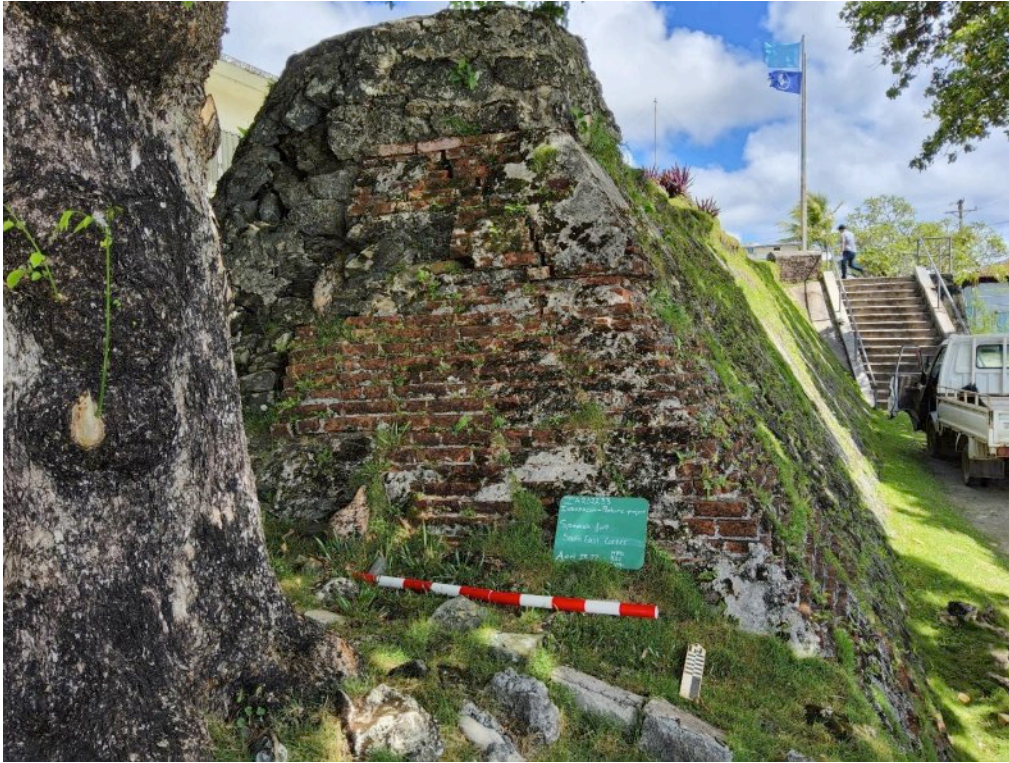
Figure 3-15 Feature 06, Southeast Corner Revealing Coursed Mortared Brick within an Interior Veneer and Cap of Mortared Masonry; View North

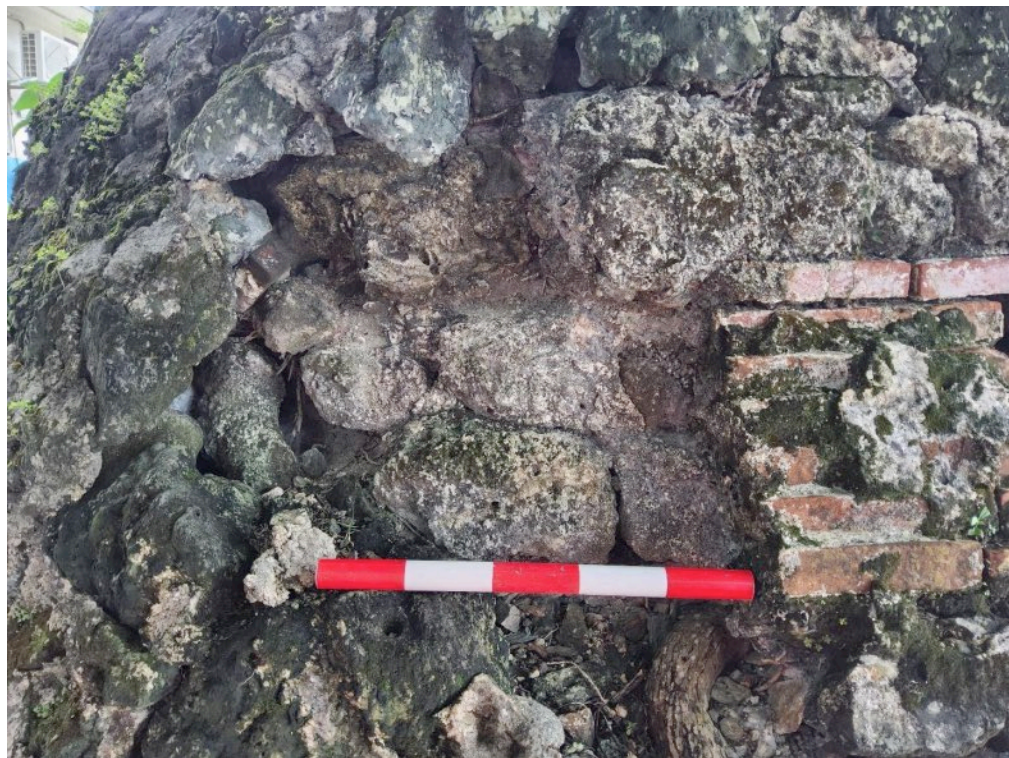
Figure 3-16 Feature 06, Detail of the Southeast Corner Showing Rubble (Left), Rough Ashlar (Center), and Brick (Right) Construction; View North

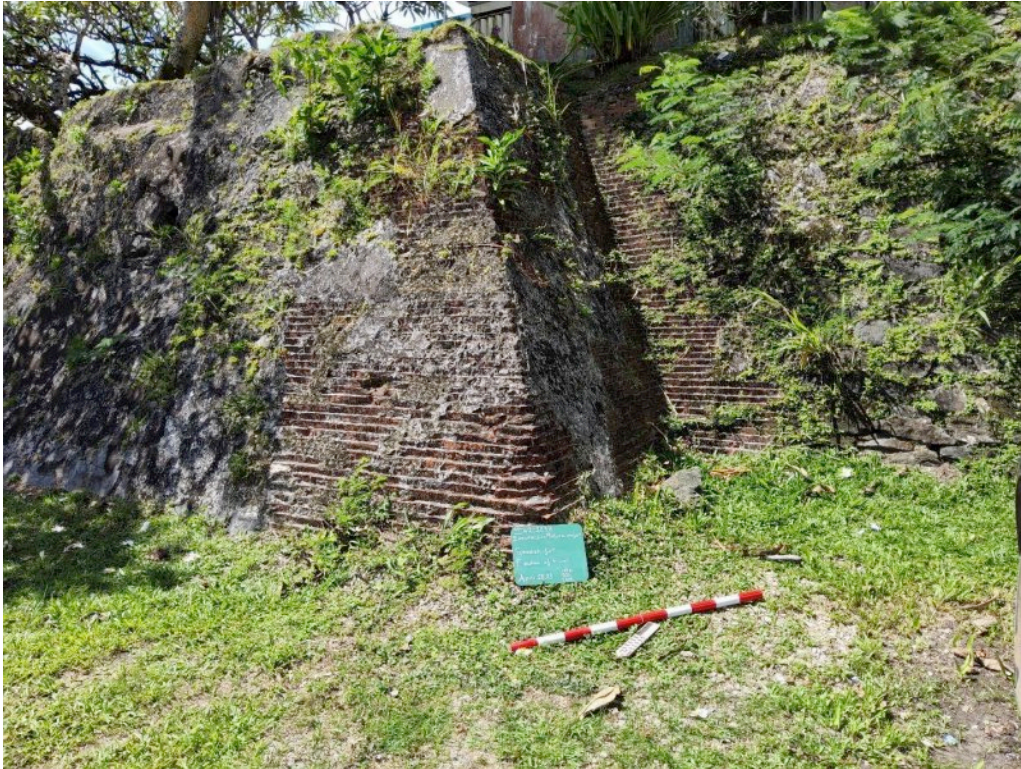
Figure 3-17 Feature 06, Northeast Corner Built of Coursed, Mortared Brick; View Facing Southeast; Note the Remnant Plaster

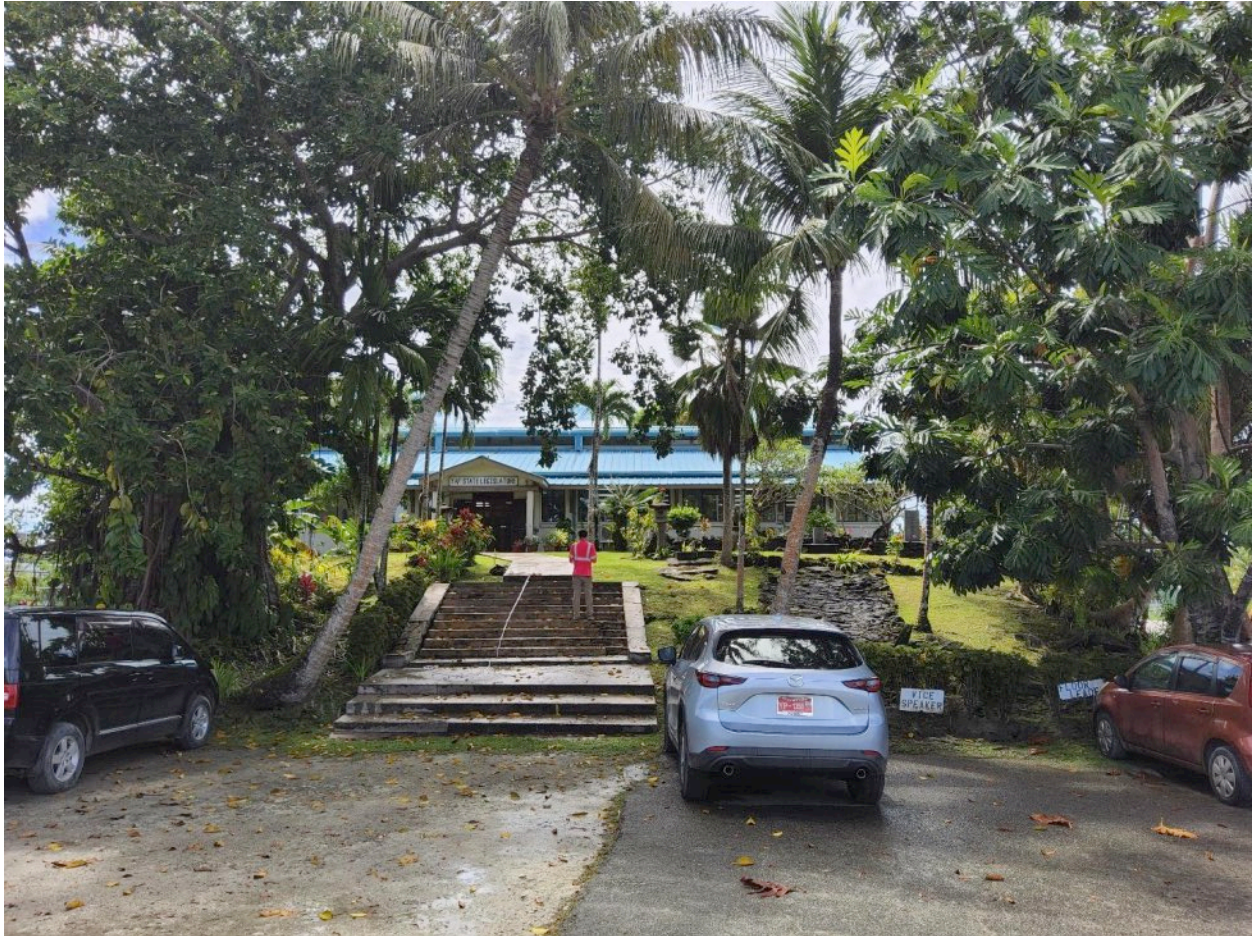
Temporary Site 03 was a large anthropogenic mound that was constructed in the mid-20th-century at the edge of what had been Tablaaw Island, but was encompassed into the Yap Port peninsula through land reclamation. The mound was approximately 197 feet (60 meters) long and 164 feet (50 meters) wide. According to local consultants, the mound was constructed by Japanese residents who remained in Yap after World War II. The mound was covered with vegetation and faced with stone in some areas. The Yap State Legislature (YSL) building and associated features were built on the mound in the 1980s (Figure 3-24).

Figure 3-24 Temporary Site 3, a Large Anthropogenic Mound Built During the Mid-20th-Century, Which Supports the Yap State Legislature Building

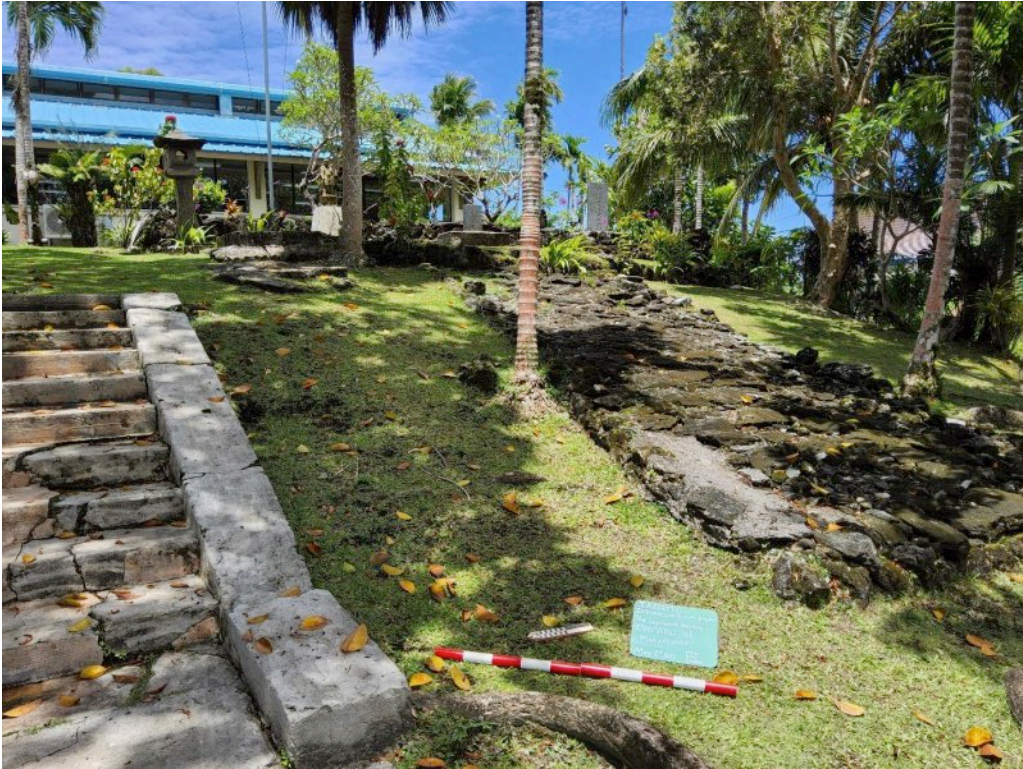
A concrete staircase leading to the YSL building was similar to Japanese-administration-era structures and is likely contemporaneous with the construction of the mound. A U.S. Coast and Geodetic Survey Benchmark survey was installed on one of the steps in 1951. Modern features associated with the YSL building included a traditional stone path, a traditional platform, and a Japanese shrine (Figure 3-25). Two *rai* that were dedicated during the opening ceremony of the YSL building were leaning on the platform. A Spanish canon, relocated from another location (source unknown), was outside of the main entrance to the building (Figure 3-26). None of the structures or relocated items atop the mound were considered components of the site, though they have cultural significance to contemporary Yapese. The mound retains integrity of location and materials, but late-20th-century construction resulted in the loss of integrity for design, setting, workmanship, feeling, and association. It is recommended as not eligible for listing in the NRHP.

Figure 3-25 Temporary Site 3 with a Stone Path (Right) that Leads to a Japanese Shrine and Traditional Yapese Platform (Top), Adjacent to the Stairs to the YSL Entrance (Left)

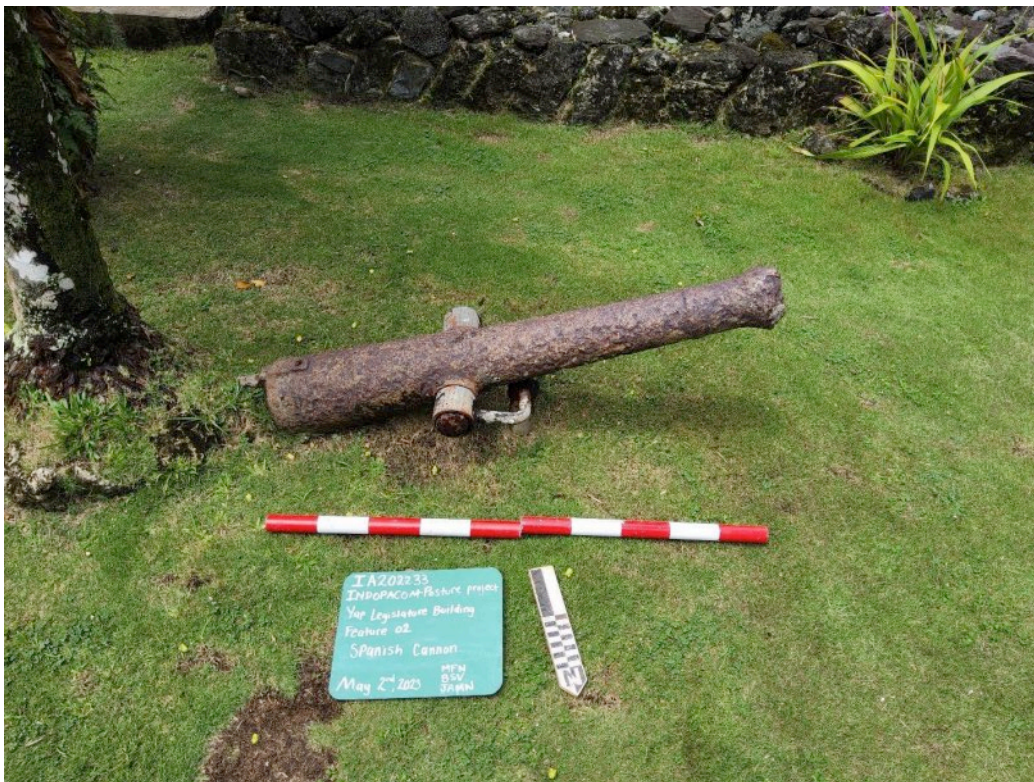
Figure 3-26 Temporary Site 3, a Spanish Cannon was Placed in Front of the Entrance to the YSL

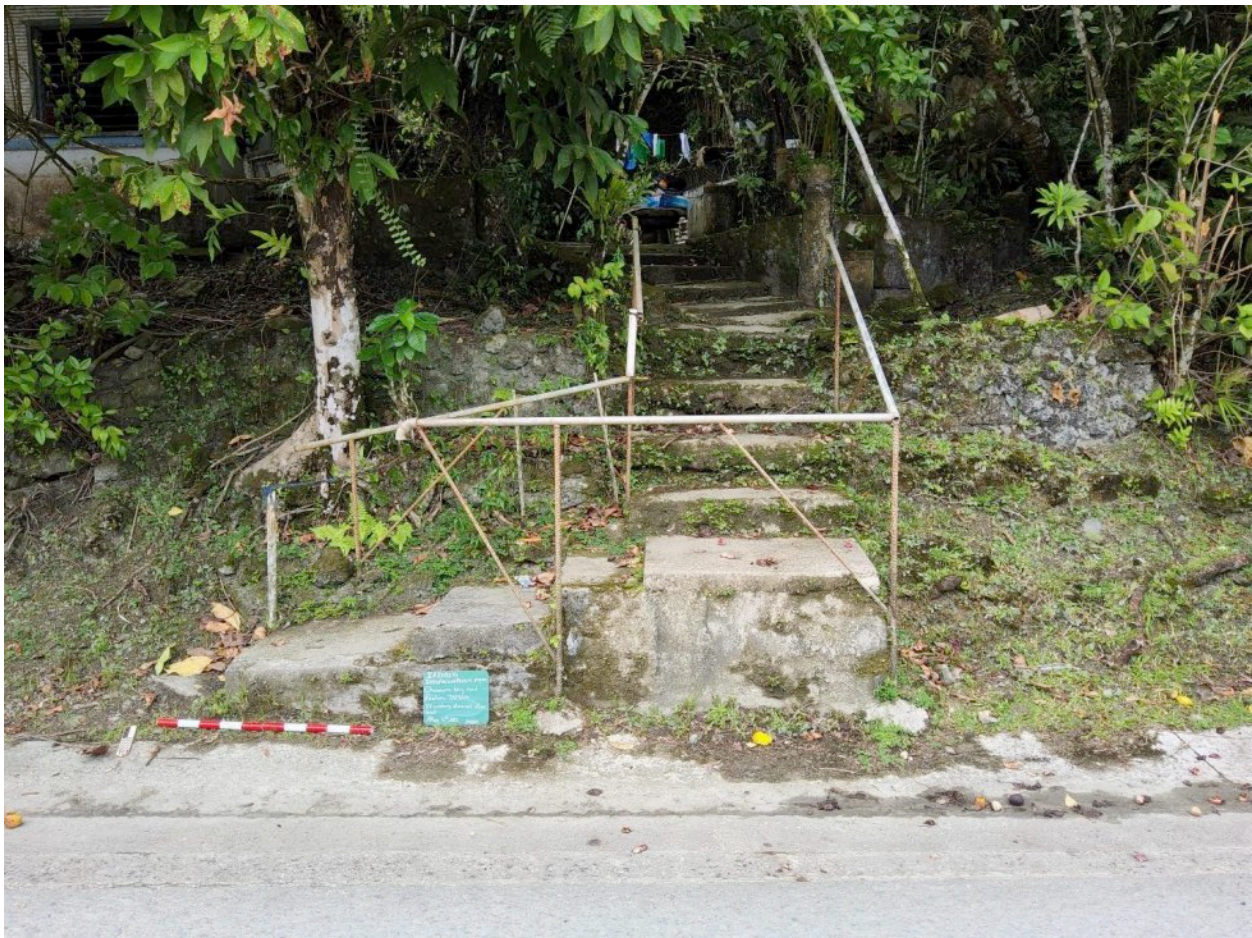
Temporary Site 01 was a stone and coral retaining wall with a concrete staircase (Figure 3-27). The wall was approximately 70 feet (21 meters) long and 6 feet (1.8 meters) high. It was built along the south edge of the road around Chamorro Bay in the village of Woorwoo, Rull Municipality. The retaining wall was on privately owned property. The concrete steps were similar to Japanese-administration-era structures, and a local consultant with family from this village stated the stairs were built by the Japanese. While the retaining wall was built in a traditional Yapese fashion, its construction date was uncertain. The stairs are an example of structural modifications to village features during the Japanese administration. Temporary Site 01 was in good condition; it is recommended as eligible for listing in the NRHP.

Figure 3-27 Temporary Site 01, Stone and Coral Retaining Wall with Japanese-era Concrete Steps, in Woorwoo Village, Rull Municipality; View South

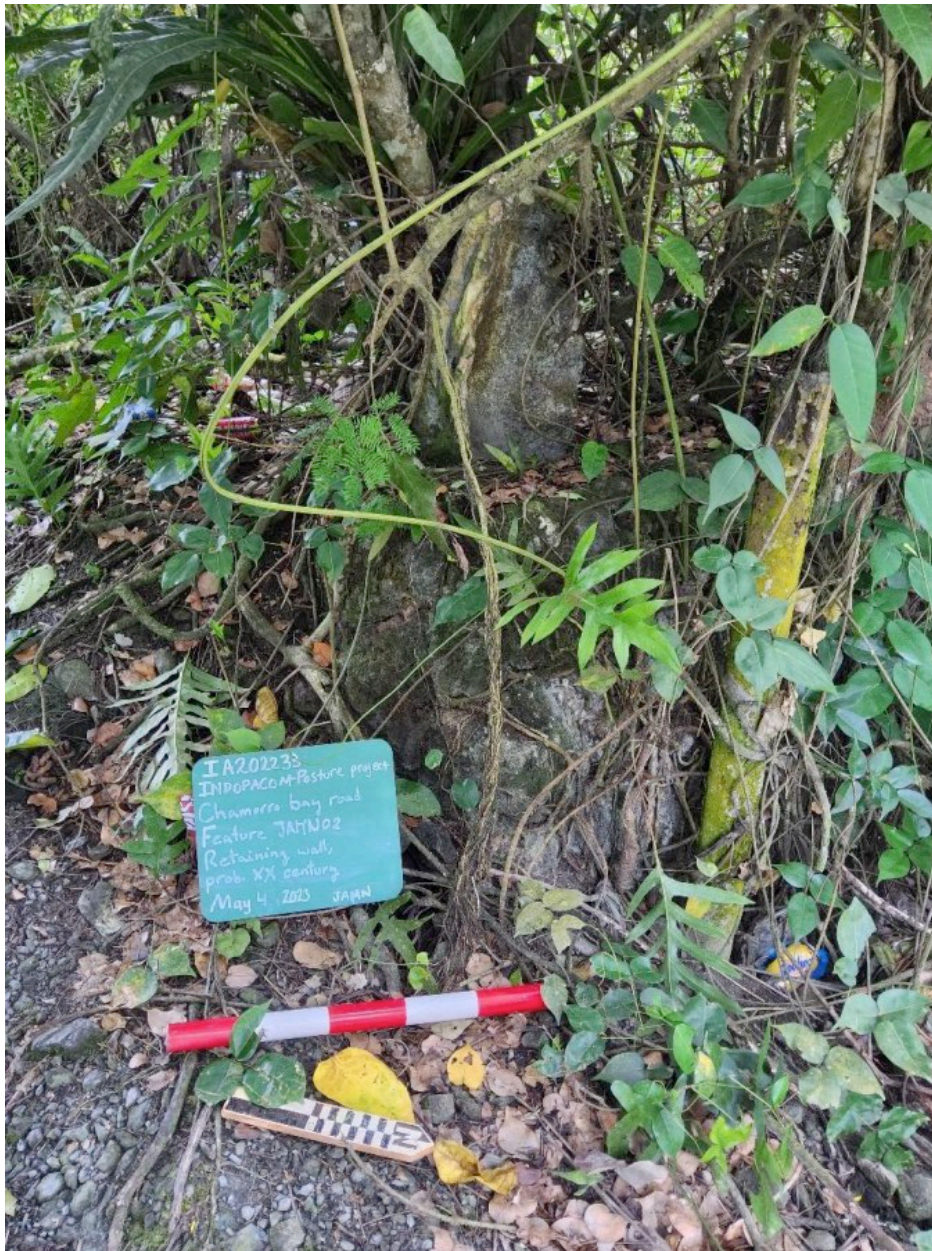
Temporary Site 02 was a stone and coral retaining wall (Figure 3-28). It was approximately 85 feet (26 meters) long by 3 feet (0.9 meters) high. It was approximately 16 feet (5 meters) south of the road around Chamorro Bay in the village of Woorwoo, Rull Municipality. The retaining wall was on privately owned property adjacent to a drainage leading into Chamorro Bay. In Yapese, this type of erosion control retaining wall is known as *tanayboch*. A large, vertically placed *Tridacna* sp. shell is at the southeast corner of the wall and the feature was covered with vegetation. The age of Temporary Site 02 was unclear, but a local consultant indicated its construction was approximately contemporaneous to Temporary Site 01. Temporary Site 02 was in good condition; it is recommended as eligible for listing in the NRHP.

Figure 3-28 Temporary Site 02, Stone and Coral Retaining Wall in Woorwoo Village, Rull Municipality; View West

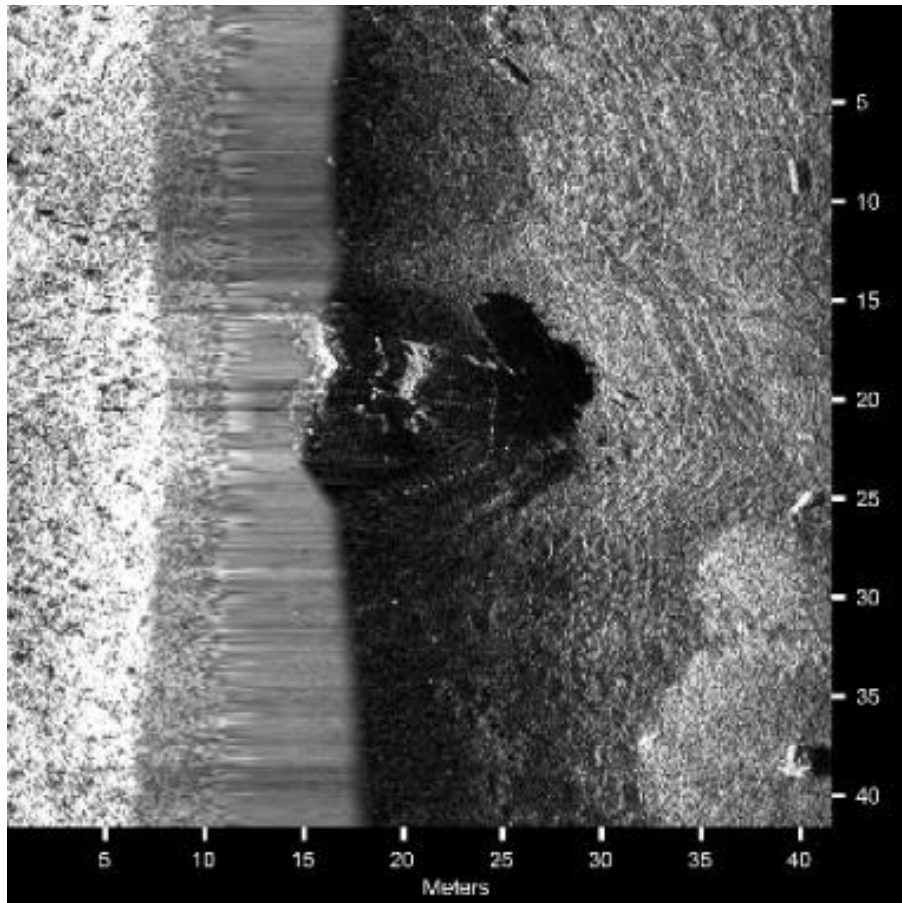
Figure 3-31 Target 09 (Acoustic Contact S006)

Target 09 was recorded as Acoustic Contact S006, in approximately 65 feet (20 meters) of water (Figure 3-31). It was a late-20th-century general cargo ship denoted as kml_78 in the NOAA ENC shipwreck database as a submerged shipwreck. The Navy Seabee MBES data designates Target 09 as a wreck, 102 feet (31 meters) long and 30 feet (9 meters) wide (Figure 3-32). Target 09 is known locally as the “Circus Wreck,” formerly named *Laura Marie*, which was purposefully sunk as an artificial reef in 1992 by Yap Divers Dive Center operating out of Manta Ray Bay Resort (2023). It is the first and only known artificial reef in the FSM.

Further research is needed to document the work life and ship construction of *Laura Marie*; however, the observed ship construction elements are consistent with late-20th-century, ocean-going general cargo ships. Attempts to identify the *Laura Marie* in ship registries were unsuccessful. Based on observed characteristics and available data, Target 09 may retain the potential to yield important information regarding maritime shipping and industry practices significant to Yap and the FSM's history. It is recommended treating Target 09 as eligible for listing in the NRHP with an avoidance buffer of 164 feet (50 meters) from the defined site extents, pending additional information.

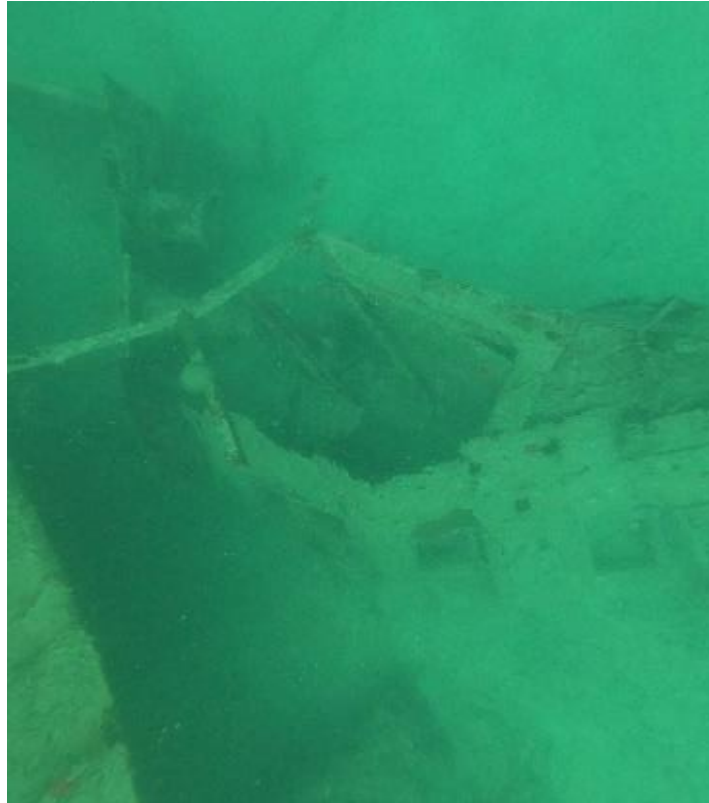
Divers spent 112 minutes investigating Target 09 and confirmed the source as the shipwreck. Target 09 was predominantly intact and lays on its port side along the western side of the Tamil Channel (West) (Survey Area 2) (Figure 3-33). Several ship construction elements were observed, including multiple hatches, the weather deck, the cabin, boat rails, a propeller, a rudder, and a stern frame. The upper decks have collapsed and now rest beside the main structure (Figure 3-34 to Figure 3-36). Local dive operators recalled that the “Circus Wreck” brought elephants and other circus animals to Yap when they were children in the 1980s.

Figure 3-34 Collapsed Upper Decks on Target 09 (Photo by AECOM)

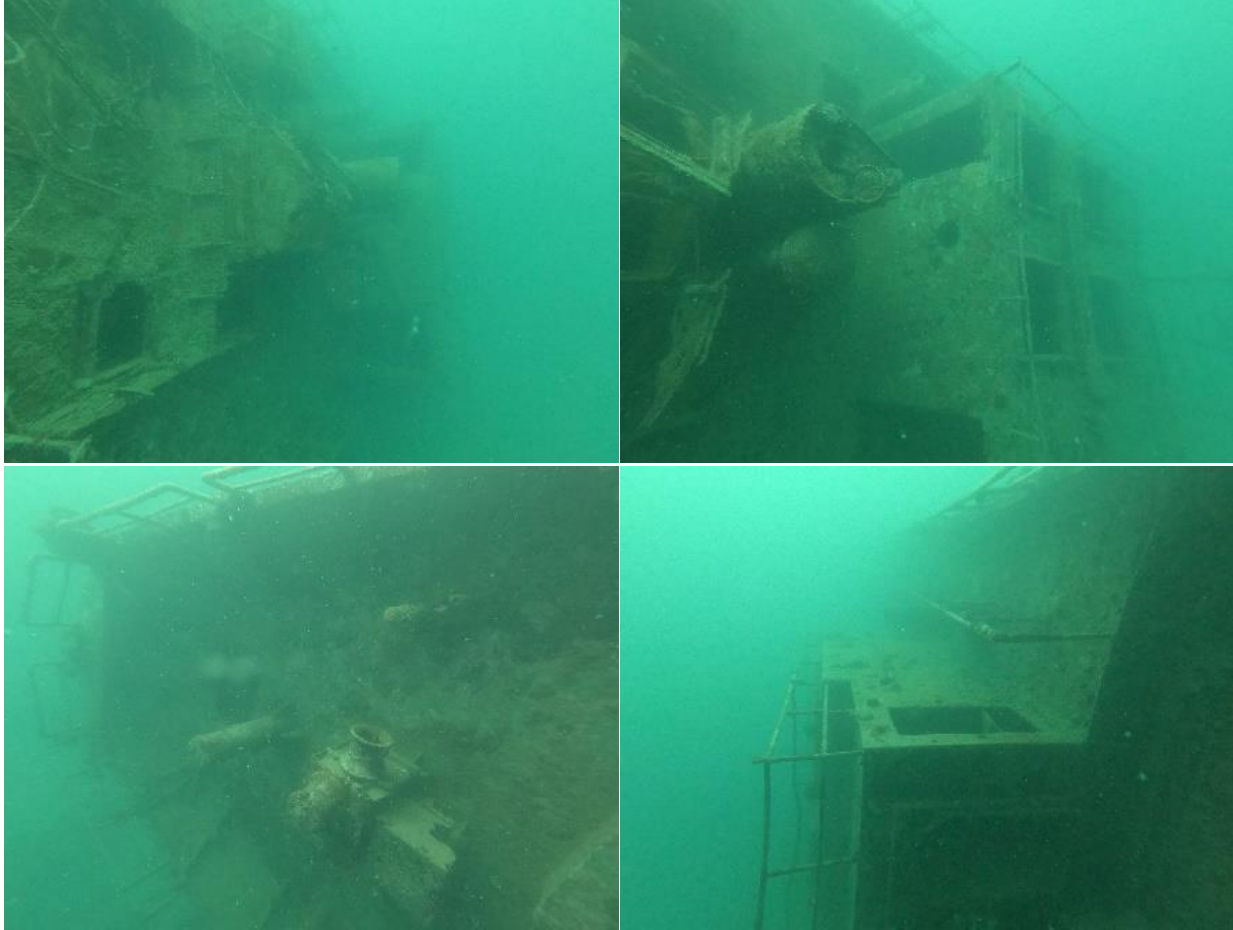
Figure 3-35 Target 09 Ship Construction Features (Photos by AECOM)

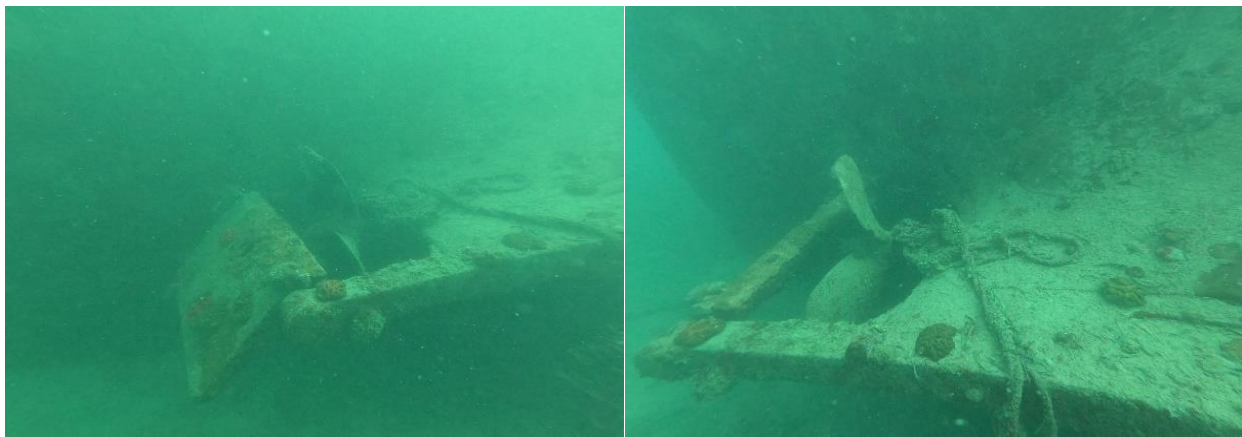
Figure 3-36 Target 09 Propeller and Rudder (Photo by AECOM)
