Final Field Report for Baseline Cultural Resources Surveys for the Sea Port in Yap, Federated States of Micronesia

Cardno GS – AECOM Pacific Joint Venture

October 2023

Project Name: Pacific Deterrence Initiative
Resource Surveys at Yap Port

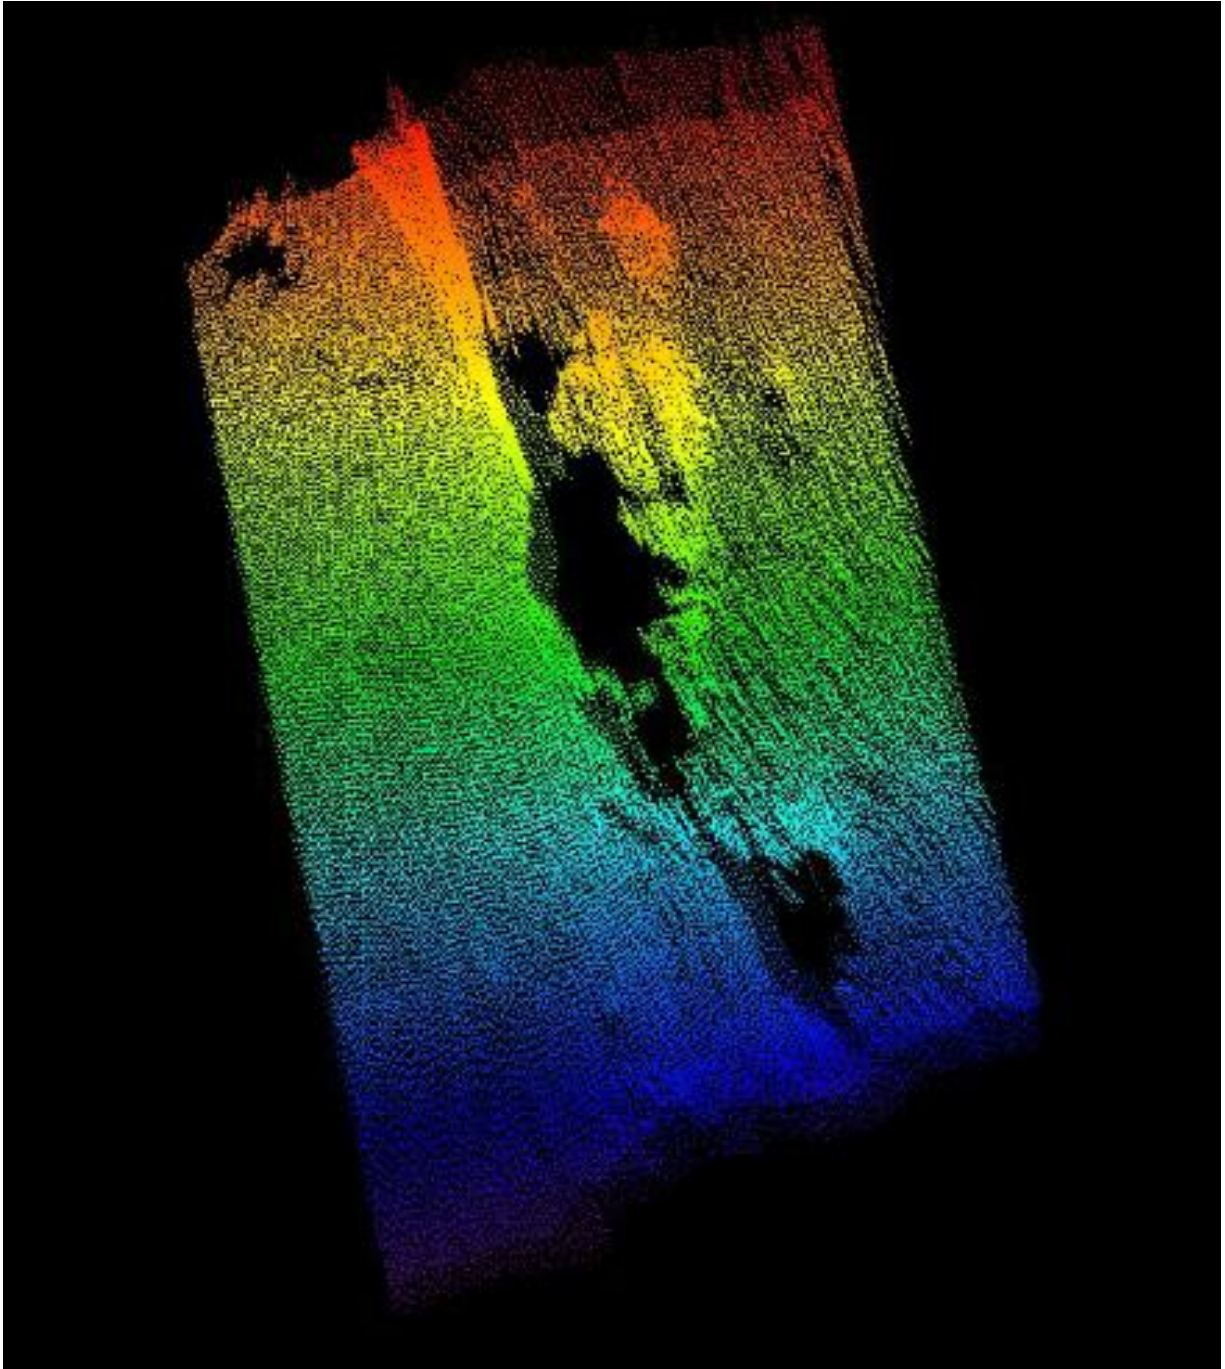
Figure 3-37 Target 10 (Navy Seabee MBES image)

Target 10 was located in approximately 45 feet (13 meters) of water (Figure 3-37). Divers did not identify any acoustic contact in the vicinity of Target 10. The source of Target 10 was a natural coral head, a non-anthropogenic object. Navy Seabee MBES data denotes Target 10 as a wreck, 30 feet (9 meters) long and 16 feet (5 meters) wide, exposed approximately 18 feet (5.6 meters) above the sea bottom.

Divers spent 18 minutes investigating Target 10 and identified the source as a coral head with substantial relief. The coral head was bulbous and elongated, which was consistent with recorded MBES data.

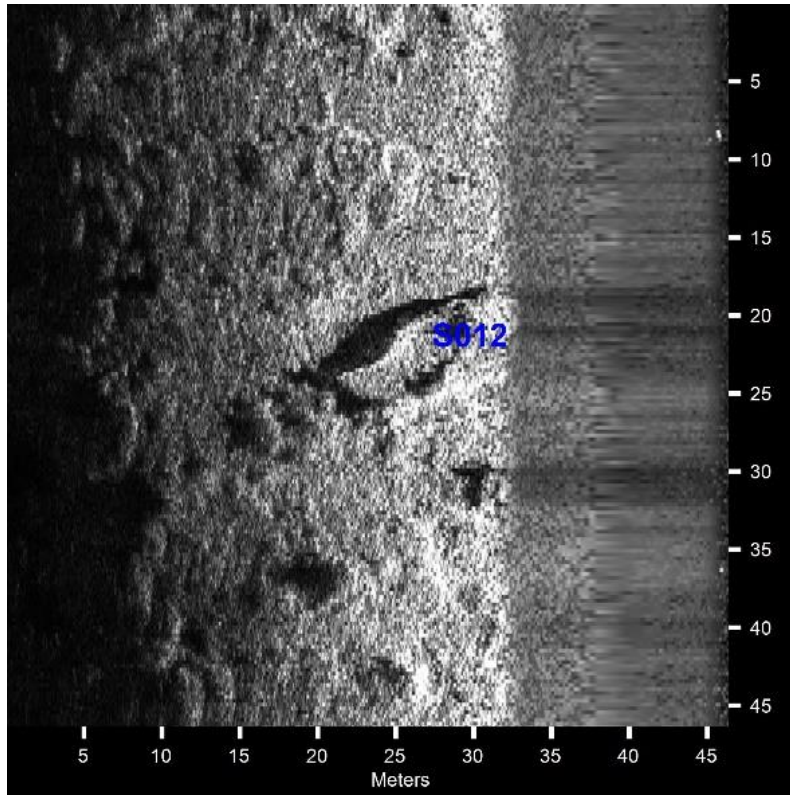
Figure 3-38 Target 11 (Acoustic Contact S012)

Target 11 was Acoustic Contact S012, which was in approximately 65 feet (20 meters) of water (Figure 3-38). It was classified as a landing craft mechanized (LCM). The Navy Seabee MBES data designates Target 11 as a landing craft, 50 feet (15 meters) long and 15 feet (4.6 meters) wide (Figure 3-39).

Based on observed characteristics and available data, Target 11 is recommended as eligible for listing in the NRHP with an avoidance buffer of 164 feet (50 meters) from the defined site extents.

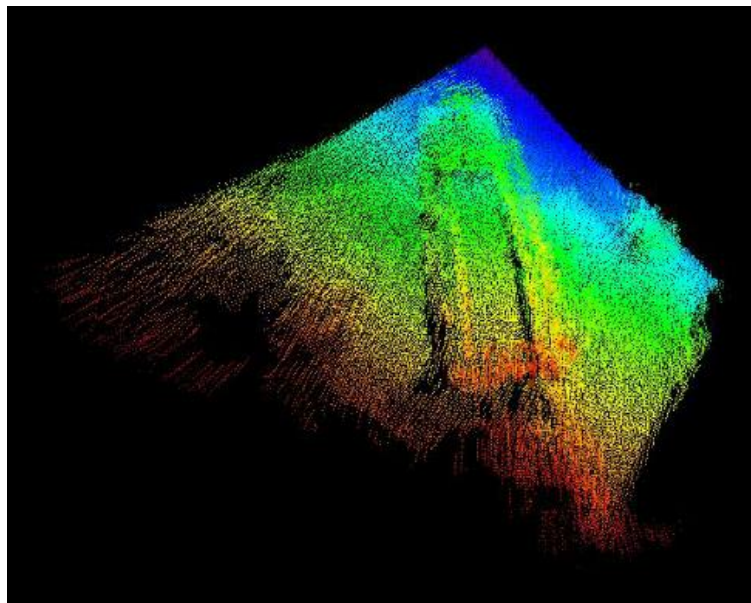
Figure 3-39 Target 11 (Navy Seabee MBES image)

Divers spent 46 minutes investigating Target 11 and identified the source as a landing craft. Archaeologists confirmed site dimensions and observed several distinguishing features consistent with a LCM, including the pilot house, access hatch, cowl vent, ramp, two ladder rungs, and corrugated floor. Substantial marine growth obscured details along the exterior sides of the landing craft. Based on the dimensions of the landing craft and distinguishing LCM features, further research determined that Target 11 is likely an LCM 3 (Figure 3-40).

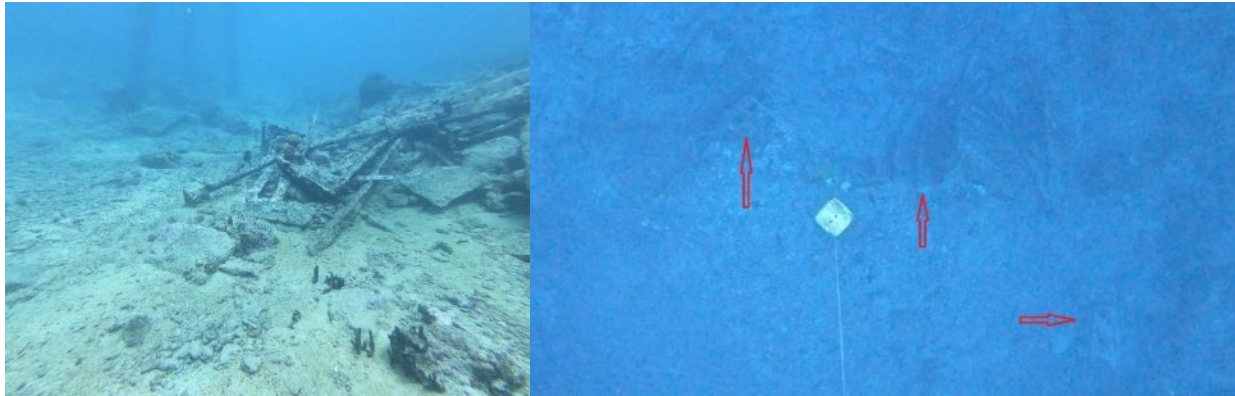
Target 24 was recorded as Acoustic Contact S018 and was a large debris field that extended from the navigation channel marker number 2 (2 pin) across the navigation channel in water depths between approximately 20 feet (6.1 meters) to over 100 feet (30.1 meters) (Figure 3-42). The eastern portion of Target 24 was recorded within acoustic imagery. The wreck was depicted on the U.S. Navy Hydrographic Office (1924) map. The source of Target 24 was identified as the scattered remains of a late-19th-century to early-20th-century steam vessel, possibly identified as either the SMS *Planet*, a German survey vessel, or the *Kokura Maru*, a cargo vessel.

Figure 3-42 Target 24 with 2 Pin in Background (Left; Photo by AECOM) and Target 24 as Seen by the Drop Camera (Right; Photo by SEI)

Based on observed characteristics and available data, Target 24 may retain the potential to yield significant information about late-19th-century to early-20th-century shipping. It is recommended treating Target 24 as eligible for listing in the NRHP with an avoidance buffer of 328 feet (100 meters) from the defined site extents, pending additional information.

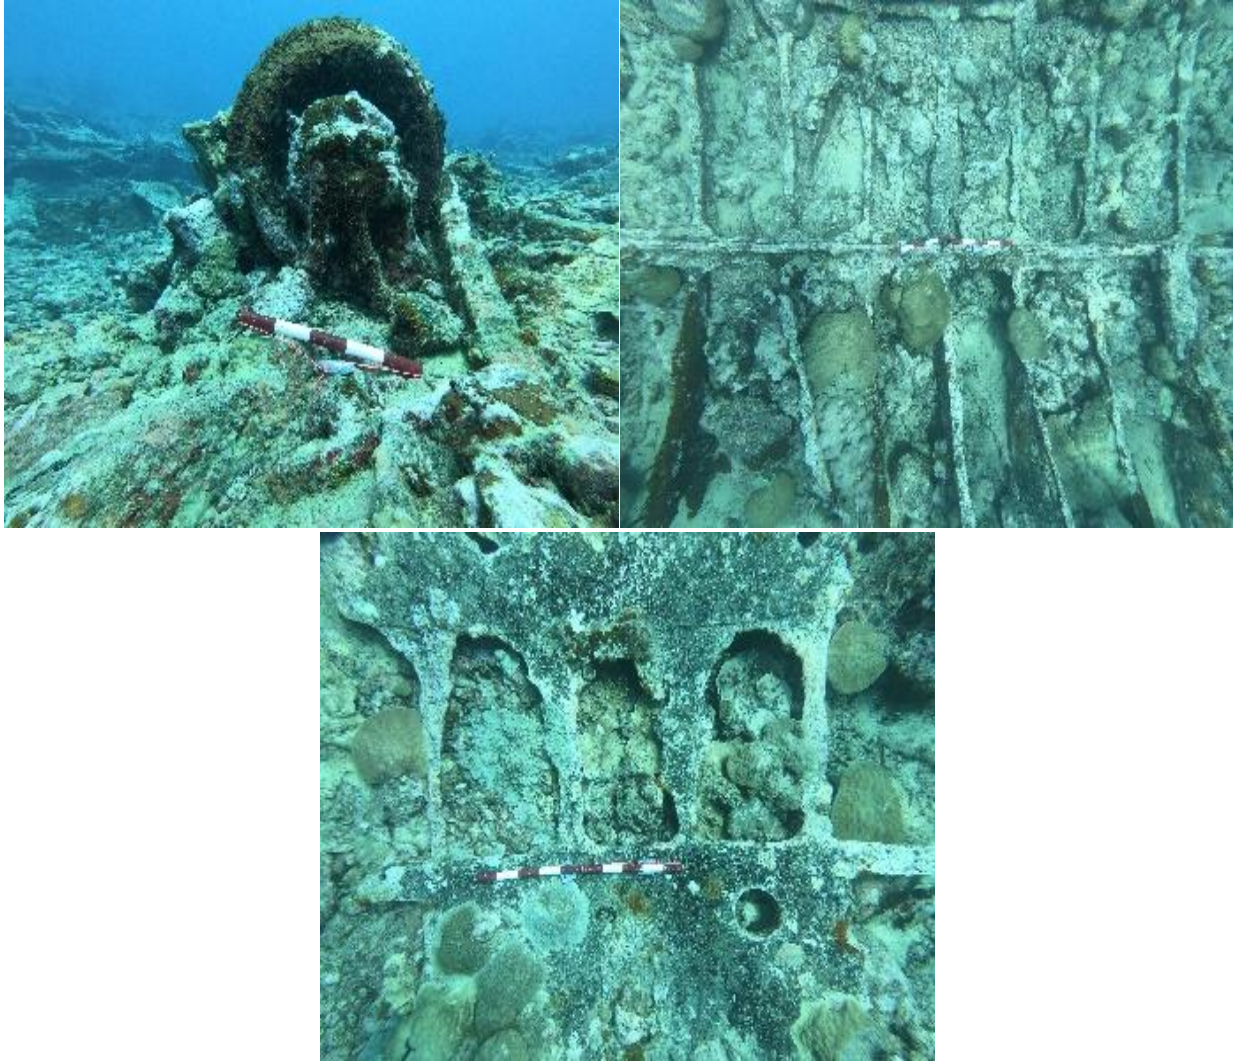
Divers spent 185 minutes investigating Target 24 within water depths approved for diving, while drop camera footage was collected in depths beyond approved diving limits. Target 24 consisted of several ship construction elements including a Scotch boiler, which dates to the mid-19th to early 20th century, a smokestack, and a mast (Figure 3-43). Other ship construction elements included a windlass, metal framing, and exterior hull sheeting with window ports (Figure 3-44). Various sizes of chains were strewn about the site. Archaeologists noted two anchors, with the smaller one resembling a Rodger-style anchor, which dates to the mid- to late 19th century. The larger anchor had a single fluke and portion of the stock visible and exposed portions resemble an admiralty anchor (Figure 3-45).

Figure 3-44 Target 24 Windlass (Top Left), Metal Framing (Top Right), and Exterior Hull Plating with Window Ports (Bottom) (Photos by AECOM)

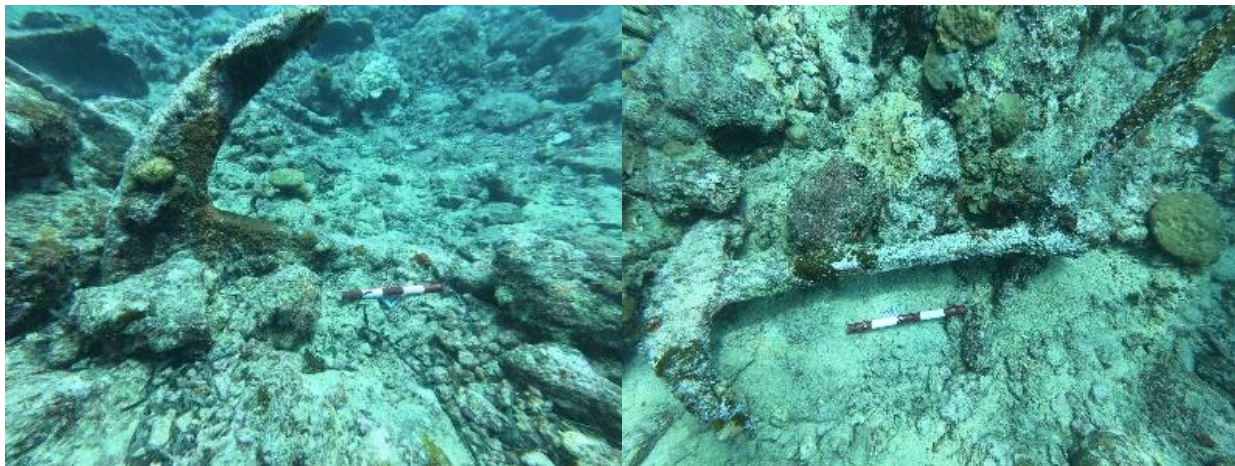
Figure 3-45 Target 24 Large Admiralty Anchor (Left) and Small Rodger-style Anchor (Right) (Photos by AECOM)

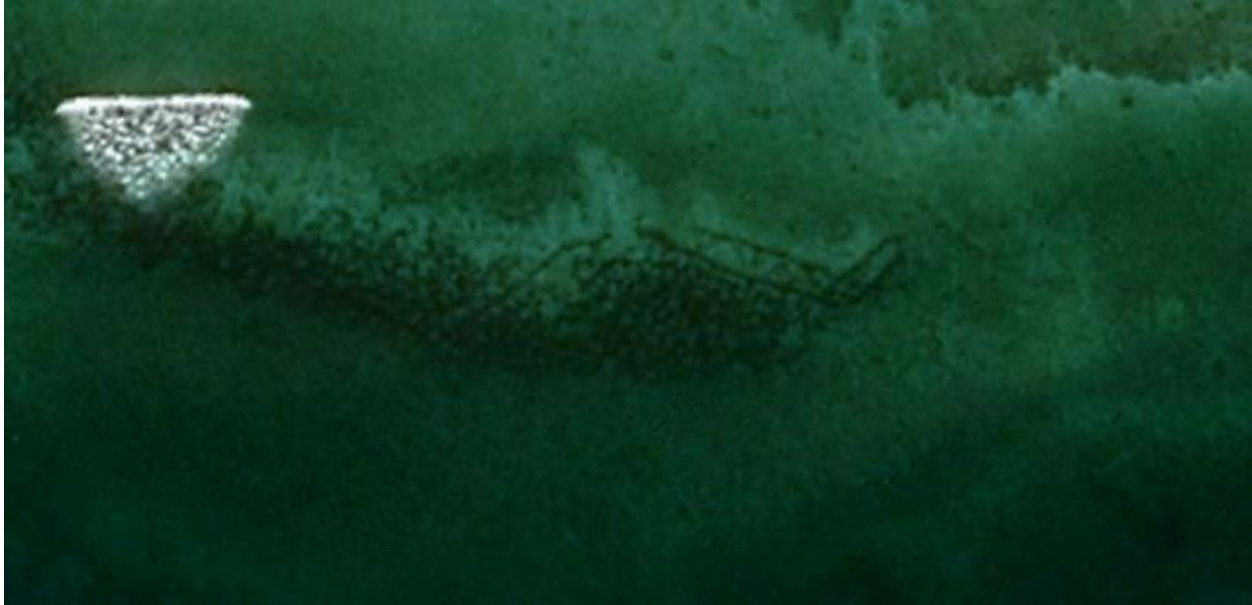
Figure 3-49 Modern Aerial Imagery Depicting Target 30

Target 30 was identified through aerial imagery as an unknown contact measuring 340 feet (103 meters) long and 26 feet (8 meters) wide in approximately 10 feet (3 meters) of water. Target 30 was visible from the surface and, after several passes investigating the target, archaeologists identified the source as a substantial linear patch of sea grass (Figure 3-49). The historic aerial imagery suggested that the linear outcrop could represent an *aech* due to its size and linear characteristics. Upon examination, however, archaeologists determined that Target 30 contained no evidence of rock or coral features. The source of Target 30 is a natural sea grass formation, a non-anthropogenic feature.

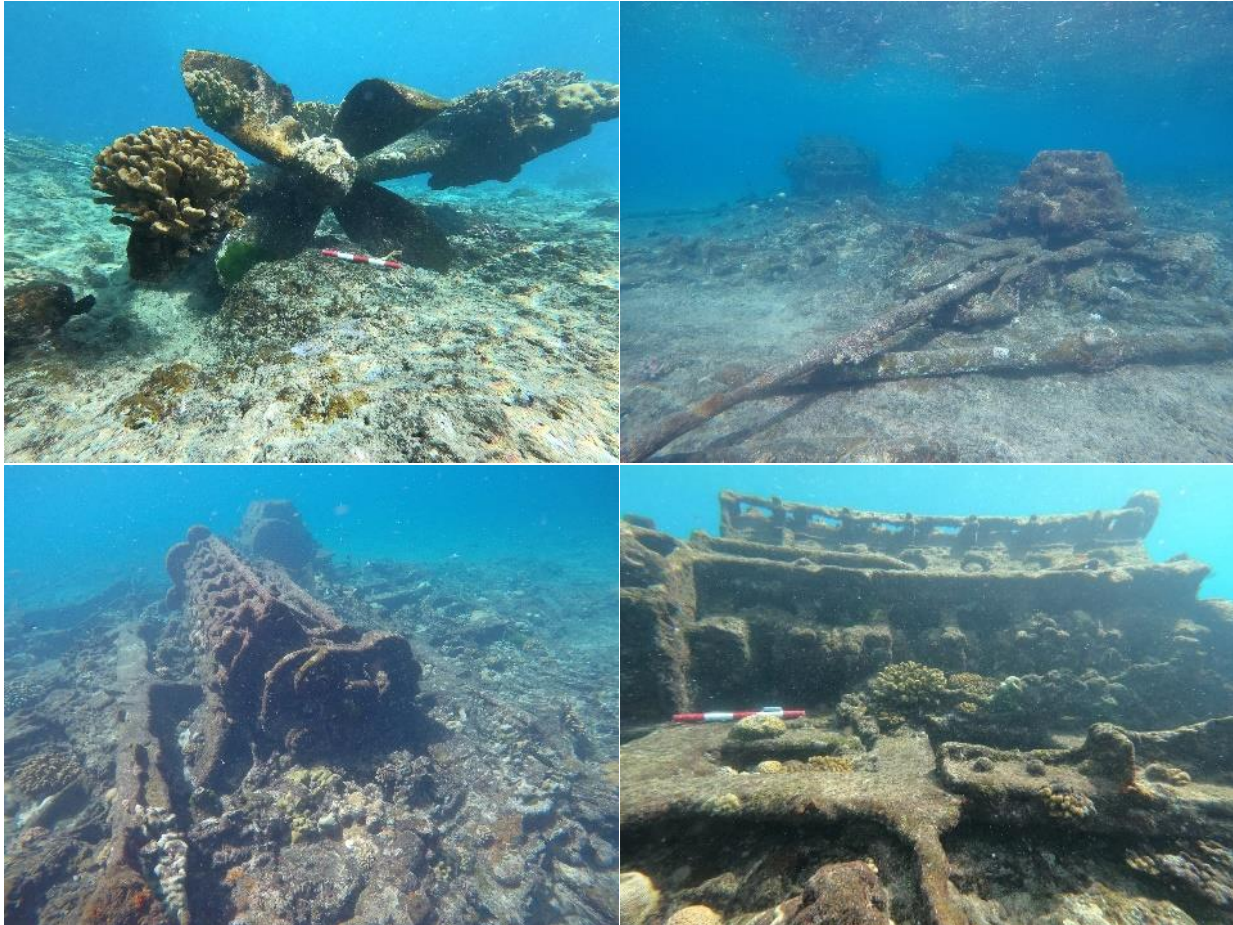
Figure 3-53 Propeller (Upper Left), Propeller and Shaft (Upper Right), and Propulsion Engine (Bottom) on Target 22 (Photos by AECOM)

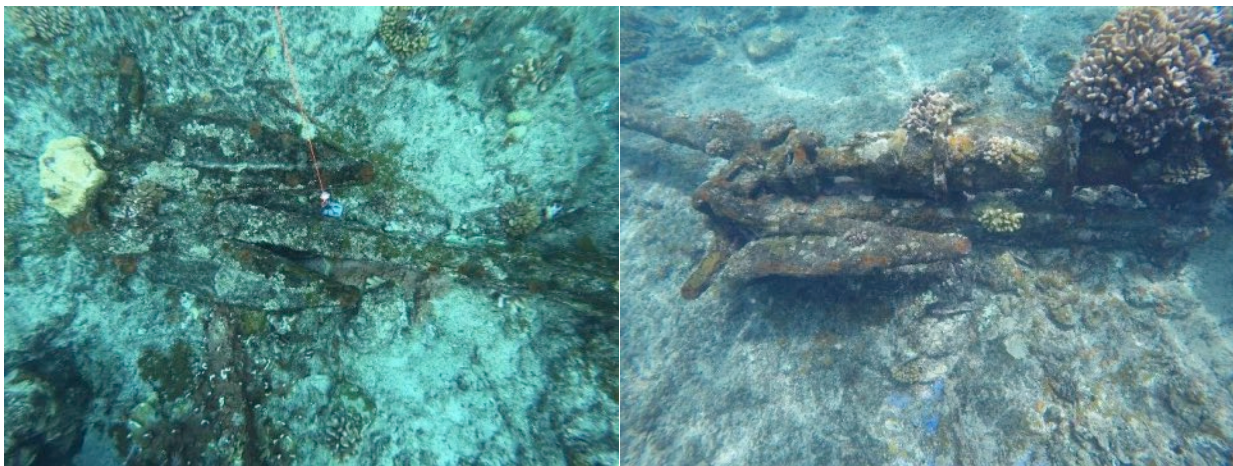
Figure 3-54 Danforth-type Anchors (Photos by AECOM)

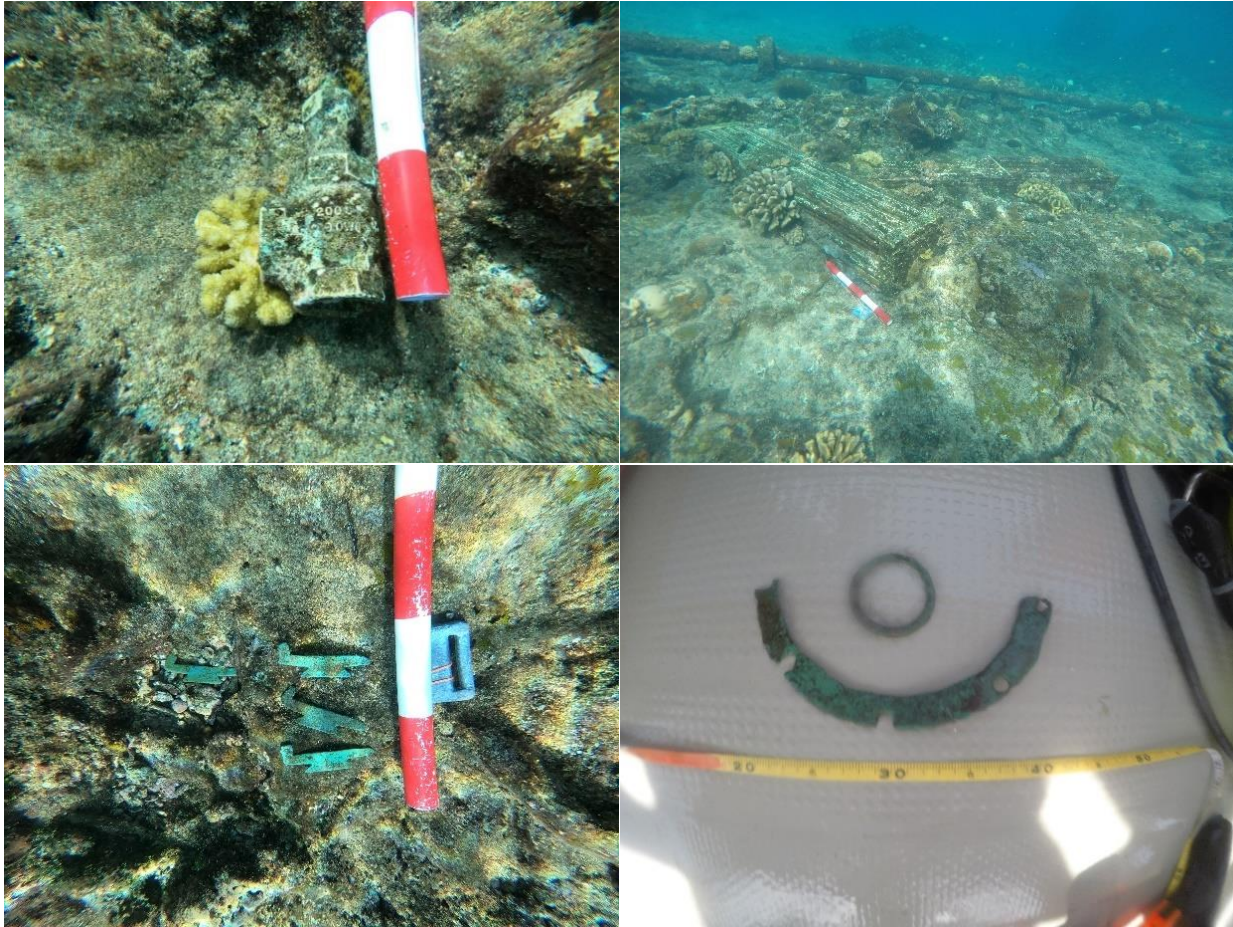
**Figure 3-55 Detailed Features (Top and Bottom Left) and Cupreous Artifacts (Bottom Right)
(Photos by AECOM)**

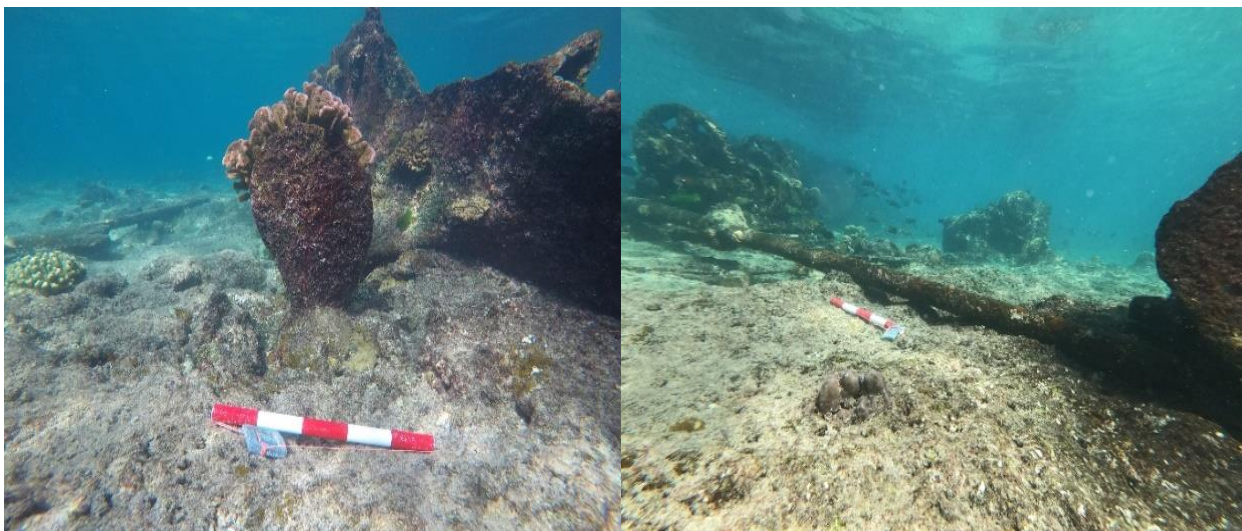
Target 26 was located near Offshore Mooring (Survey Area 1) in approximately 10 feet (3 meters) of water along the edge of a reef. Target 26 was denoted as kml_77 in the NOAA ENC shipwreck database as a visible shipwreck, always dry. Target 26 rests along the outer edge of the reef and, while investigating the target, archaeologists noted that during low tide sections of the wreck became exposed. Divers spent 34 minutes investigating Target 26 and identified the source as having elements consistent with late-19th-century to early-20th-century ships with construction features including large machinery, such as an engine and a large windlass (Figure 3-56). Target 26 also consisted of two partially buried propellers, the blades each measuring 2 feet (0.5 meters) long and 1 foot (0.4 meters) wide, and prop shafts (Figure 3-57). Two Rodger- or kedge-Admiralty-style anchors, typical of the 19th century, were located near the propellers (Figure 3-58). Archaeologists observed a large gouge in the seabed that led up to the shipwreck, implying the ship ran into the reef during the wrecking event (Figure 3-59). Observed construction elements such as engine and prop shafts appear to reflect its historic design prior to the wrecking event. Due to heavy amounts of surge and shallow water, the entirety of Target 26 was not observed during diver investigation. Strong surge and waves, as well as tropical weather, may have dispersed the site onto the reef. Based on the observed construction elements, Target 26 is likely a late-19th-century to early-20th-century vessel. Based on observed characteristics and available data, Target 26 may retain the potential to yield significant information about late-19th-century to early-20th-century shipping and site formation processes. It is recommended treating Target 26 as eligible for listing in the NRHP with an avoidance buffer of 328 feet (100 meters) from the defined site extents, pending additional information.

Figure 3-57 Propeller Prop (Left) and Shaft (Right) (Photos by AECOM)

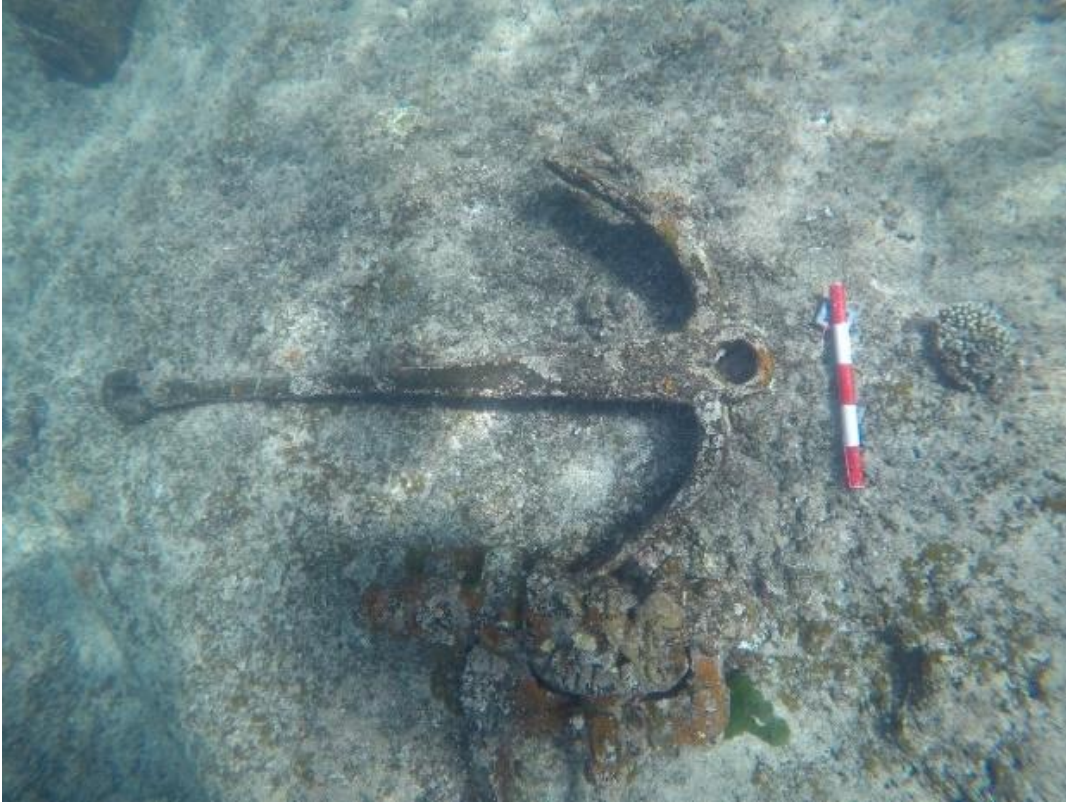
Figure 3-58 Anchor on Target 26 (Photo by AECOM)

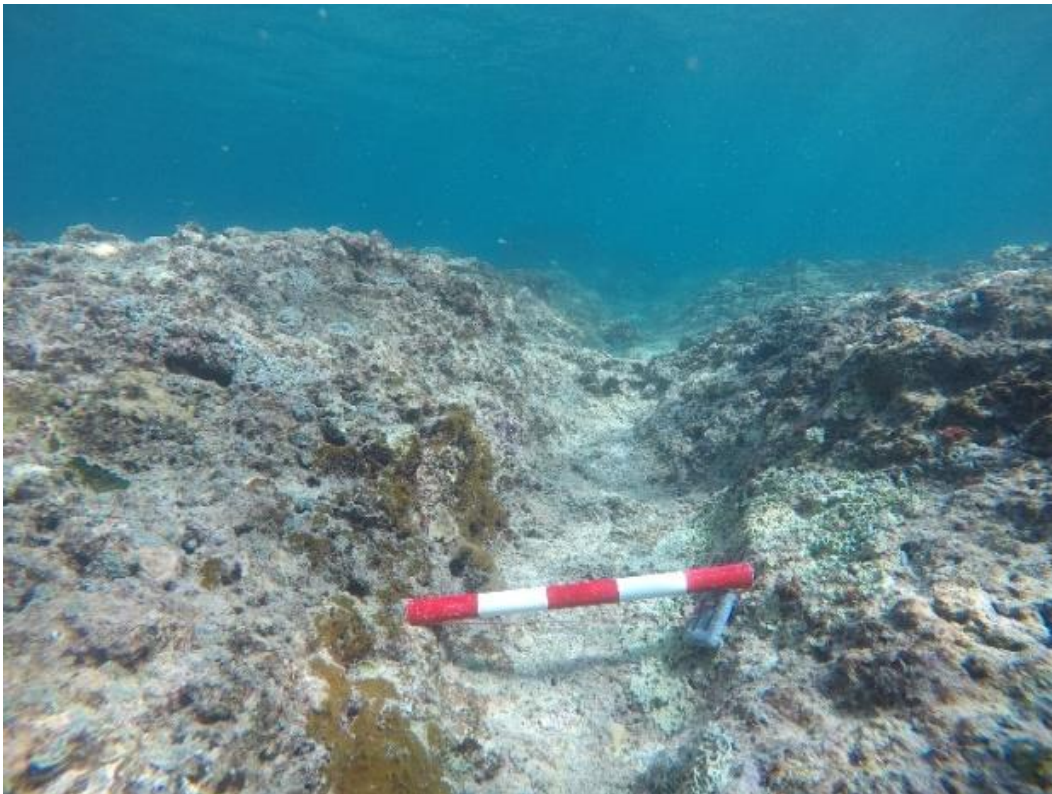
Figure 3-59 Large Gouge in Seabed Leading Up to Target 26 (Photo by AECOM)

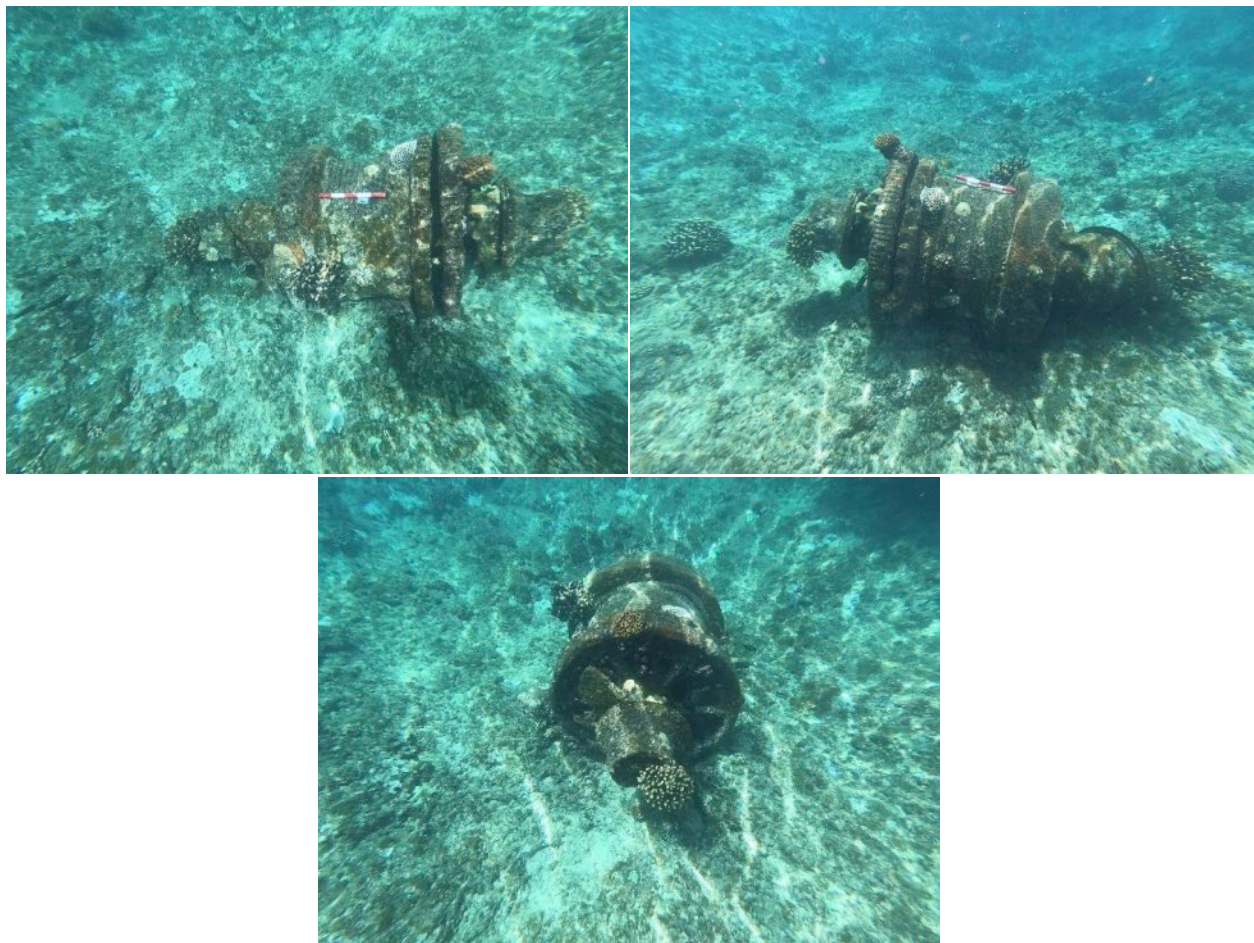
Figure 3-60 Target 27 (Photos by AECOM)

Target 27 was located near Tamil Channel Entrance (West) (Survey Area 3) in approximately 10 feet (3 meters) of water near Target 23. Target 27 is an isolated object, measuring 10 feet (3 meters) long and 5 feet (1.5 meters) wide, that resembles a section of a windlass or cargo winch (Figure 3-60). The lack of context and lack of anchor chain suggest that it is not an anchor windlass but could be a windlass or winch used for hauling yards or cargo. The make of the windlass/winch was reminiscent of an early- to mid-20th-century windlass. Target 27 was a probable early- to mid-20th century windlass and may be related to Target 23. It is possible that Target 27 had associated buried material. Based on observed characteristics and available data, Target 27 may be related to Target 23 and, as such, may retain the potential to yield important information regarding maritime shipping and industry practices significant to Yap and the FSM's history. Due to its potential association with Target 23, it is recommended treating Target 27 as eligible for listing in the NRHP pending additional information. Target 27 was encompassed within the recommended avoidance zone of Target 23 and may be related; therefore, an additional avoidance buffer for Target 27 is not currently recommended.

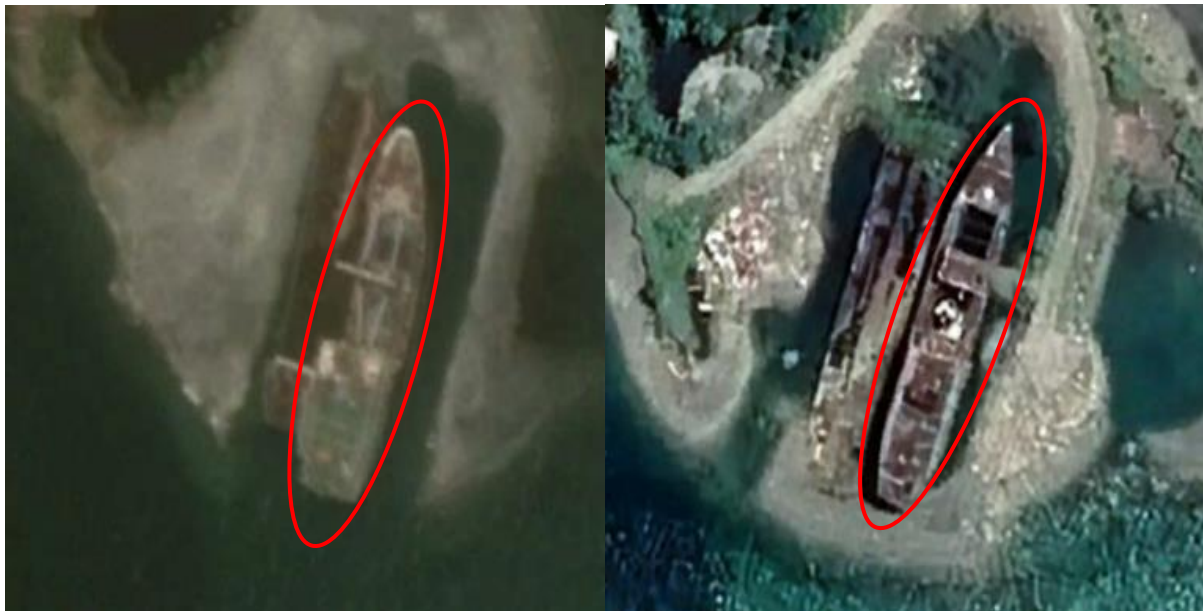
Figure 3-62 2013 Aerial Images of Target 01 (Google Earth)

Target 01 was located in Yap Port (Survey Area 4). Target 01 was first identified via aerial imagery as an unknown contact measuring 184 feet (56 meters) long and 43 feet (10 meters) wide (Figure 3-62). Target 01 first appeared in aerial imagery in 2013, with its upper decks and superstructure intact, but was not visible in 2008 imagery. Archaeologists conducted a pedestrian survey at low tide and with access around a majority of the target. Archaeologist identified Target 01 as a general cargo ship and observed the name *Micro Spirit* and “Yap” across the stern (Figure 3-63). Target 01 contained multiple ship construction elements, including welded deck plating, Plimsoll mark, fixed skeg, and rudders (Figure 3-64). The superstructure was salvaged along with the bulwark, leaving the weather deck and two hatchways (Figure 3-65). The *Micro Spirit* was a general cargo ship built in 1978 by Hashimoto Shipbuilding in Kobe, Japan (ShipSpotting 2010) (Figure 3-66). Owned by the Micronesian Government, *Micro Spirit* served as a cargo and passenger ship for the islands of Micronesia until the late 2000s, when it was abandoned near the Yap Recycling Center and partially salvaged. Figure 3-67 shows the state of the target in 2014 compared to what archaeologists examined in 2023. Based on observed construction elements and research into *Micro Spirit*, Target 01 is a late-20th-century general cargo ship. Based on observed characteristics and available data, Target 01 has been substantially altered and no longer retains integrity as it relates to its original use. Additionally, Hashimoto Shipbuilding built other similar vessels, such as the *Micro Chief*, some of which are still afloat (BalticShipping.com 2023). It is recommended that Target 01 is not eligible for listing in the NRHP.

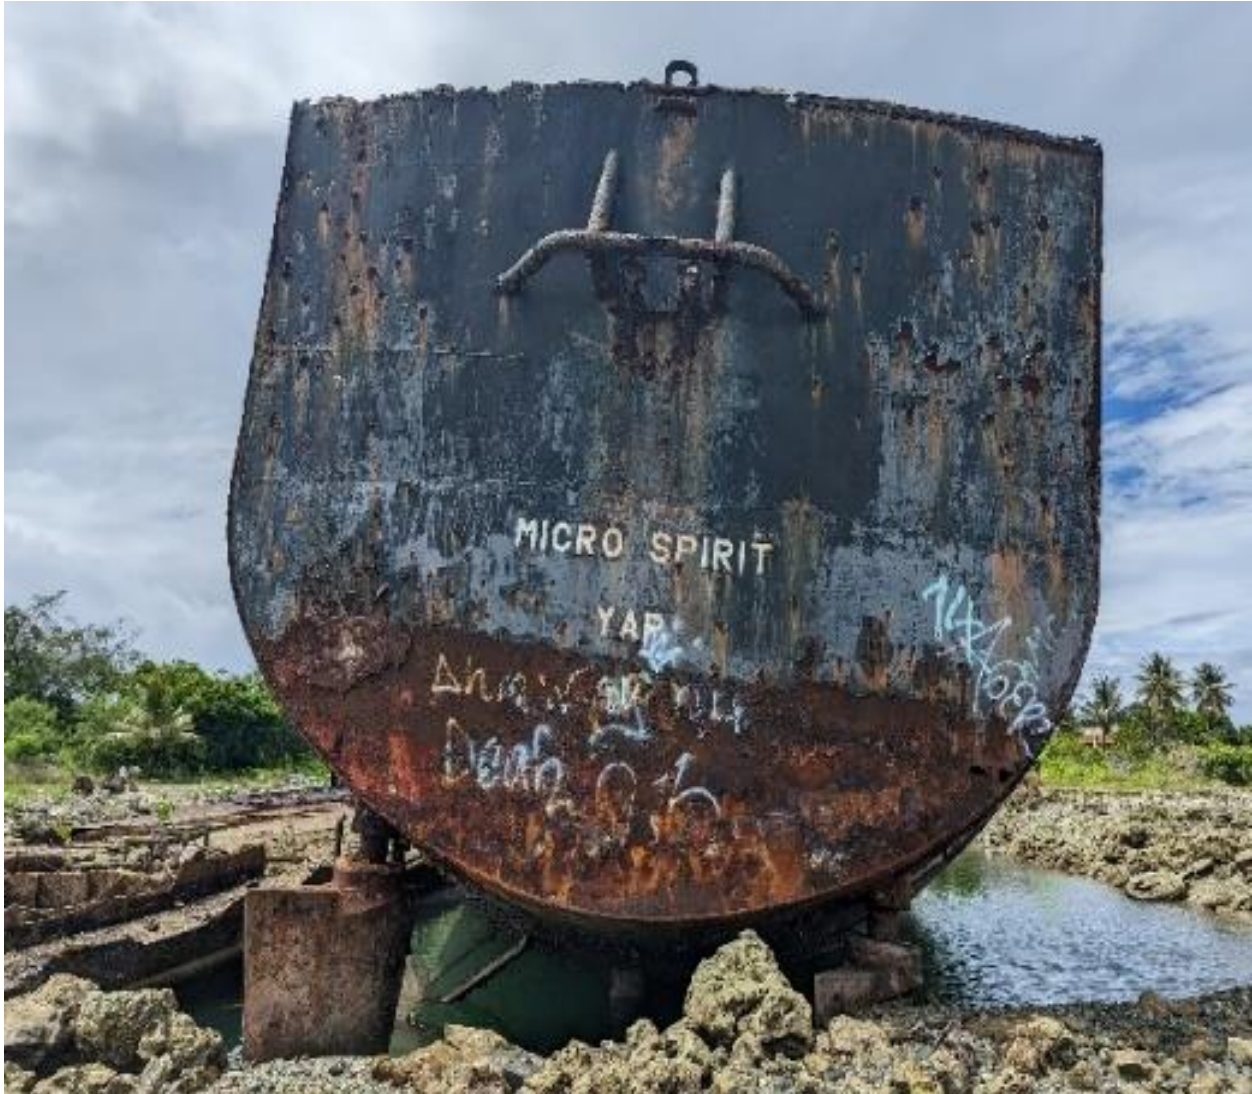
Figure 3-63 Image of Nameplate Micro Spirit, Yap on Target 01 (Photo by AECOM)

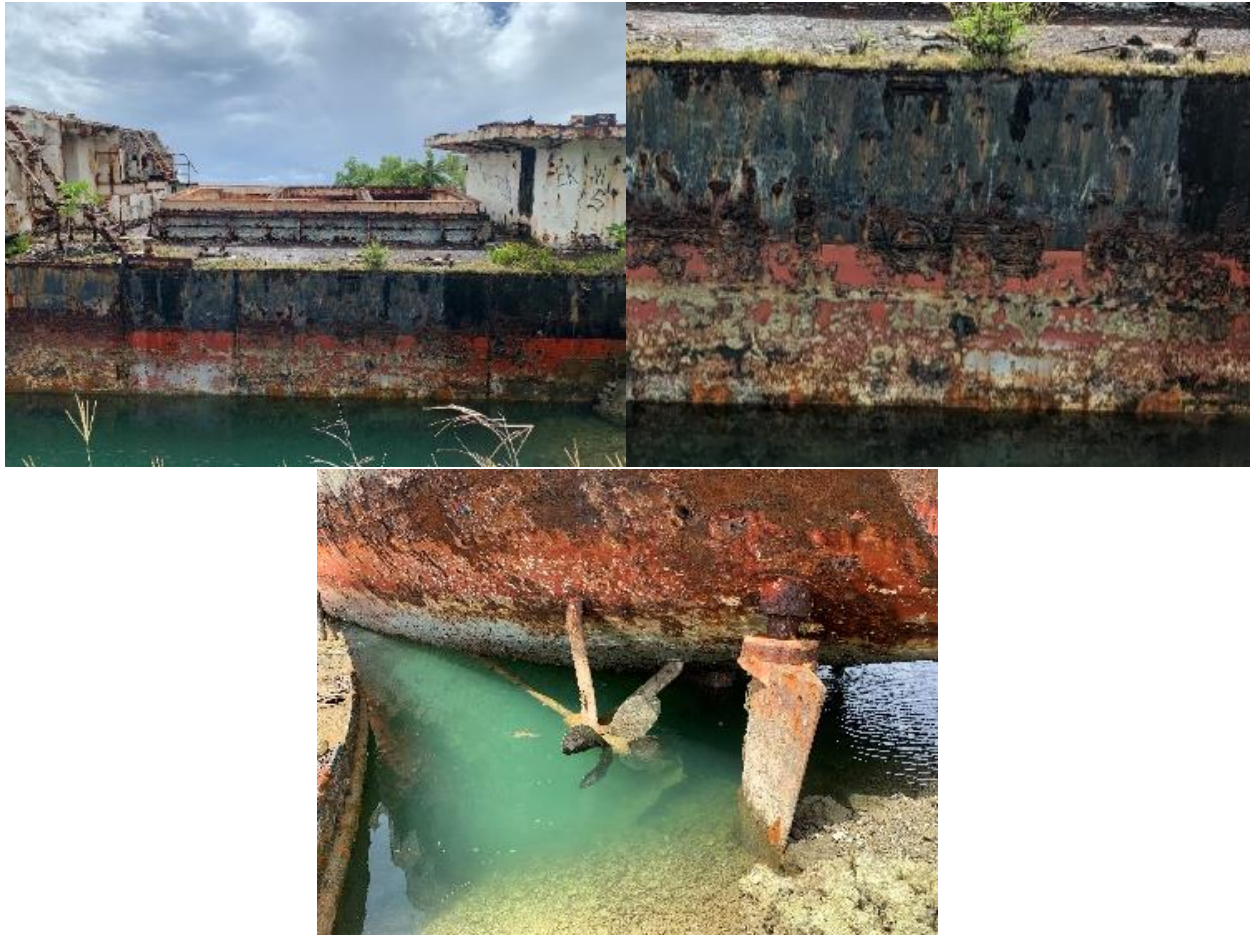
Figure 3-64 Welded Deck Plating, Plimsoll Mark, Fixed Skag, and Rudders on Target 01 (Photo by AECOM)

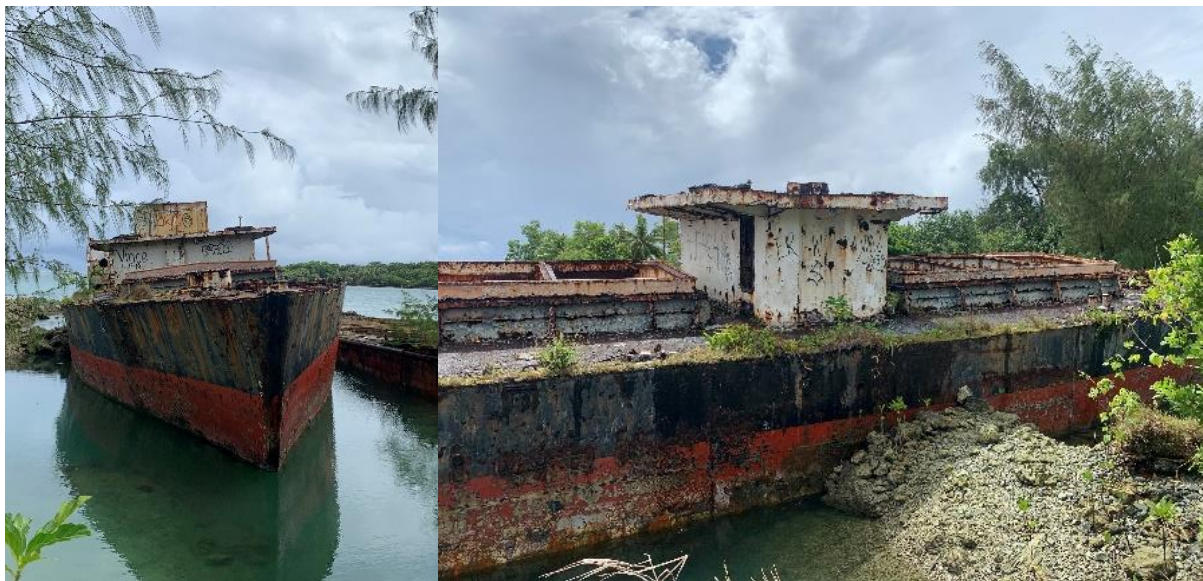
Figure 3-65 Weather Deck and Two Hatchways on Target 01 (Photo by AECOM)

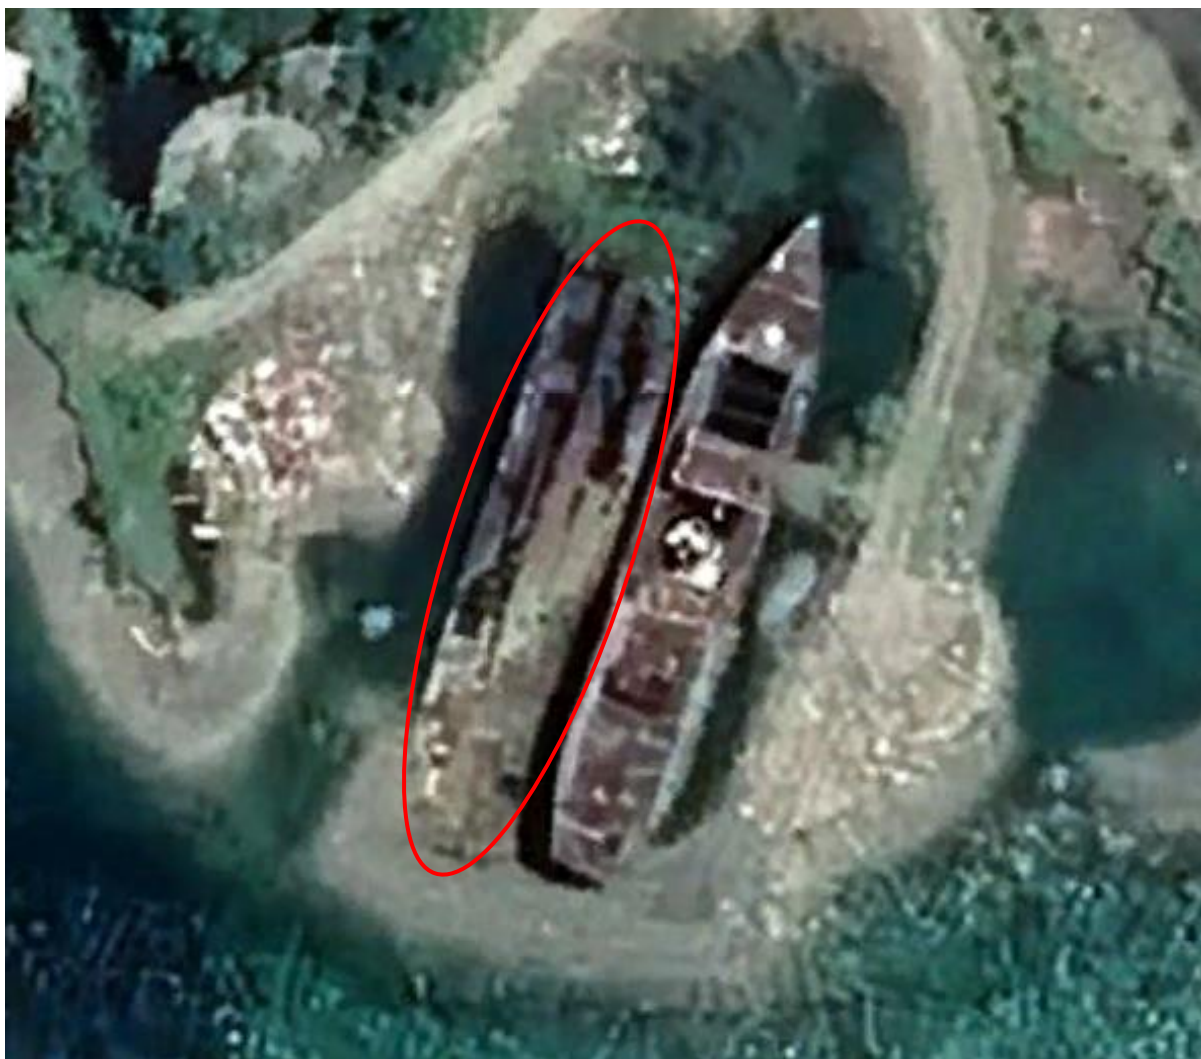
Figure 3-69 Aerial Imagery of Target 02 (Google Earth)

Target 02 was located in Yap Port (Survey Area 4). Target 02 was first identified partially exposed in aerial imagery as an unknown contact measuring 175 feet (53 meters) long and 37 feet (11 meters) wide (Figure 3-68). Target 02 first appeared on aerial imagery in 2013 but is not visible in 2008 aerial imagery (Figure 3-69). Archaeologists conducted a pedestrian survey at low tide and with access around a majority of the target. Archaeologists identified Target 02 as a rectangular barge and observed multiple ship construction elements, including welded deck plating, Plimsoll mark, rub rails, and iron I-beam support/framing (Figure 3-70). Target 02 was partially salvaged, with evidence that a superstructure in the aft section once existed. A partial nameplate remained visible on the stern with, “ANIL_A_” legible (Figure 3-71). Attempts to identify the vessel in ship registries were unsuccessful; however, observed construction elements are consistent with late-20th-century, open-ocean barge construction methodologies. Large structural cracks observed along the hull and its location near other identified vessels imply Target 02 was likely pulled ashore to facilitate the salvage/scraping process. Based on observed construction elements and vessel size, Target 02 was likely an ocean-going barge. Based on observed characteristics and available data, Target 02 has been substantially salvaged and no longer retains integrity as it relates to its original use. Additionally, the presence of construction materials such as PVC piping and rubberized electrical coating suggest a recent construction date. Target 02 is recommended as not eligible for listing in the NRHP.

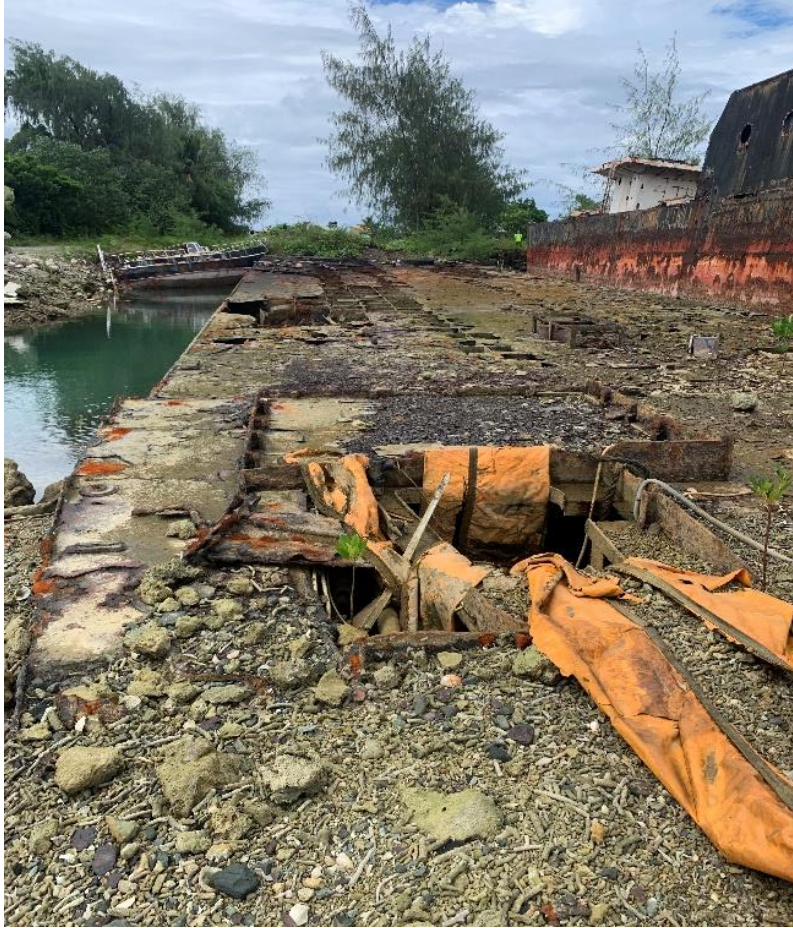
Figure 3-70 Evidence of Superstructure and Construction Elements of Target 02 (Photo by AECOM)

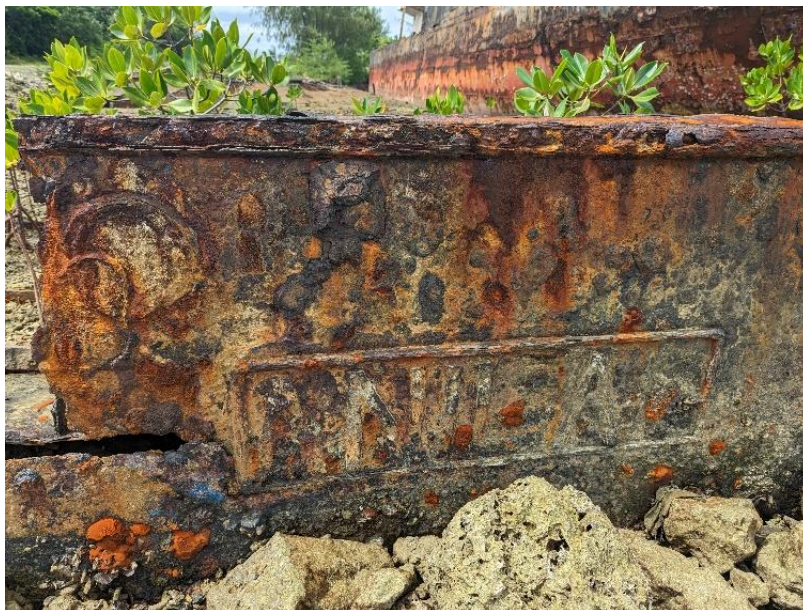
Figure 3-71 Partial Nameplate on the Stern of Target 02 (Photo by AECOM)
