Final Field Report for Baseline Cultural Resources Surveys for the Sea Port in Yap, Federated States of Micronesia

Cardno GS – AECOM Pacific Joint Venture

October 2023

Project Name: Pacific Deterrence Initiative
Resource Surveys at Yap Port

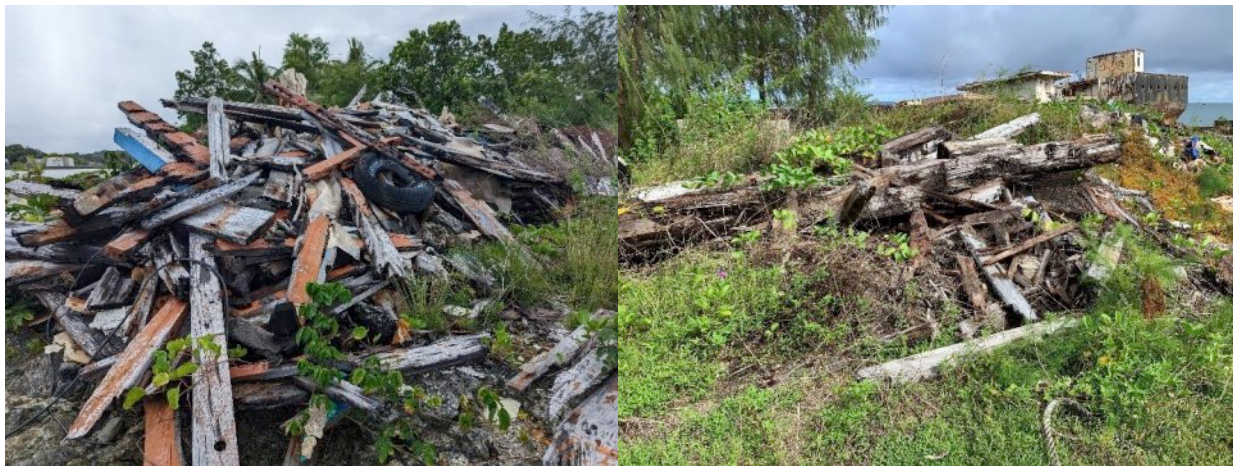
Figure 3-74 Target 04 (Photos by AECOM)

Target 04 was located in Yap Port (Survey Area 4) (Figure 3-74). Target 04 was scattered in approximately four locations and was visible in aerial imagery as an unknown contact encompassing an area of about 130 feet by 50 feet (40 meters by 15 meters). Target 04 first appeared on aerial imagery in 2022 but was not visible in 2019 aerial imagery; however, in the 2019 aerials, within the vicinity of the Target 04 remains are two beached vessels (Figure 3-75 and Figure 3-76). These vessels first appeared in the aerial imagery from 2018 but not in 2017. It is possible these two vessels may be the intact vessels for Targets 04 and 05. Archaeologists conducted a pedestrian survey at low tide and with access around a majority of the target. Archaeologists identified Target 04 as the disarticulated remains of a wooden vessel. Target 04 is single-framed, with 2-inch (5-centimeter) outer hull planking. The frames were 3.5 inches (9 centimeters) wide and between 10 inches and 10.5 inches (25 centimeters and 26.7 centimeters) apart (Figure 3-77). Target 04 also has evidence of heavy fastening using both wooden treenails and iron bolts (Figure 3-78). Archaeologists identified a distinguishable keelson and rudder-like timbers in the largest pile. Archaeologists also identified an engine, prop shaft, and propeller with cloth or fibrous matting or pay between the wood timbers (Figure 3-79). An additional engine, prop shaft, and propeller sits at the edge the adjacent forest. Archaeologists could not confirm a relationship between the engine/propeller and the main timber piles during the investigation. Observed construction elements are consistent with early-20th-century shipbuilding techniques; however, due to Micronesia's remoteness and a potential lack of access to large iron bolts, the use of treenails as a common material may be more commonplace in more recent ship construction activities. The modern engine, prop, and shaft suggested that Target 04 may have been retrofitted to update the propulsion capabilities of the vessel. Based on observed construction elements, Target 04 was possibly a mid- to late-20th-century wooden vessel retrofitted with a modern engine, propeller, prop, and shaft. Although identified ship elements can be seen within the disarticulated remains, the site lacks integrity for design, setting, workmanship, feeling, and association and, therefore, is not likely to yield important information. Target 04 is recommended as not eligible for listing in the NRHP.

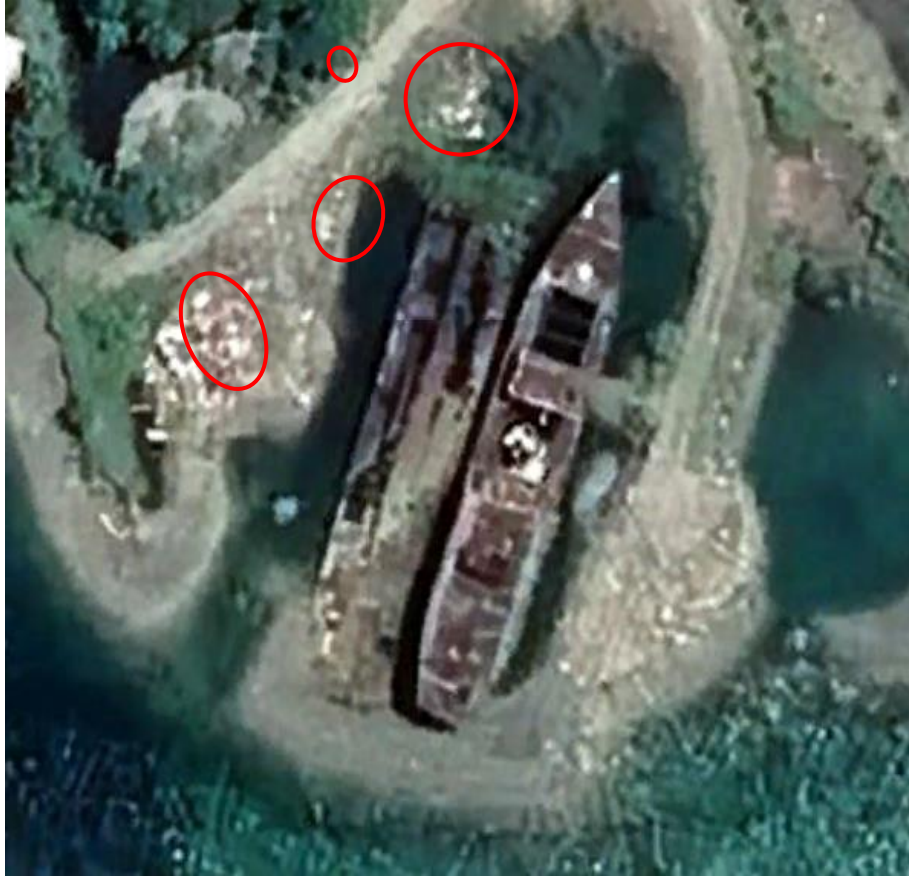
Figure 3-75 Aerial Imagery of Target 04 (Google Earth)

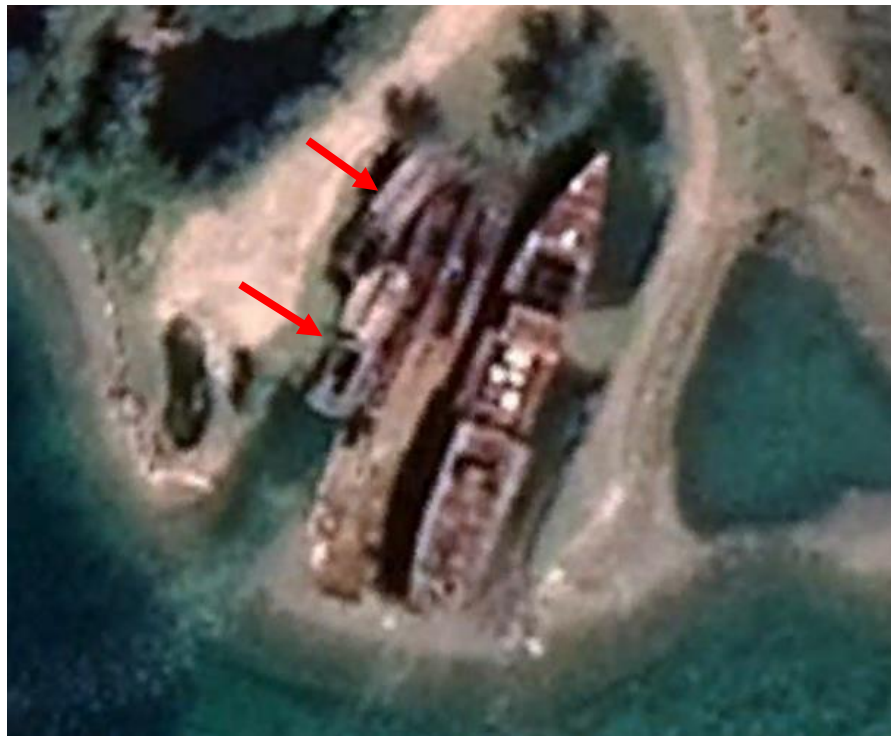
Figure 3-76 2019 Aerial Imagery Depicting Two Beached Vessels (Google Earth)

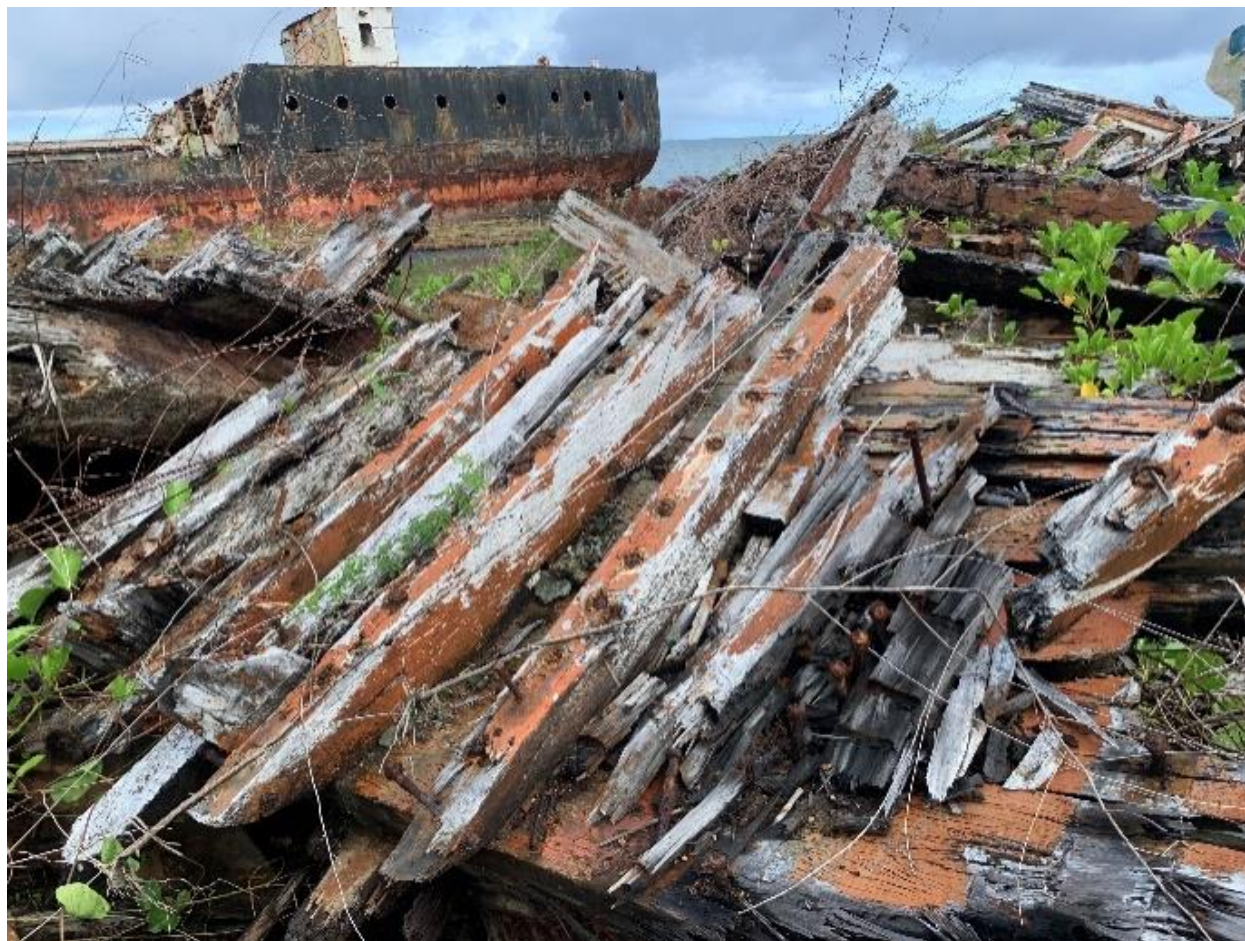
Figure 3-77 Frames and Outer Hull Planking (Photo by AECOM)

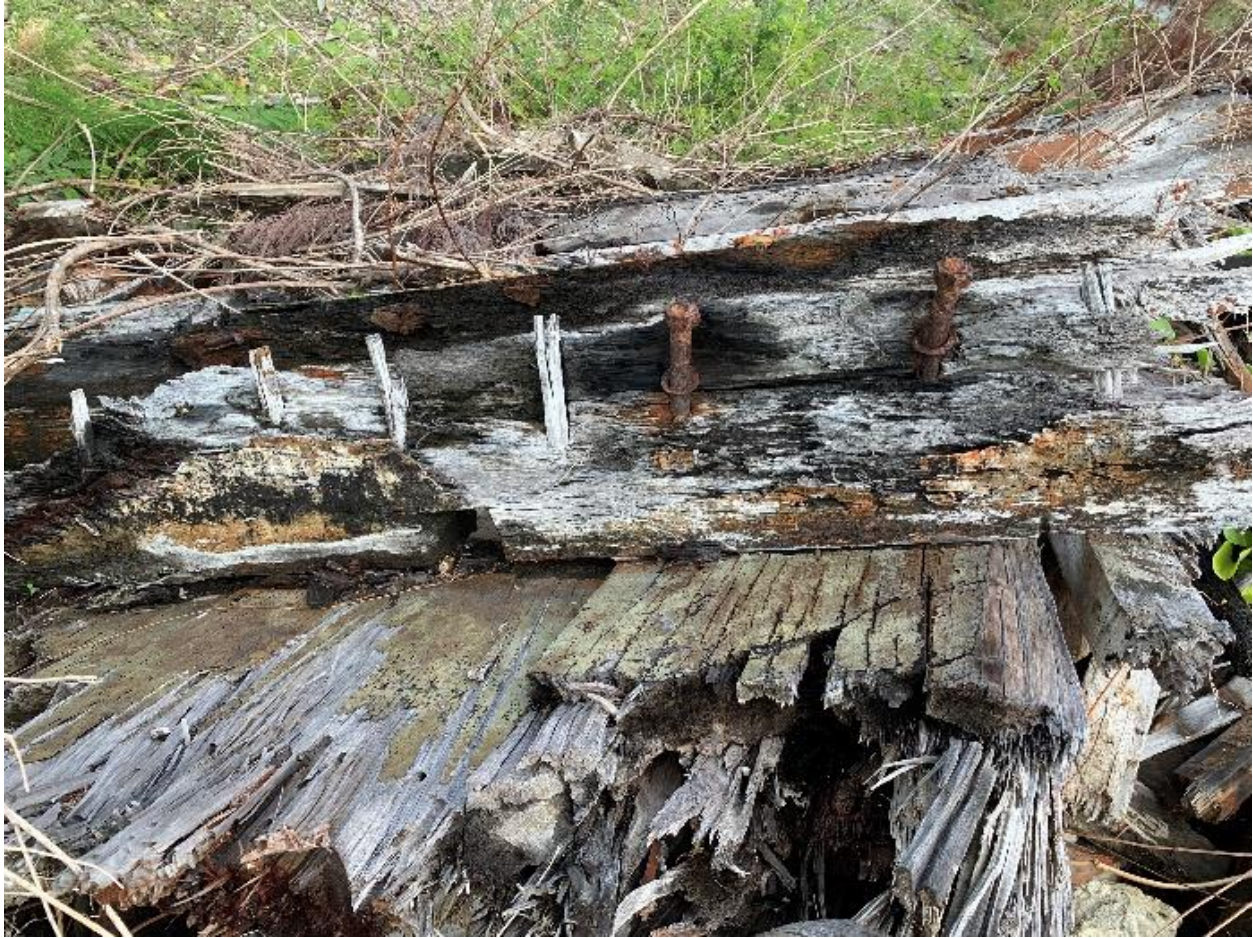
Figure 3-78 Treenails and Iron Bolts (Photo by AECOM)

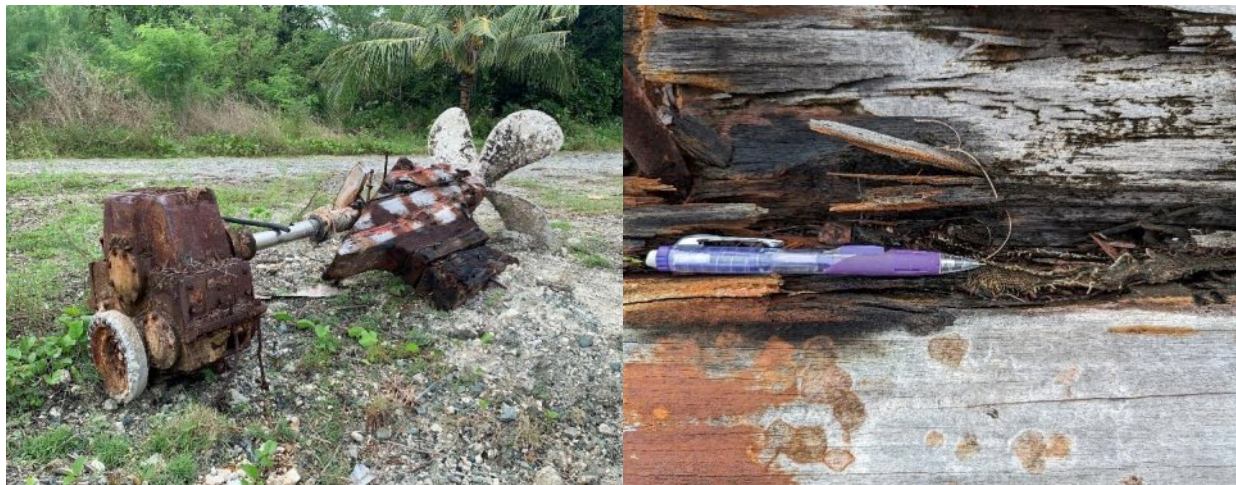
Figure 3-79 Engine, Propeller, Prop and Shaft, and Fiber Insulation on Target 04 (Photos by AECOM)

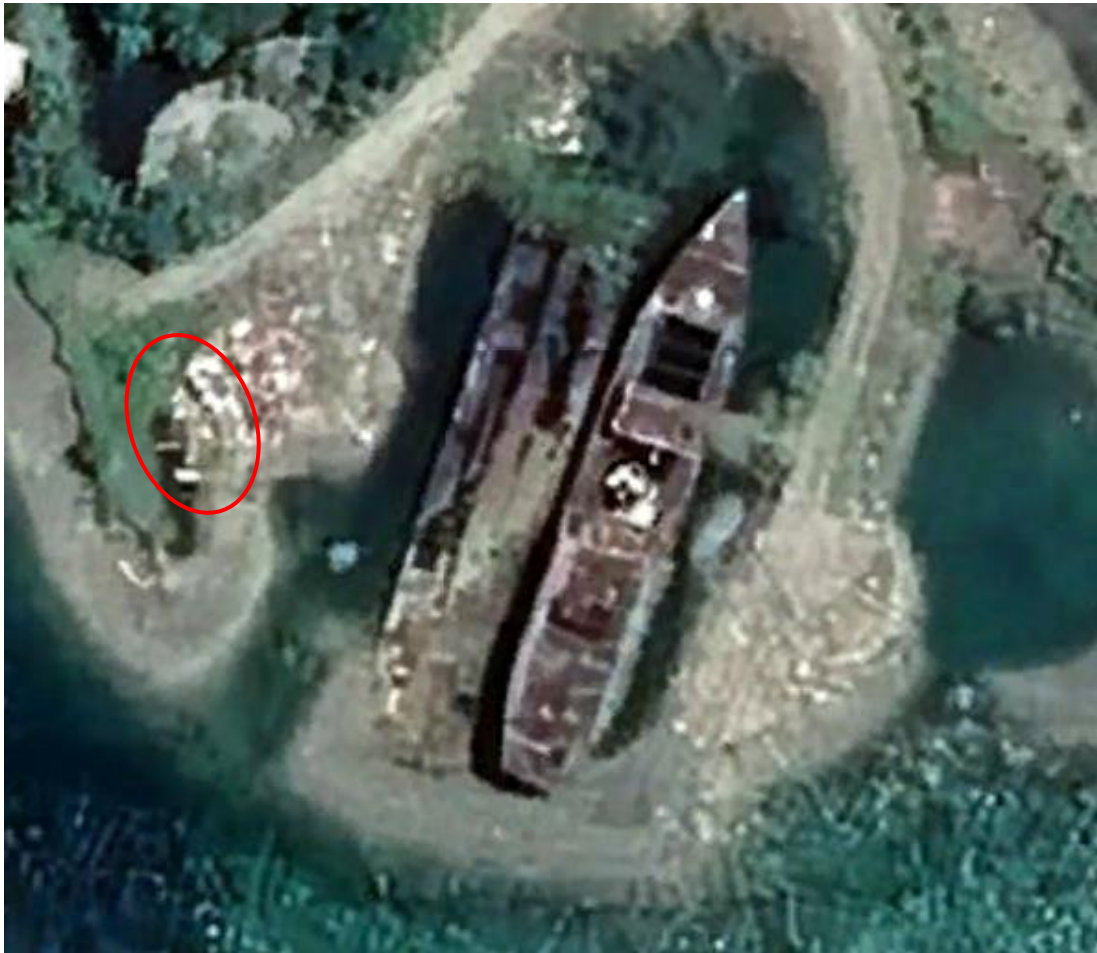
Target 05 was located in Yap Port (Survey Area 4) (Figure 3-80). Target 05 was identified as exposed in aerial imagery as an unknown contact measuring roughly 35 feet (10 meters) long and 3 feet (9 meters) wide. Target 05 first appeared on aerial imagery in 2022 but was not visible in 2019 aerial imagery; however, in the 2019 aerials, within the vicinity of the Target 05 remains are two beached vessels (Figure 3-80). These vessels first appeared in the aerials from 2018 but not in 2017. It is possible these two vessels are the intact vessels for Targets 04 and 05. Archaeologists conducted a pedestrian survey at low tide and with access around a majority of the target. Archaeologists identified Target 05 as the disarticulated remnants of a fiberglass boat in pieces within the same scrap pile as the main structure of Target 04 (Figure 3-81). A potential relationship with Target 04 was not established during the investigation; however, observed construction elements are consistent with features of a late-20th-century fiberglass boat. Based on observed construction materials, Target 05 was likely the remains of a modern fiberglass boat with an unknown relationship to Target 04. Target 05 is a modern fiberglass vessel that lacks integrity and, therefore, is not likely to yield important information. Target 05 is recommended as not eligible for listing in the NRHP.

Figure 3-80 Aerial Imagery of Target 05 (Google Earth)

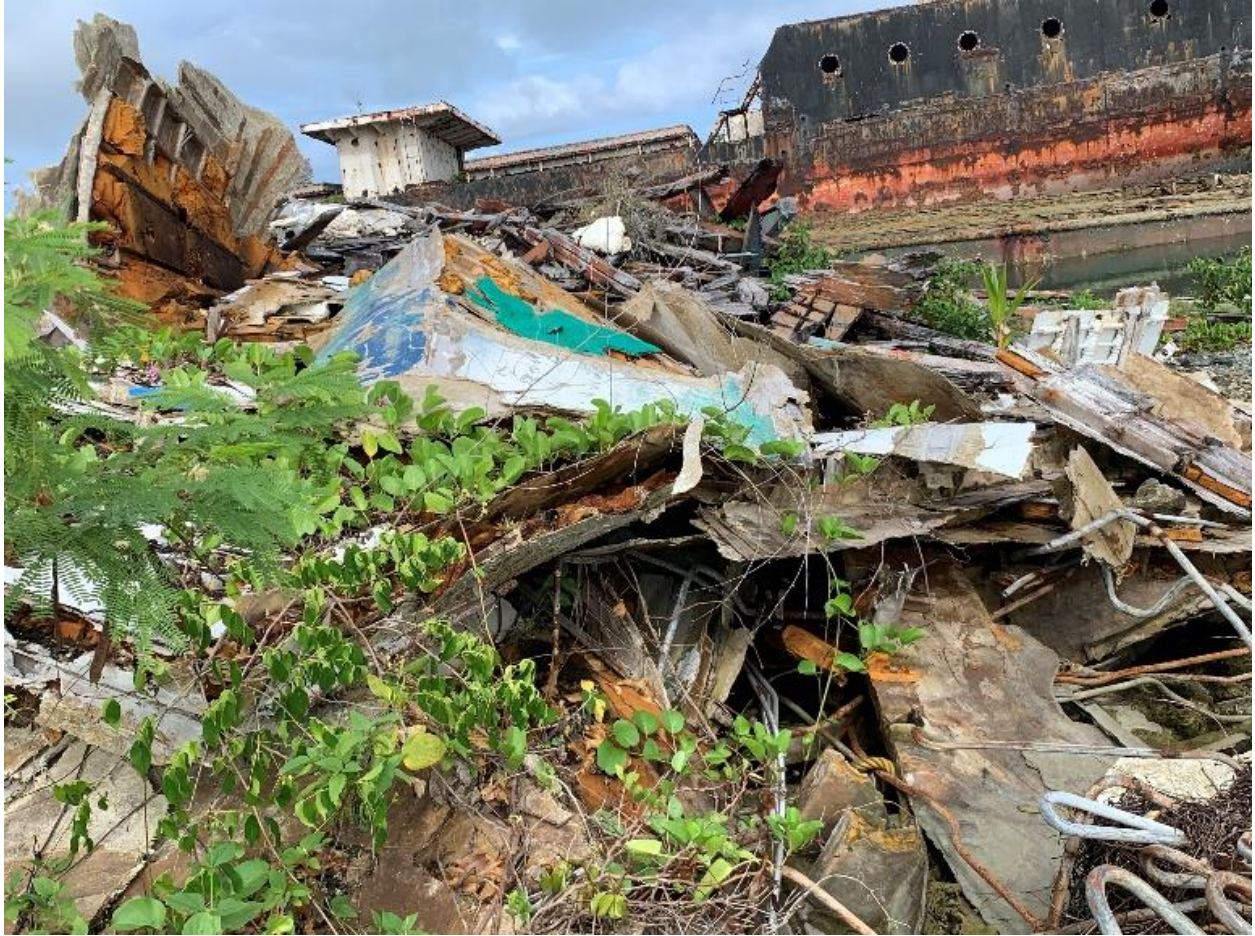
Figure 3-81 Target 05 (Photo by AECOM)

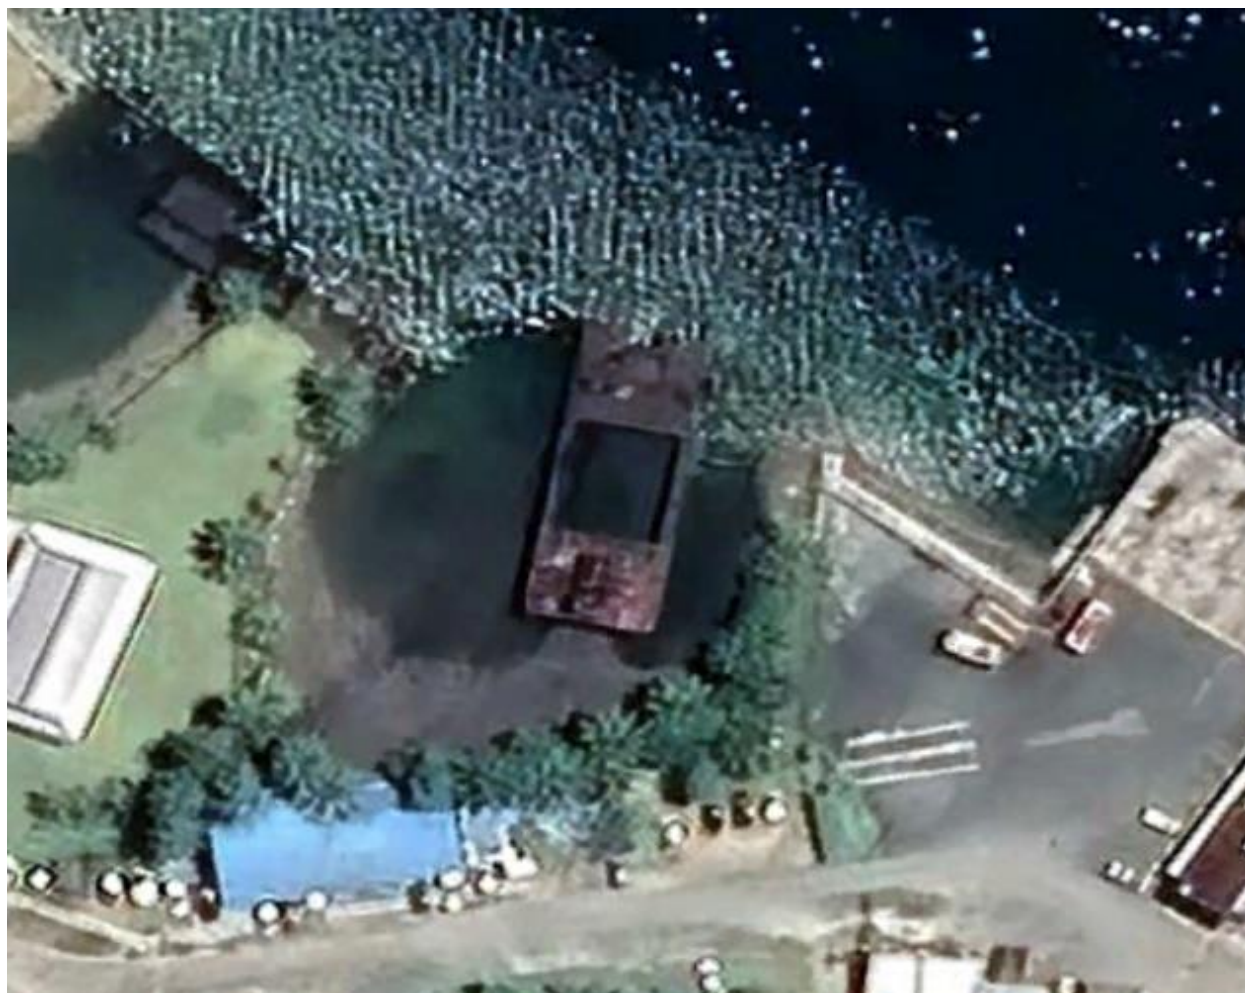
Figure 3-83 Aerial Imagery of Target 06 (Google Earth)

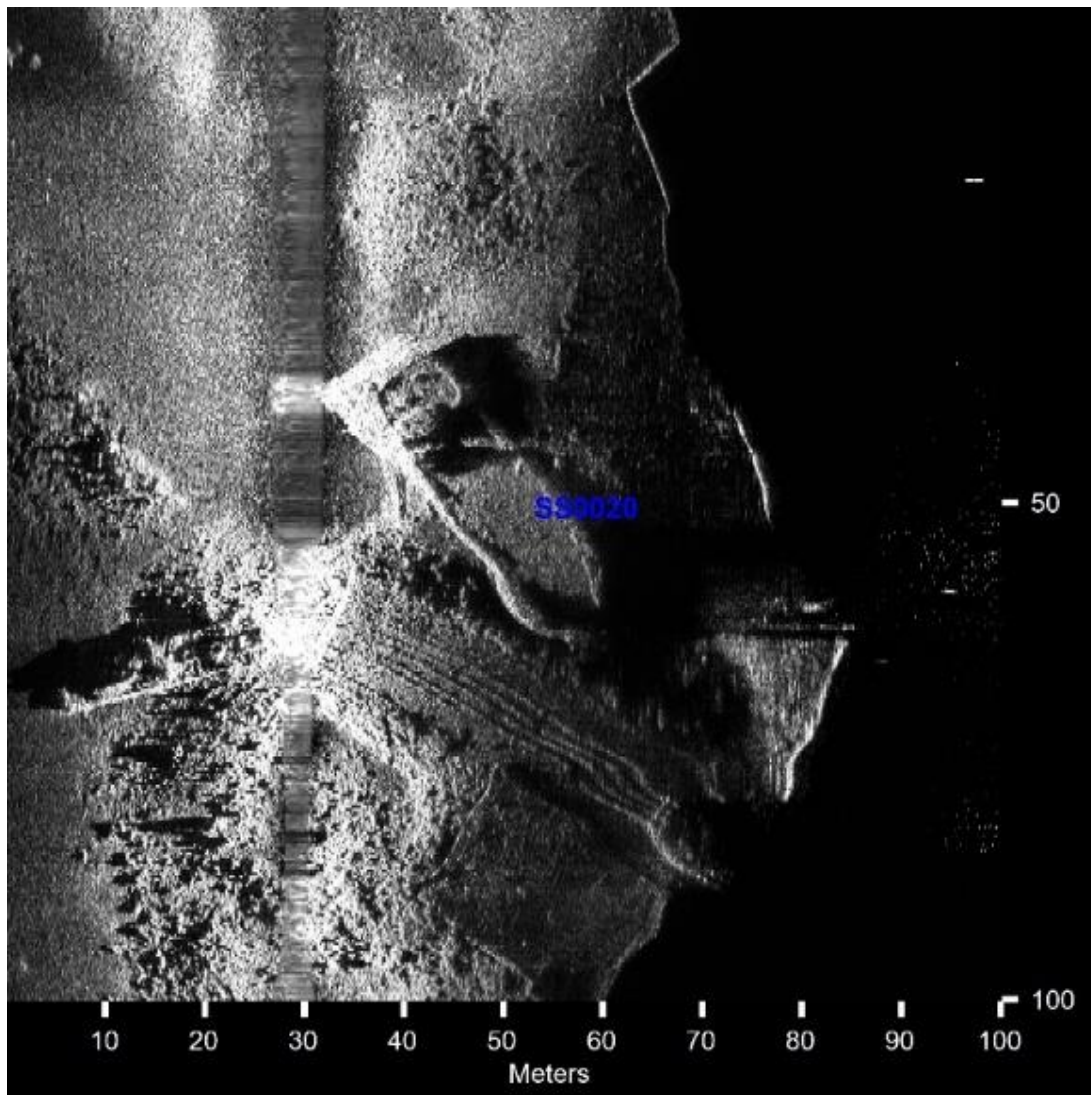
Target 07 consisted of Acoustic Contact S020, which was located in Yap Port (Survey Area 4) in approximately 15 feet (4.6 meters) of water. Target 07, which was 105 feet (32 meters) long and 26 feet (8 meters) wide, was situated just north and adjacent to a boat ramp, lying parallel against the sea wall (Figure 3-84). While investigating Target 07, archaeologists noted that the target was completely submerged during high tide but became substantially exposed during low tide (Figure 3-85). Divers spent 34 minutes investigating Target 07 and identified the source as a cargo shipwreck with mid- to late-20th-century features such as an anchoring system, iron deck plating, hatches, and welded metal deck planking (Figure 3-85). Substantial marine growth obscured details including names or other potential identification markers; however, observed construction elements are consistent with mid- to late-20th-century ship construction methodologies. Based on observed construction elements and vessel size, Target 07 was likely a cargo ship. Based on observed characteristics and available data, Target 07 may retain the potential to yield important information regarding maritime shipping and industry practices significant to Yap and the FSM's history. It is recommended treating Target 07 as eligible for listing in the NRHP with an avoidance buffer of 164 feet (50 meters) from the defined site extents, pending additional information.

Figure 3-84 Target 07 (Acoustic Contact S020)

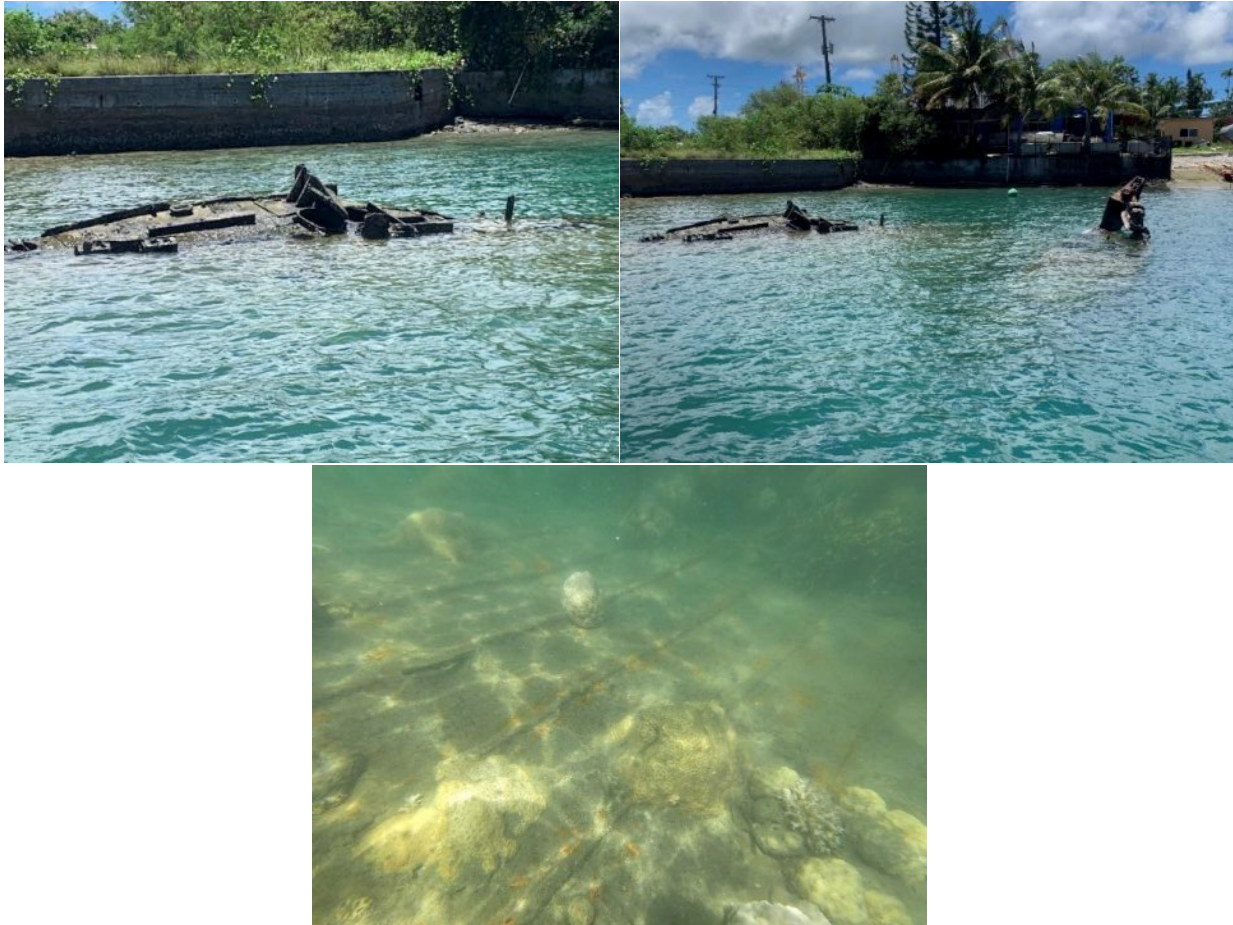
Figure 3-85 Target 07 Ship Construction Elements (Photos by AECOM)

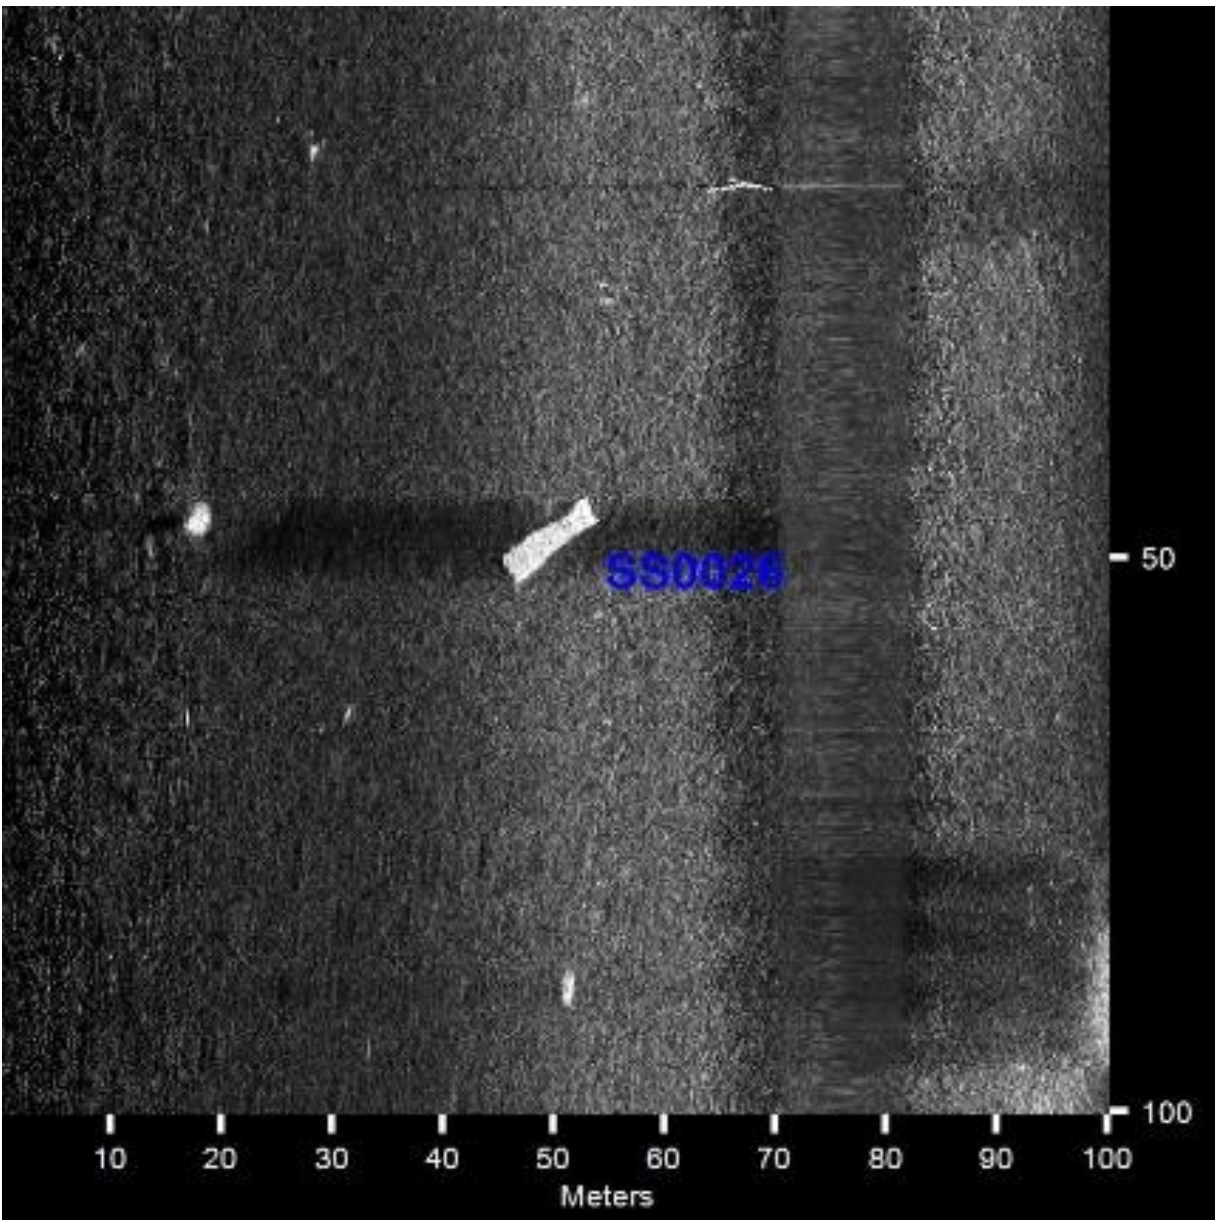
Target 12 consisted of Acoustic Contact S026 and was located in Yap Port (Survey Area 4) in approximately 65 feet (20 meters) of water (Figure 3-86). Navy Seabee MBES data denotes Target 12 as a wreck measuring 50 feet (15 meters) long and 16 feet (5 meters) wide (Figure 3-87). Divers spent 40 minutes investigating Target 12 and identified the source as a partially buried metal object, likely a shipwreck or pontoon pier. Archaeologists observed four long rectangular hatches separated by two perpendicular gaps. Additionally, a small, circular feature bisected by a bar was noted on the target (Figure 3-88). The features observed are consistent with mid- to late-20th-century marine construction. Based on observed characteristics and available data, Target 12 may retain the potential to yield important information regarding maritime shipping and industry practices significant to Yap and the FSM's history. It is recommended treating Target 12 as eligible for listing in the NRHP with an avoidance buffer of 164 feet (50 meters) from the defined site extents, pending additional information.

Figure 3-86 Target 12 (Acoustic Contact S026)

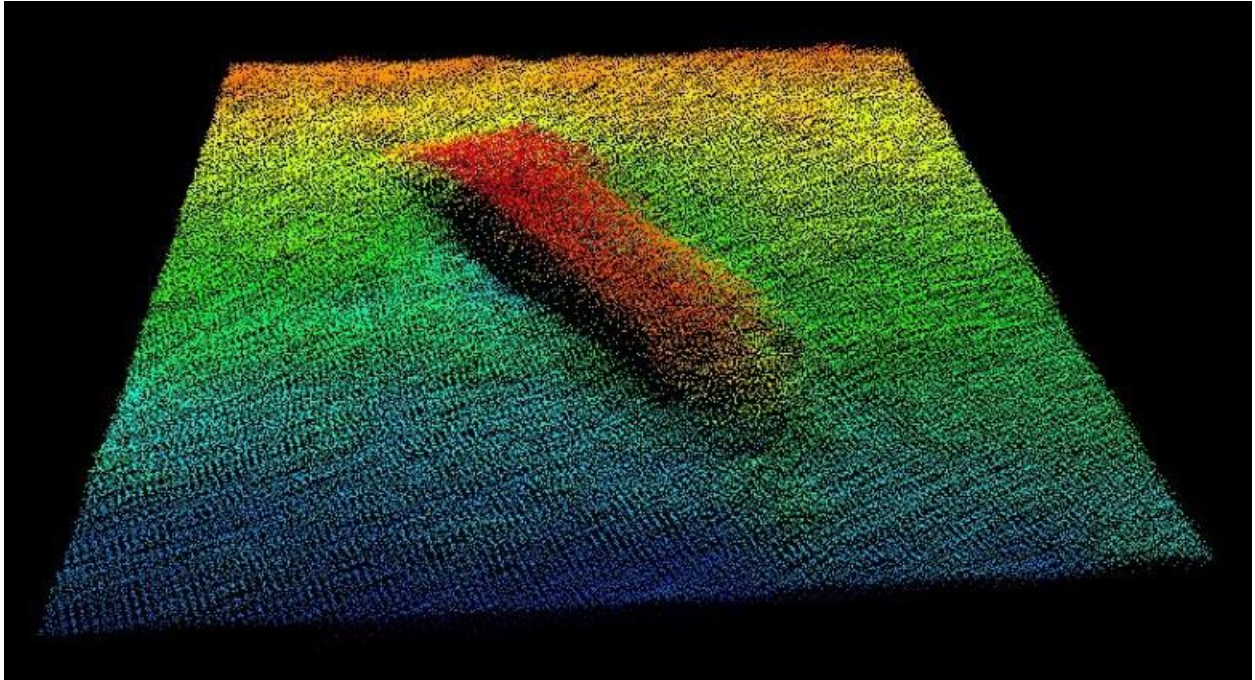
Figure 3-87 Target 12 (Navy Seabee MBES Imagery)

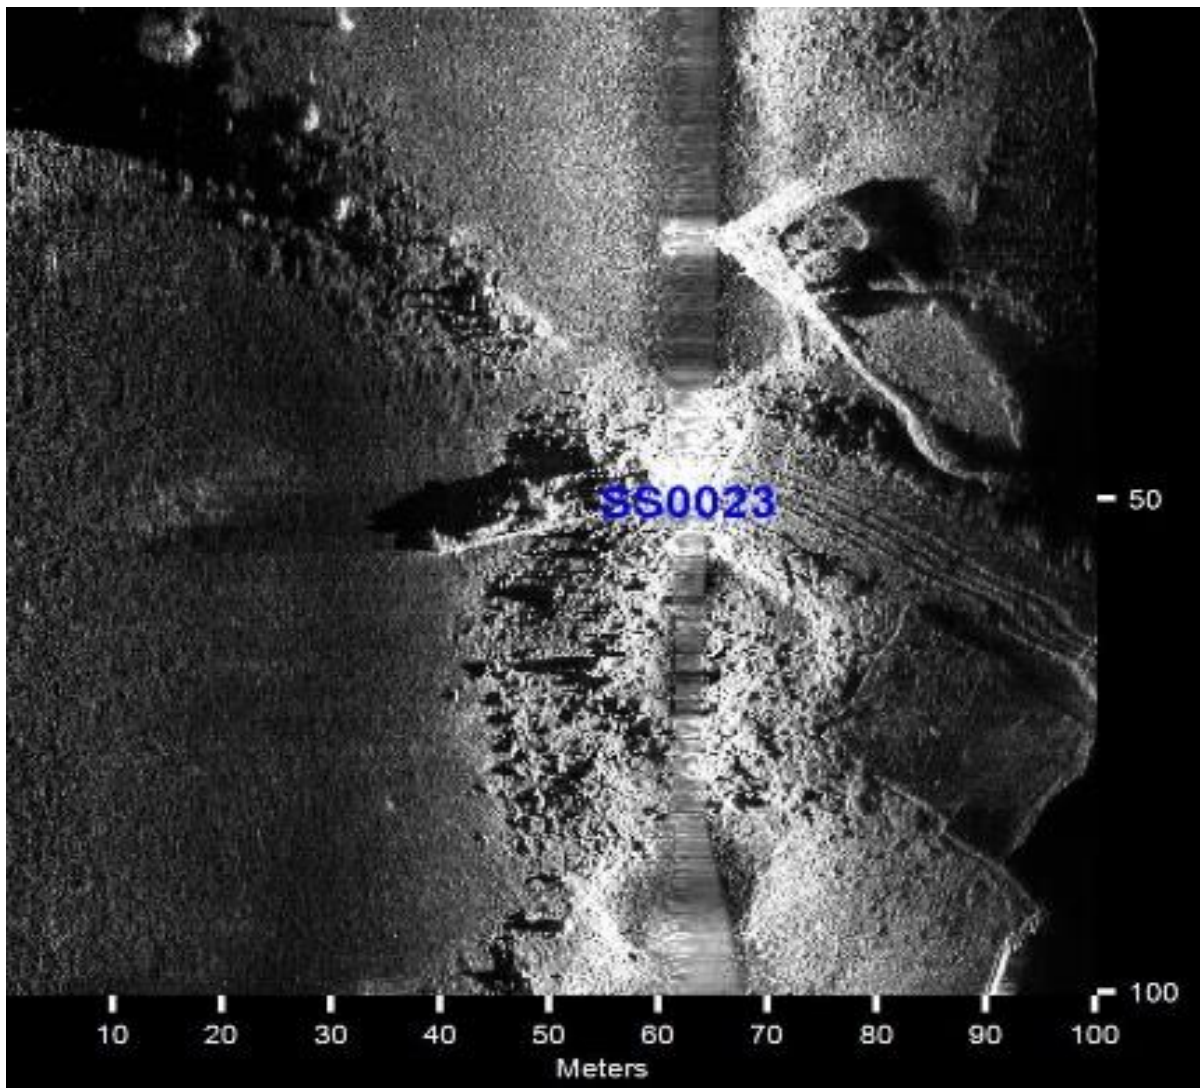
Target 13 consisted of Acoustic Contact S023 and was located in Yap Port (Survey Area 4) in approximately 45 feet (14 meters) of water (Figure 3-89). Navy Seabee MBES data denotes Target 13 as a wreck, measuring 79 feet (24 meters) long and 20 feet (6 meters) wide (Figure 3-90). Divers spent 34 minutes investigating Target 13 and identified the source as a barge or work craft, observing multiple ship construction elements including welded deck plating, open hatches, mooring bits, and a 55-gallon drum (Figure 3-91 and Figure 3-92). Archaeologists also noted an unidentified anchor, similar to a kedge Admiralty-style anchor, hanging off the vessel (Figure 3-93). Substantial marine growth obscured details including names or other potential identification markers; however, observed construction elements are consistent with mid- to late-20th-century shipbuilding techniques. Based on observed construction elements and vessel size, Target 13 is likely a barge or work craft. Based on observed characteristics and available data, Target 13 may retain the potential to yield important information regarding maritime shipping and industry practices significant to Yap and the FSM's history. It is recommended treating Target 13 as eligible for listing in the NRHP with an avoidance buffer of 164 feet (50 meters) from the defined site extents, pending additional information.

Figure 3-89 Target 13 (Acoustic Contact S023)

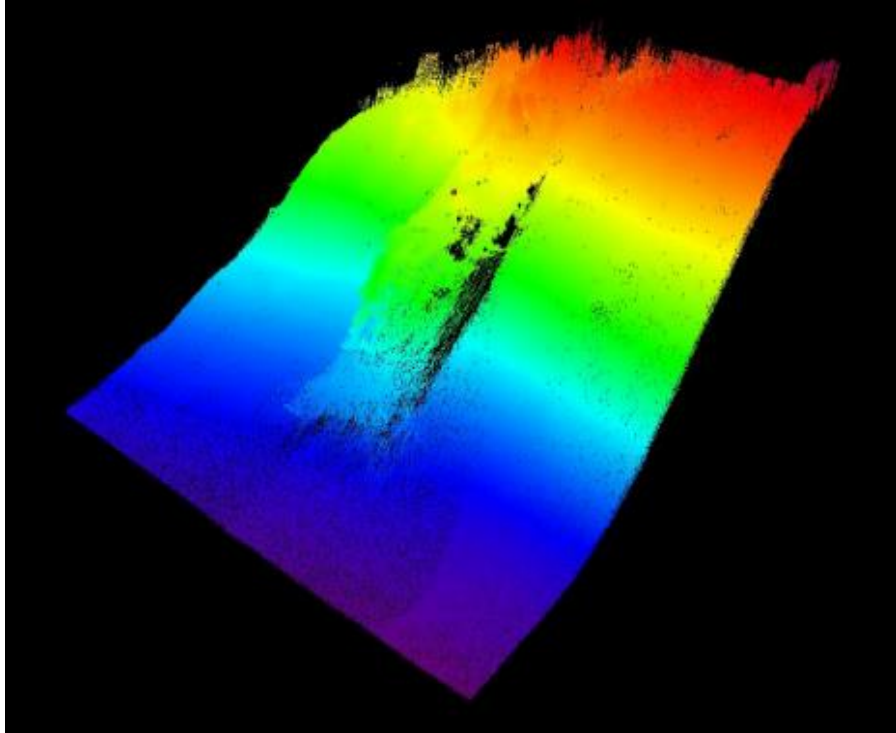
Figure 3-90 Target 13 (Navy Seabee MBES Imagery)

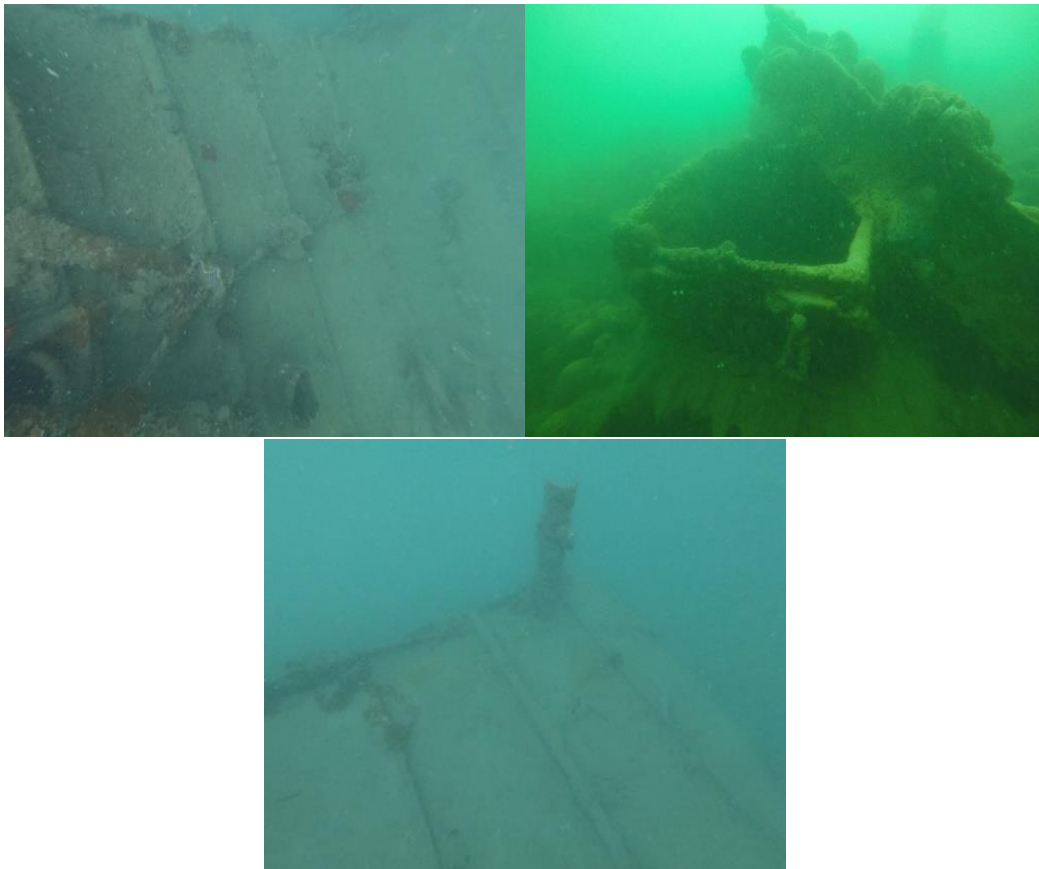
Figure 3-91 Welded Decking and Open Hatch of Target 13 (Photos by AECOM)

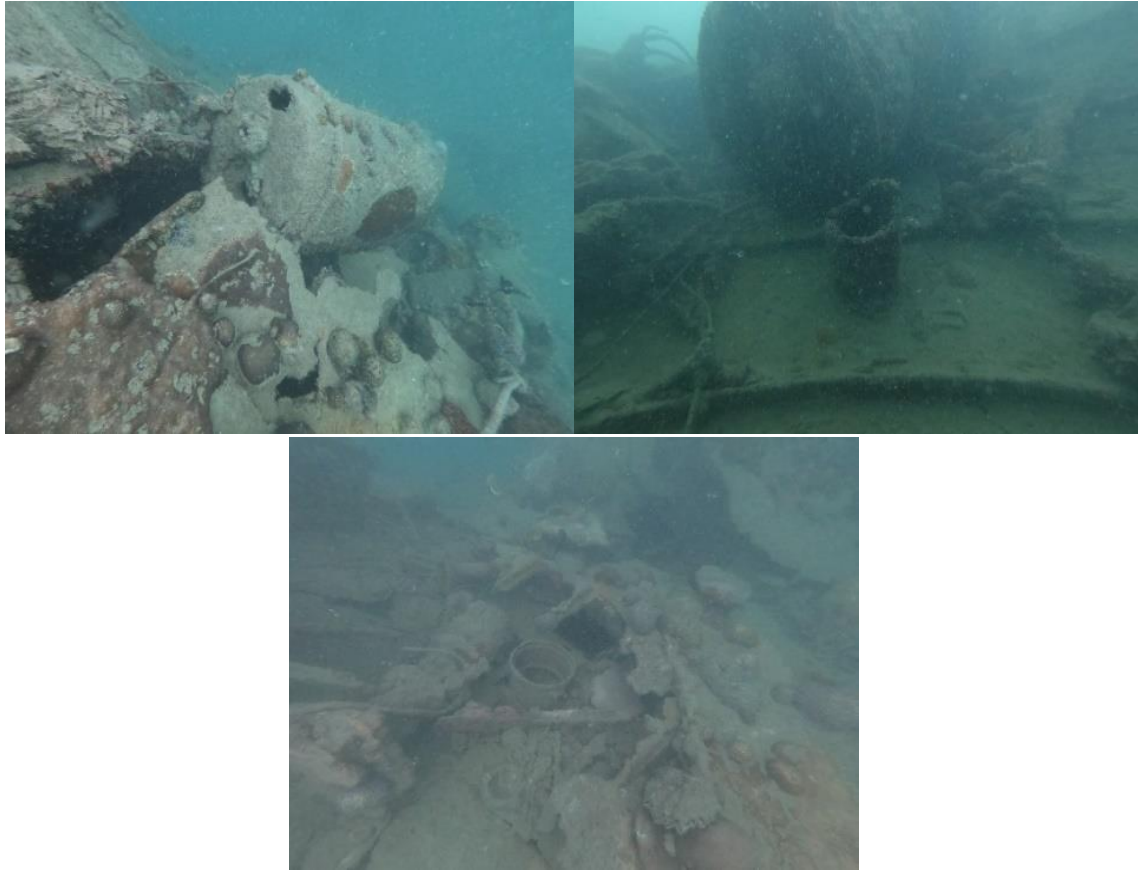
Figure 3-92 55-Gallon Drum and Other Features of Target 13 (Photos by AECOM)

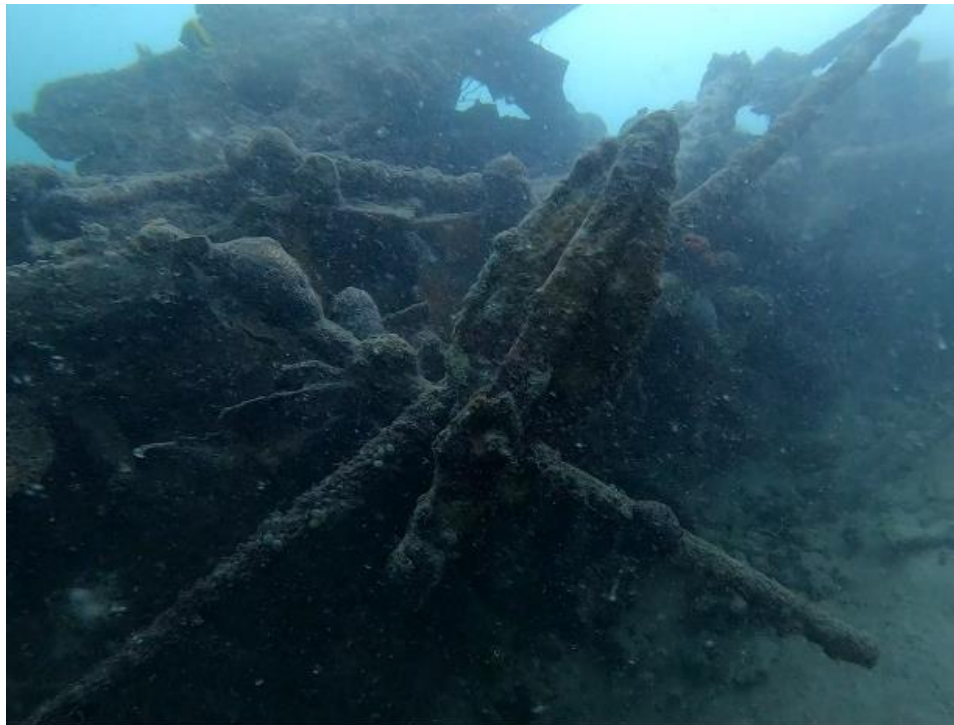
Figure 3-93 Unidentified Anchor on Target 13 (Photo by AECOM)

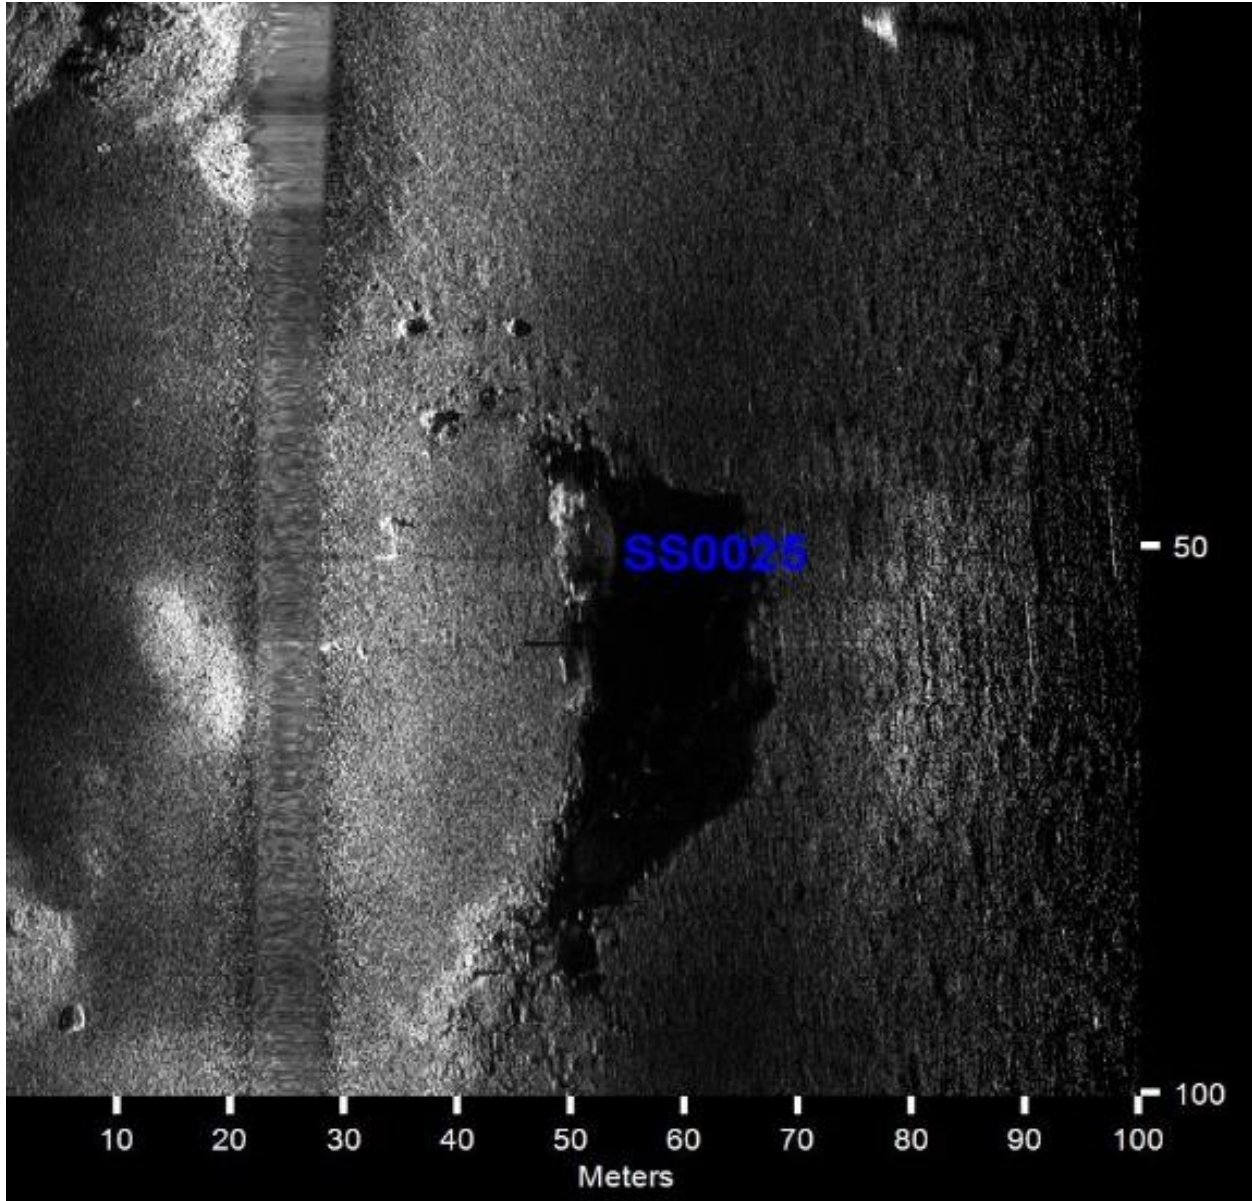
Target 18 consisted of Acoustic Contact S025 and was located in Yap Port (Survey Area 4) in approximately 40 feet (12 meters) of water (Figure 3-94). Contact S025 was an unknown contact measuring 35 feet (10 meters) long and 16 feet (5 meters) wide. Divers spent 20 minutes investigating Target 18 and identified the source as a ridge of rocks/coral reef with substantial relief (Figure 3-95). The rock/coral reef was long and linear, which is consistent with recorded sonar imagery. The source of Target 18 was a natural rock/coral ridge, a non-anthropogenic object.

Figure 3-94 Target 18 (Acoustic Contact S025)

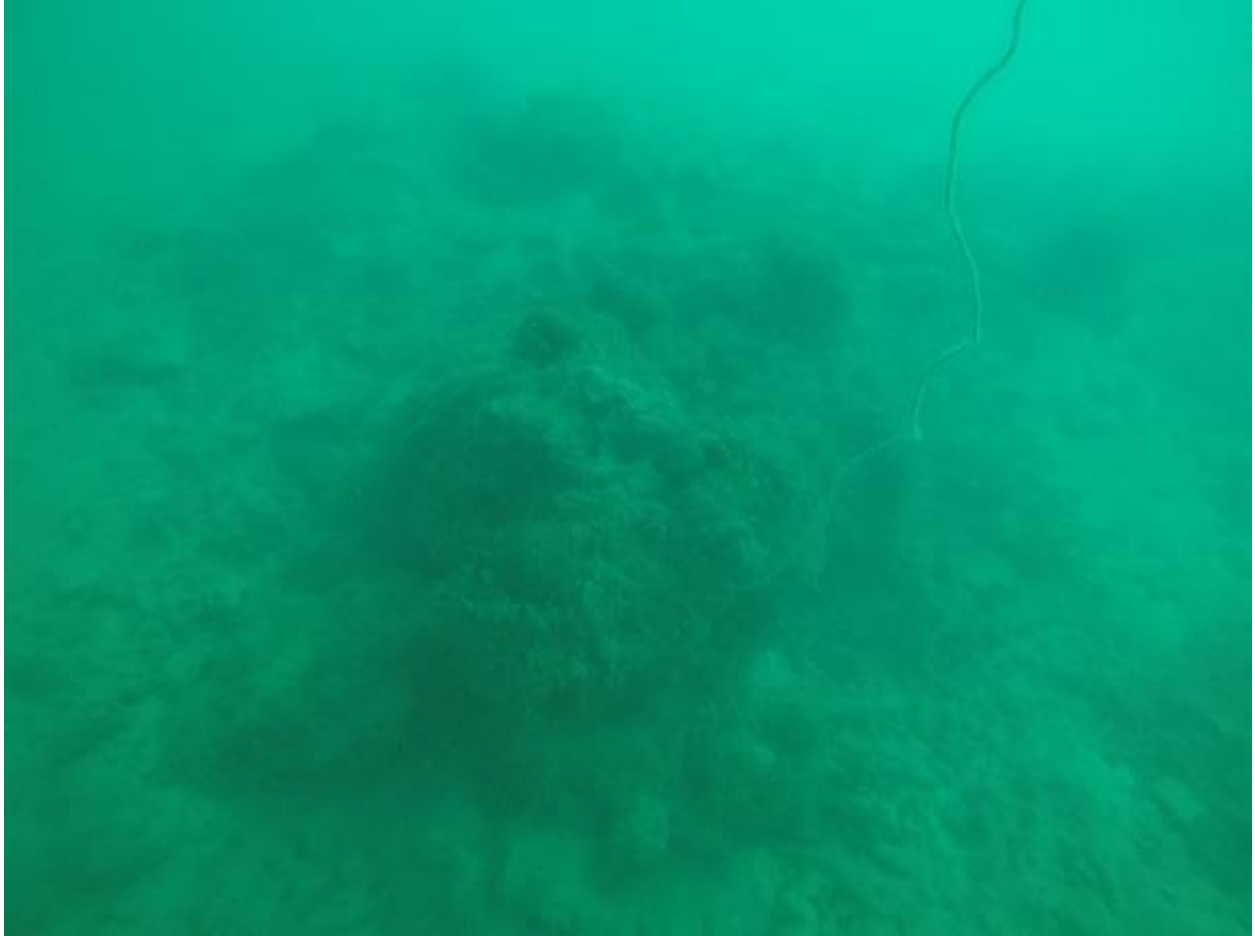
Figure 3-95 Target 18 (Photo by AECOM)
