Final Field Report for Baseline Cultural Resources Surveys for the Sea Port in Yap, Federated States of Micronesia

Cardno GS – AECOM Pacific Joint Venture

October 2023

Project Name: Pacific Deterrence Initiative
Resource Surveys at Yap Port

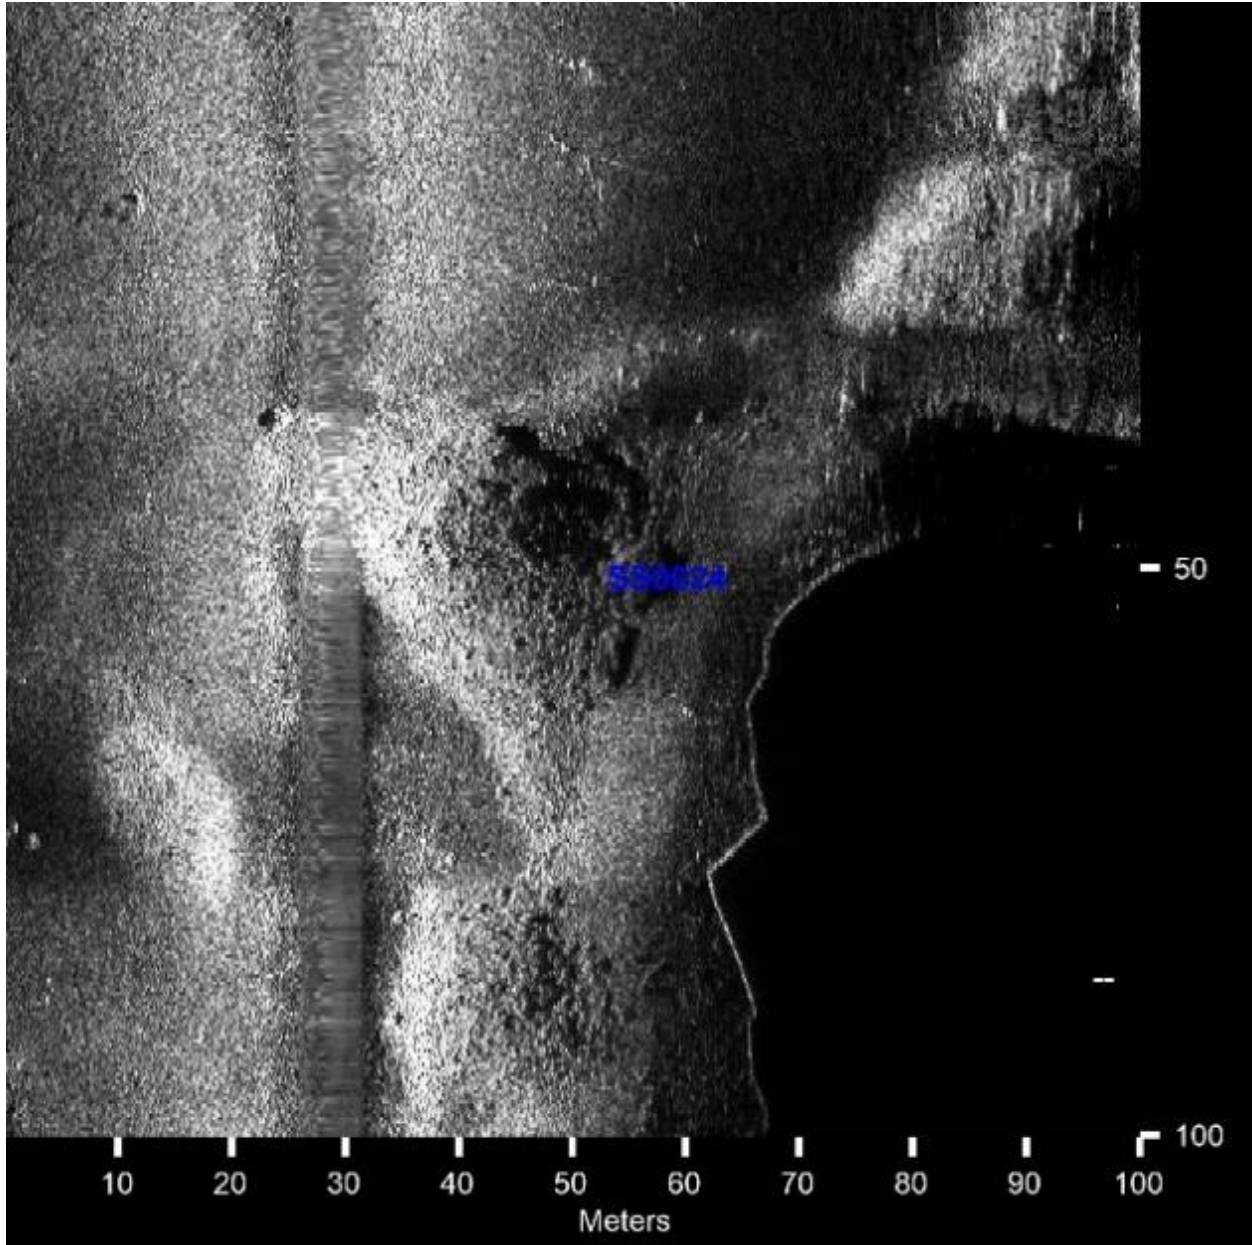
Target 19 consisted of Acoustic Contact S024 and was located in Yap Port (Survey Area 4) in approximately 19 feet (6 meters) of water (Figure 3-96). Contact S024 was an unknown contact measuring 50 feet (15 meters) long and 50 feet (15 meters) wide. Divers spent 18 minutes investigating Target 19 and identified the source as a large rock with substantial relief. The rock was rectangular in form, which was consistent with recorded sonar imagery. The source of Target 19 was a natural rock, a non-anthropogenic object.

Figure 3-96 Target 19 (Acoustic Contact S024)

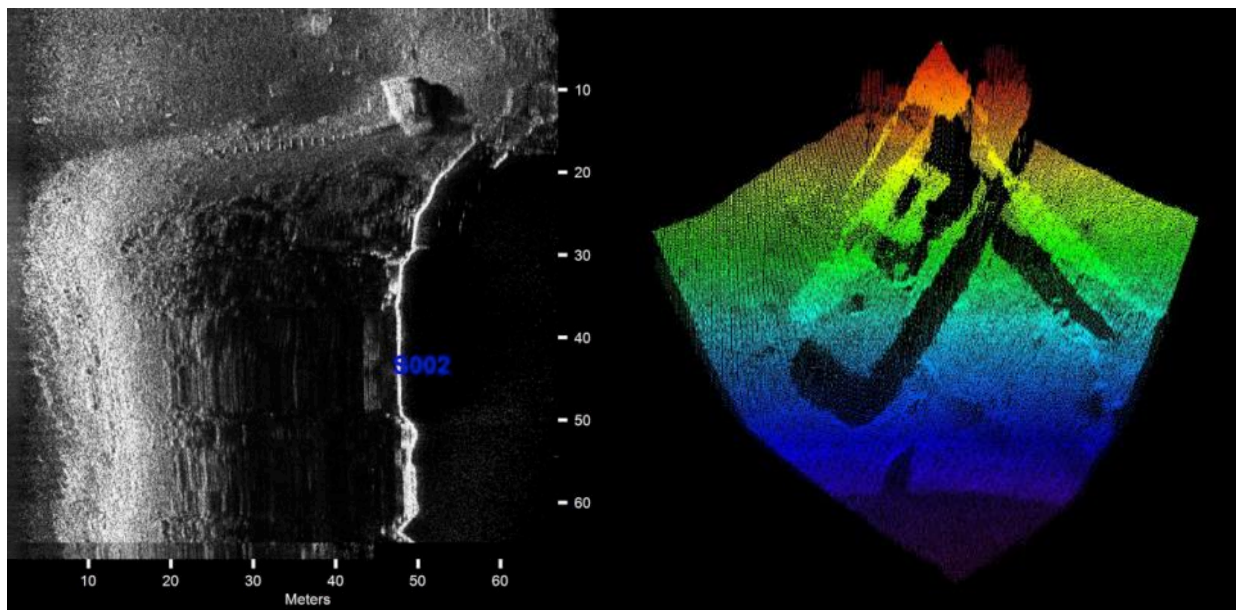
Target 25 consisted of Acoustic Contact S002 and was located near Yap Port (Survey Area 4) in approximately 47 feet (14 meters) of water. Navy Seabee MBES data designates the target as a wreck, measuring 43 feet (13 meters) long and 16 feet (5 meters) wide (Figure 3-97). Divers spent 139 minutes investigating Target 25 and identified the source as a towboat or work boat, with a portion of an old sea wall wrapped around the cabin and still attached to shore via a line (Figure 3-98). Archaeologists observed a large bollard or mooring bitt that was uprooted from the aft metal deck plating (Figure 3-99). The mooring bitt was pointed toward a large towing winch (Figure 3-100). It is probable that the uprooted mooring bitt was caused by what the winch was towing. Other construction elements observed included several hatches, an engine room, machinery in the cabin, access holes, H-bits, and rub rails off the stem and stern (Figure 3-101). Several cables and dock lines were tied and strewn about the target. Roughly 30 feet (10 meters) from Target 25 was a section of metal sheeting that may have also been associated with a nearby seawall. Based on the observed construction elements, Target 25 was likely a mid- to late-20th-century towboat or similar work boat. Based on observed characteristics and available data, Target 25 may retain the potential to yield important information regarding maritime shipping and industry practices significant to Yap and the FSM's history. It is recommended treating Target 25 as eligible for listing in the NRHP with an avoidance buffer of 164 feet (50 meters) from the defined site extents, pending additional information.

Figure 3-97 Target 25 (Acoustic Contact S002) (Left) and Navy Seabee MBES Imagery (Right)

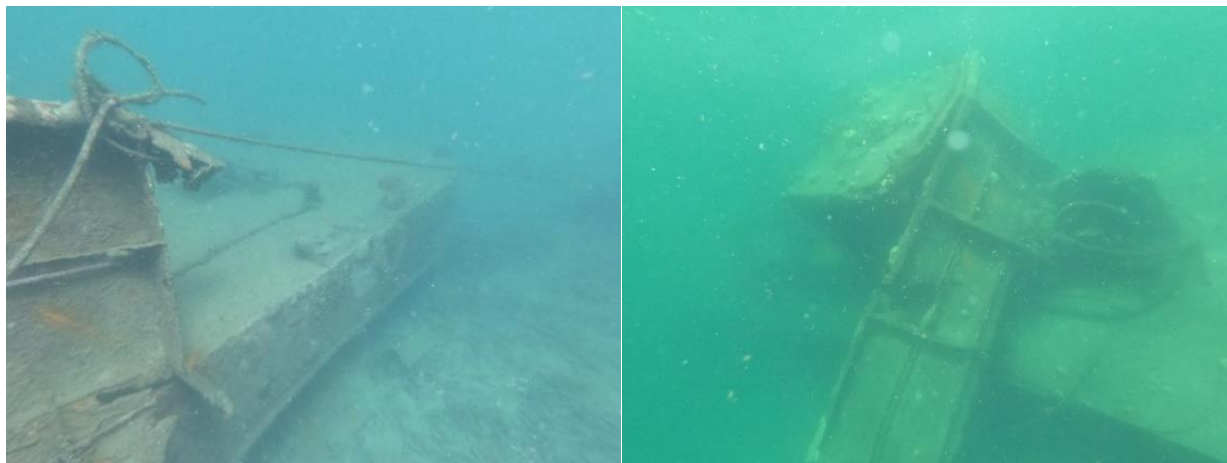
Figure 3-98 Target 25 with Sea Wall Wrapped Around and Attached to Shore by a Mooring Line (Photo by AECOM)

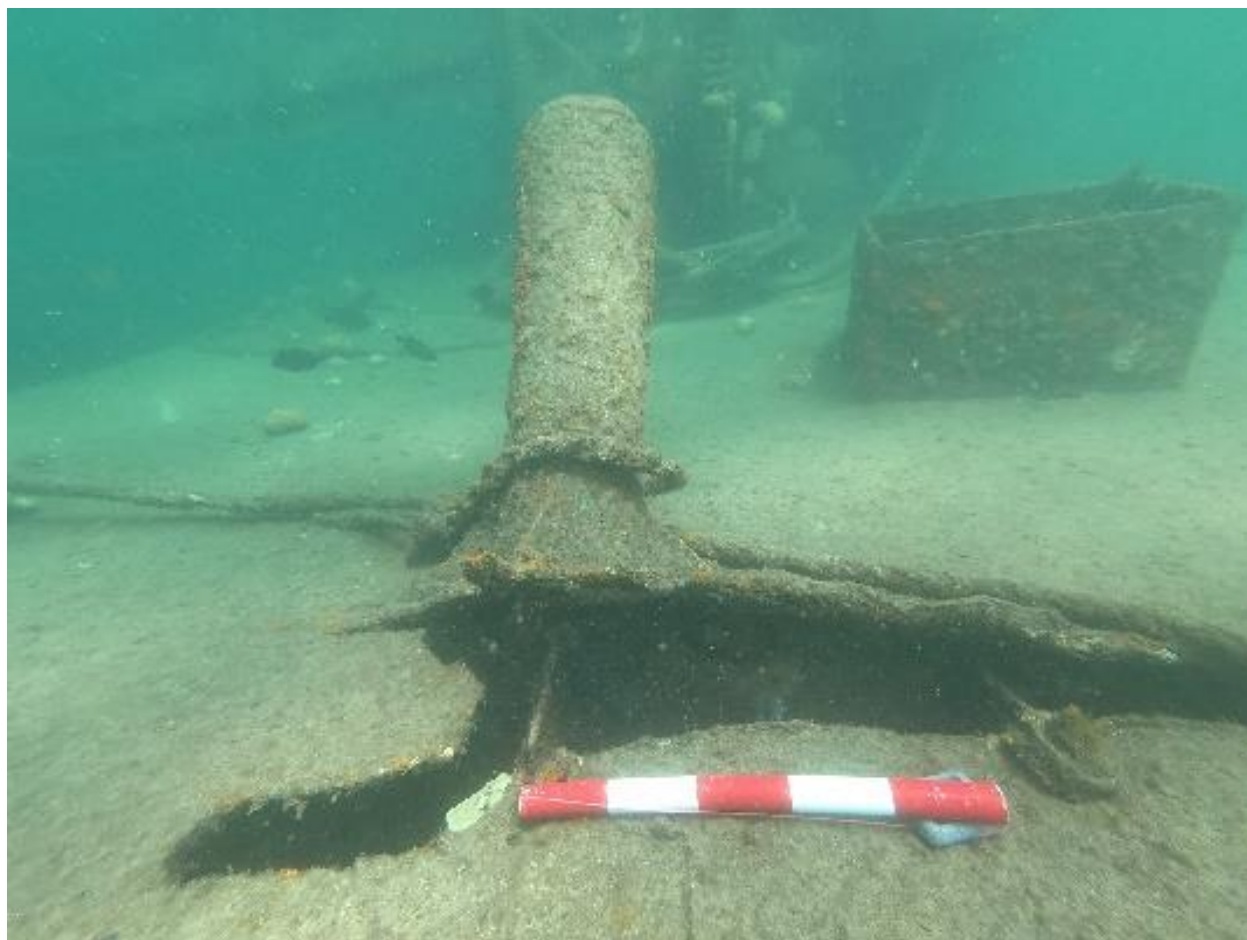
Figure 3-99 Mooring Bitt Unrooted Towards Towing Winch (Photo by AECOM)

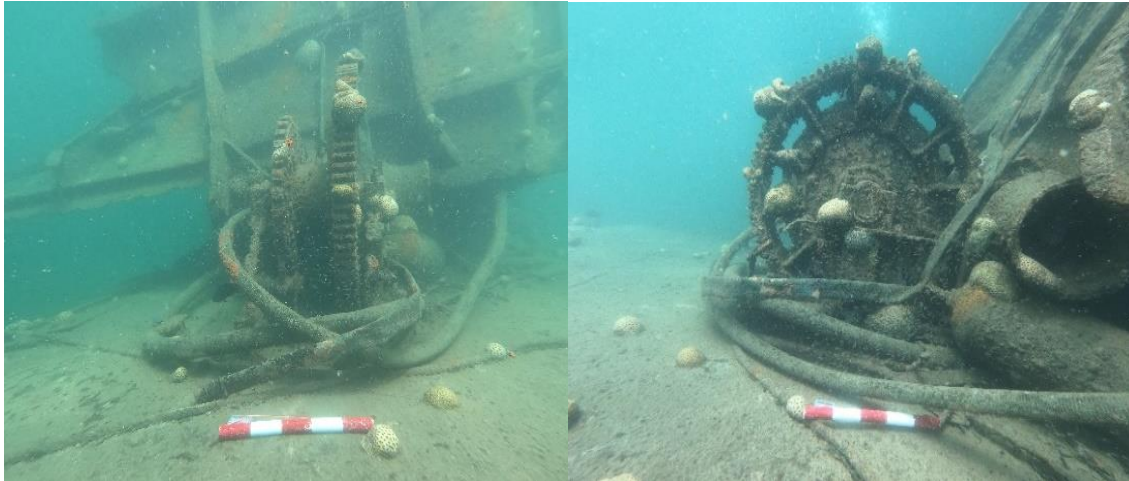
Figure 3-100 Towing Winch (Photos by AECOM)

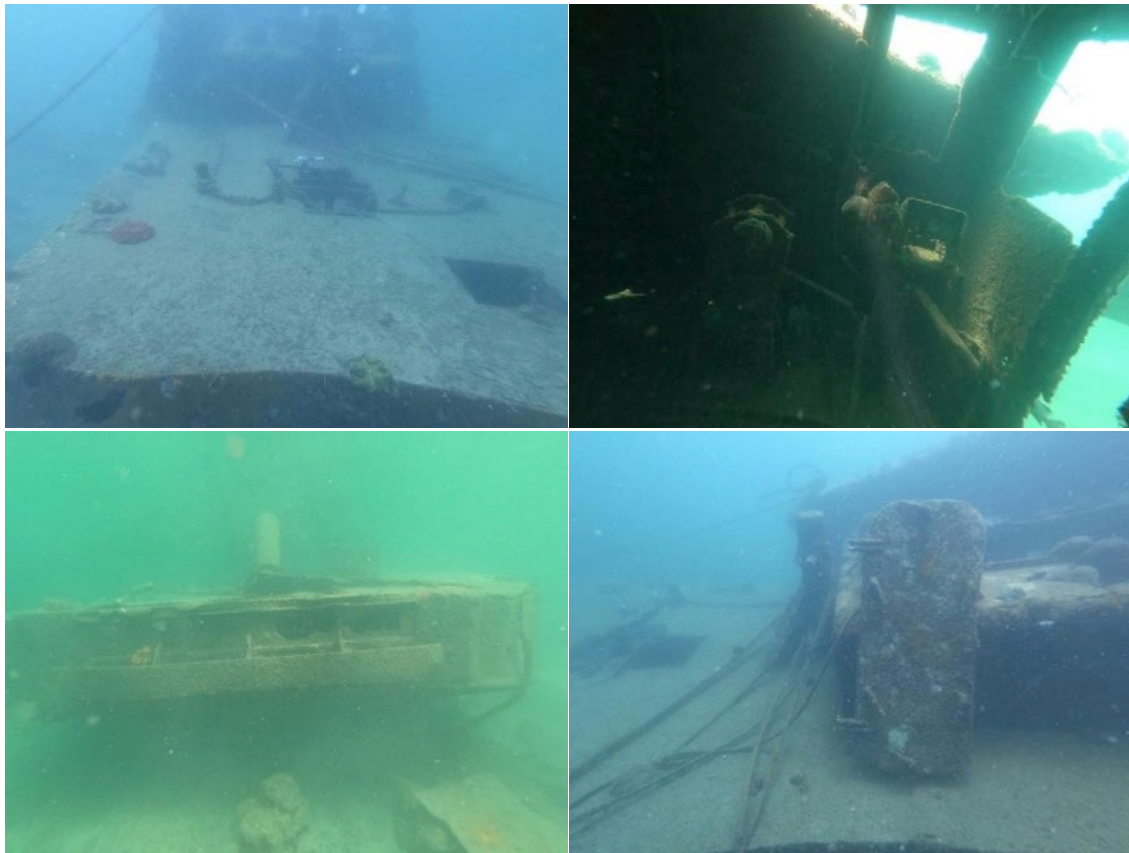
Figure 3-101 Hatch (Top Left), Machinery in Cabin (Top Right), Rub Rail (Bottom Left), and Dock Line (Bottom Right) on Target 25 (Photos by AECOM)

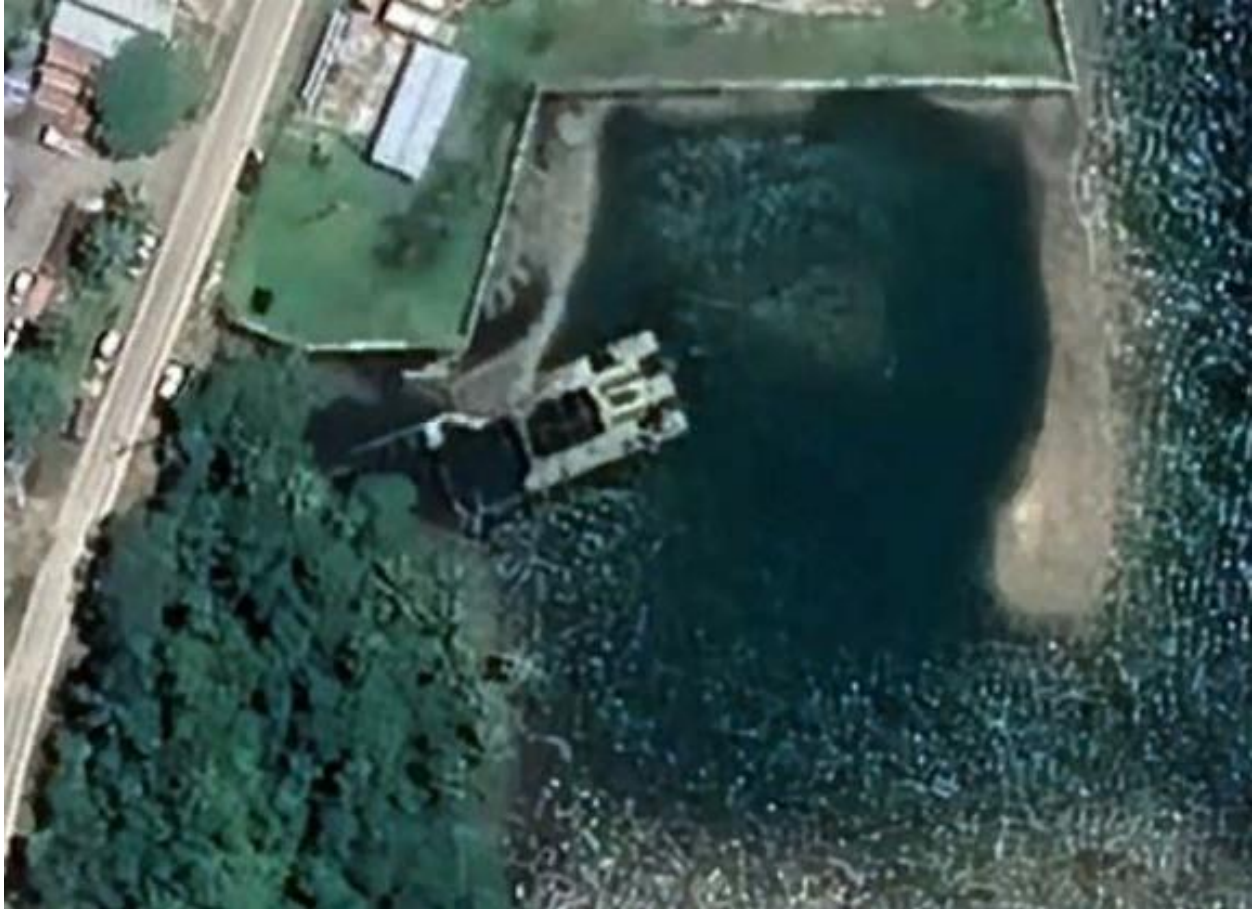
Figure 3-104 Aerial Image of Target 15 (Google Earth)

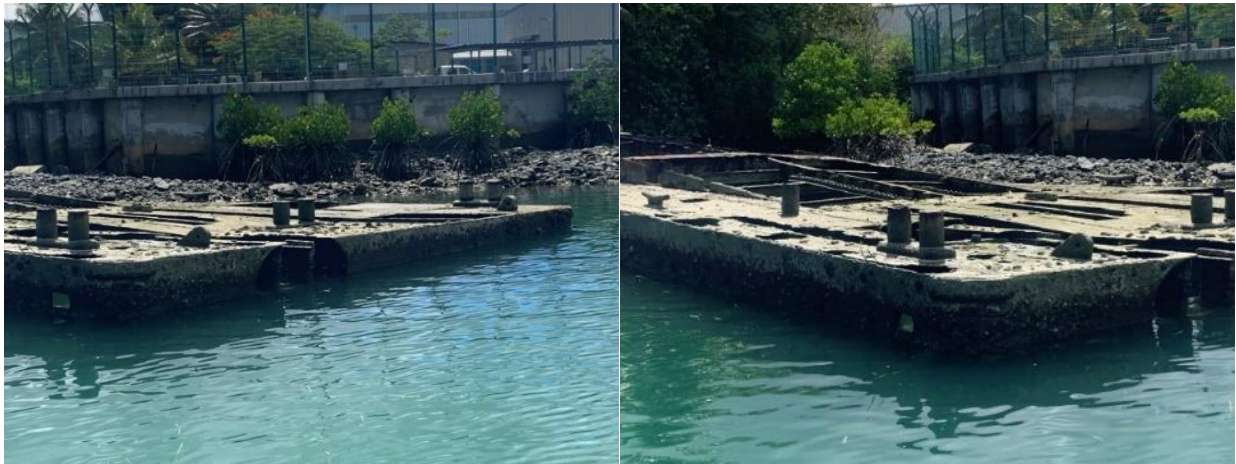
Figure 3-105 Target 15 (Photos by AECOM)

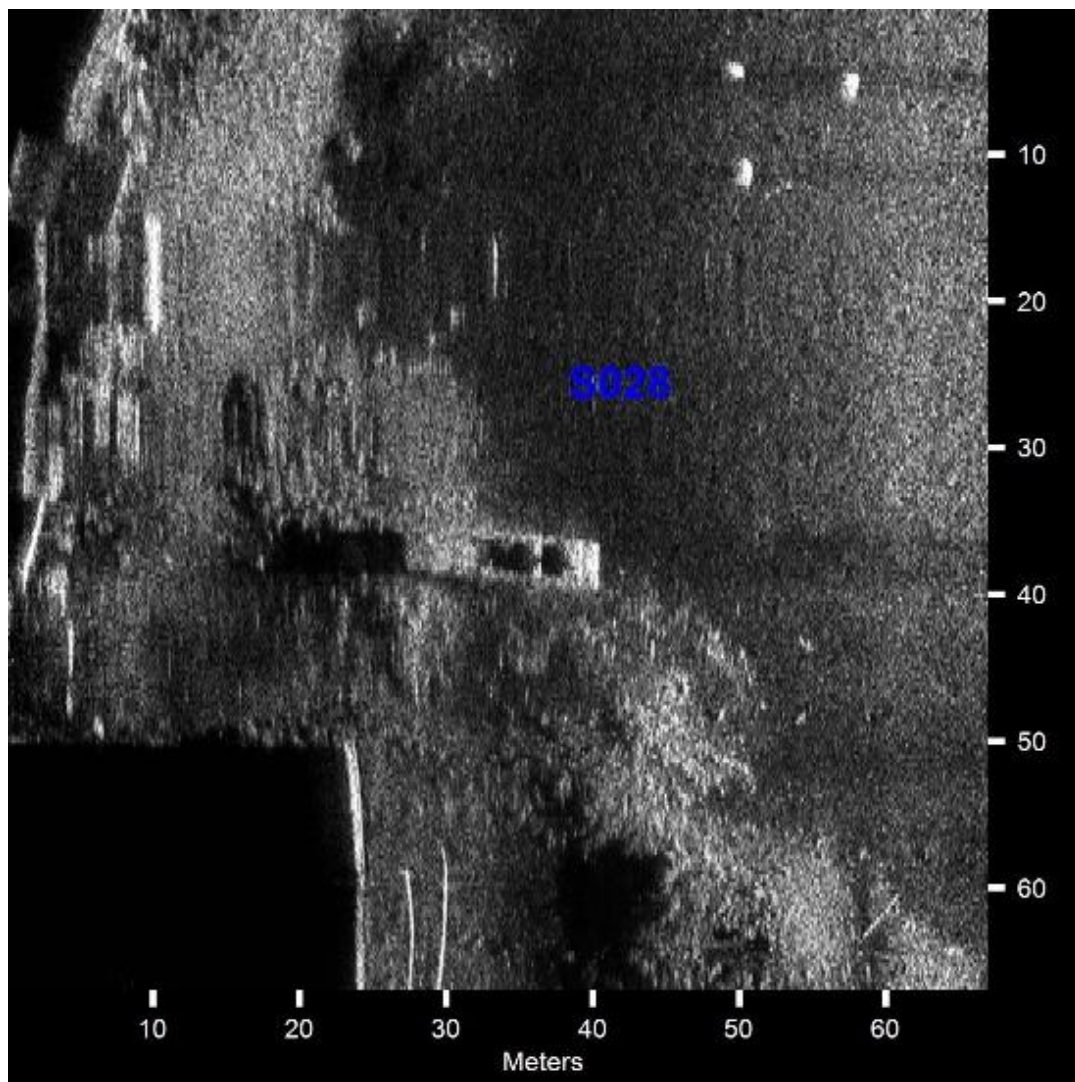
Target 16 consisted of Acoustic Contact S028 and was located in Yap Port–Southwest (Survey Area 5) in approximately 33 feet (10 meters) of water (Figure 3-106). Navy Seabee MBES data designated Target 16 as a wreck, measuring 46 feet (14 meters) long and 20 feet (6 meters) wide (Figure 3-107). Target 16 sat parallel to a seawall in the harbor. Divers spent 92 minutes investigating Target 16 and identified the source as a landing craft or similarly styled cargo transport. Archaeologists observed several features including the pilot house, cargo tie rings, access holes to wing tanks, and corrugated flooring (Figure 3-108). The deck plating near the pilot house was missing, exposing the engine room and engine parts (Figure 3-109). The ramp was detached and laying on the sea bottom, partially buried (Figure 3-110). Substantial marine growth obscured details along the interior and exterior sides of the landing craft. Based on observed construction features, Target 16 was likely a landing craft. Based on observed characteristics and available data, Target 16 may have the potential to yield significant information about World War II activities on Yap. It is recommended treating Target 16 as eligible for listing in the NRHP with an avoidance buffer of 164 feet (50 meters) from the defined site extents, pending additional information.

Figure 3-106 Target 16 (Acoustic Contact S028)

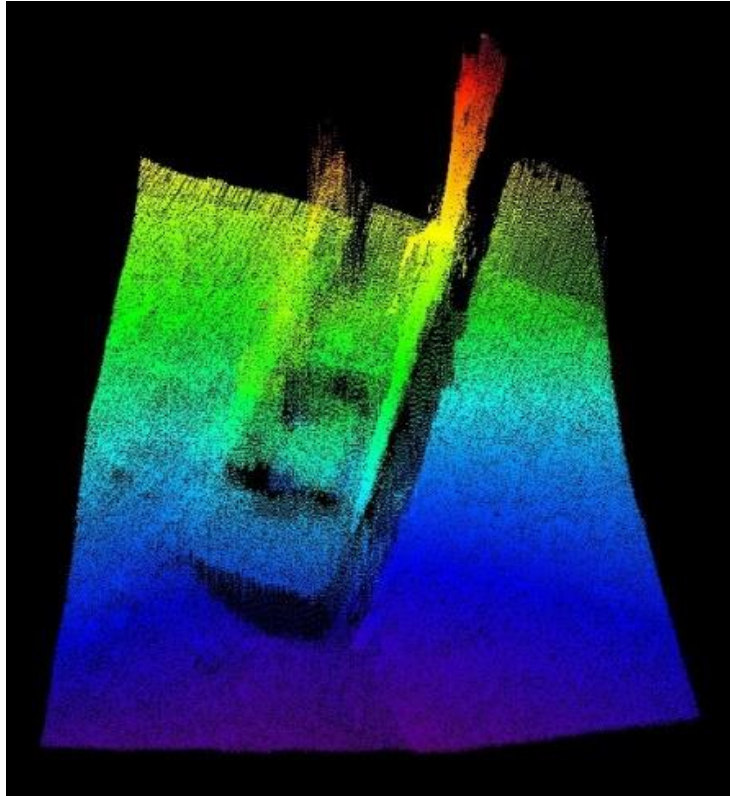
Figure 3-107 Target 16 (Navy Seabee MBES Imagery)

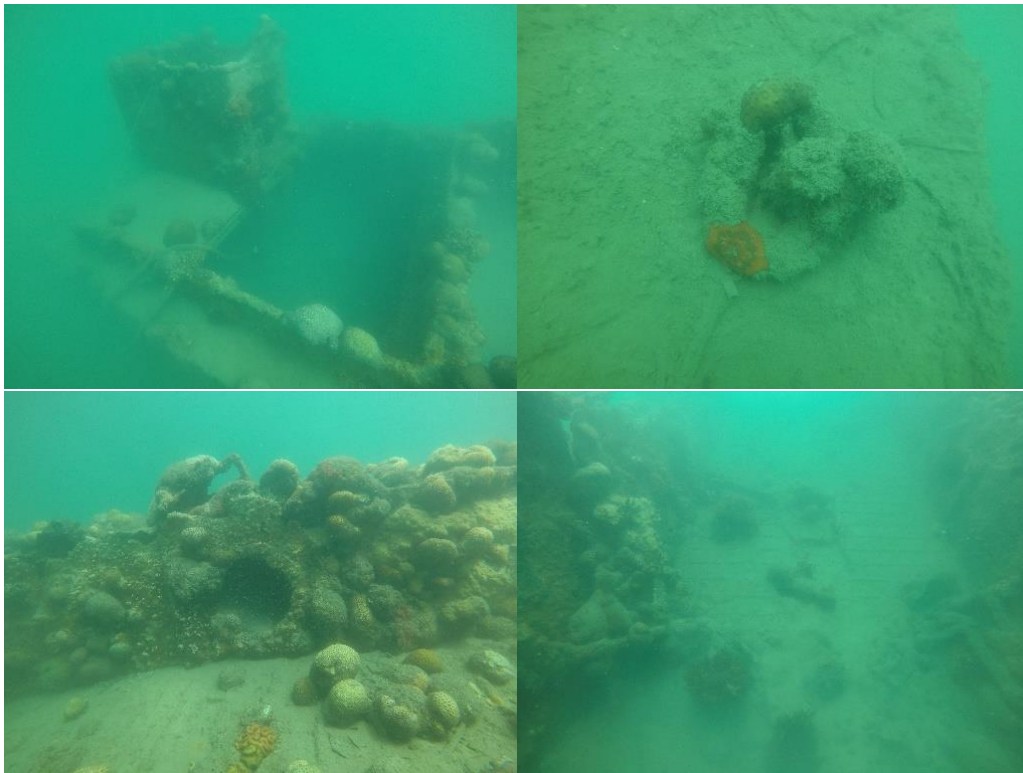
Figure 3-108 Pilot House (Top Left), Cargo Tie Rings (Top Right), Access Holes to Wing Tanks (Bottom Left), and Corrugated Flooring (Bottom Right) on Target 16 (Photos by AECOM)

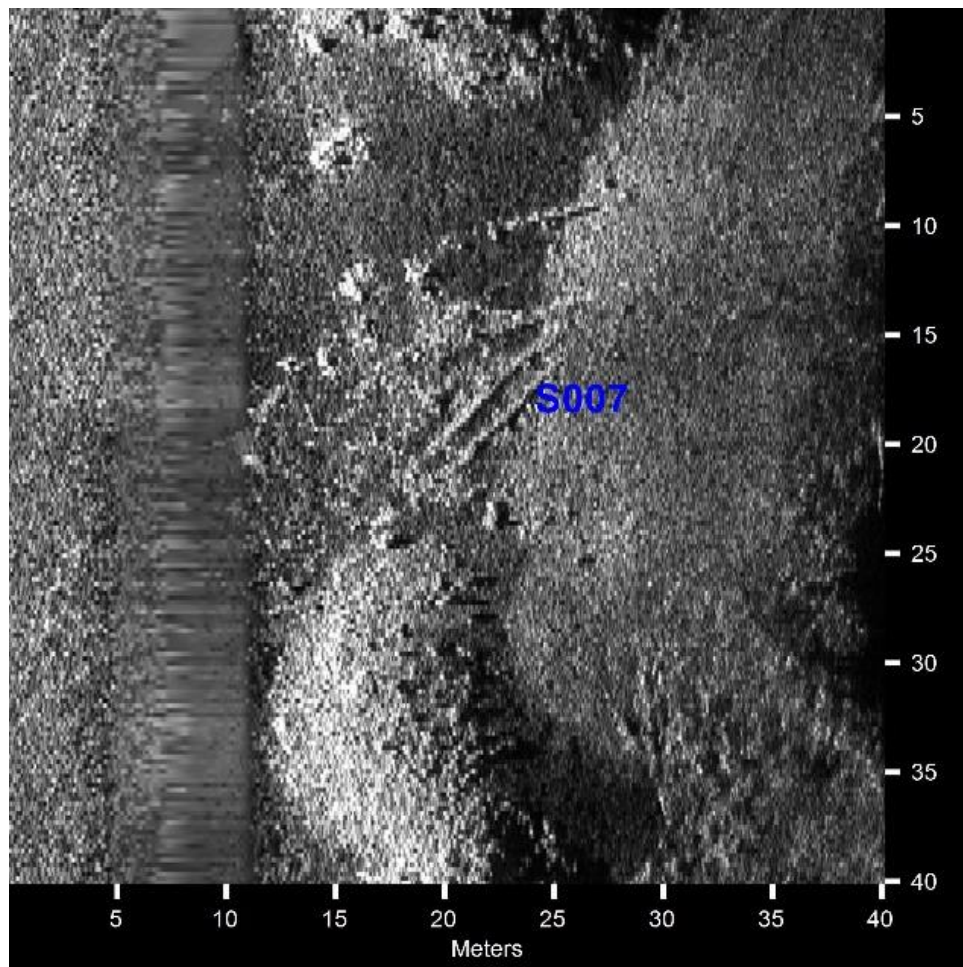
Target 17 consisted of Acoustic Contact S007 and was located in Yap Port–Southwest (Survey Area 5) in approximately 15 feet (4.5 meters) of water (Figure 3-111). Target 17 was located off the Vital FSM Petrocorp petroleum plant in Tamil Harbor. Divers spent 112 minutes investigating Target 17 and identified the source as consistent with pier remnants. The main features observed at Target 17 consisted of five partially buried parallel metal beams each measuring 33 feet (10 meters) long and 1.3 feet (0.4 meters) wide (Figure 3-112). Throughout the site, archaeologists noted several vertical metal supports existing parallel to the beams. Some of the supports were connected by a crossbar, while others were freestanding. Archaeologists also noted triangular support brackets (Figure 3-112). Historical charts from Japanese surveys dated 1917–1921 depicted a pier in the location of Target 17 (U.S. Navy Hydrographic Office 1924). Photographs from 1945 depict the pier as a raised stretch of dirt without visible structure (Figure 3-113) (MissingAirCrew.com, n.d.). By 1976, this location consisted of the current petrol facility with substantial shoreline improvements and stabilization efforts, including a spit extending southward. Based on the historical charts, Target 17 may be the disarticulated remains of a pier dating to the Japanese administration. Based on observed characteristics and available data, Target 17 is a disarticulated pier structure that lacks integrity for design, setting, workmanship, feeling, and association and, therefore, is not likely to yield important information. Target 17 is recommended as not eligible for listing in the NRHP.

Figure 3-111 Target 17 (Acoustic Contact S007)

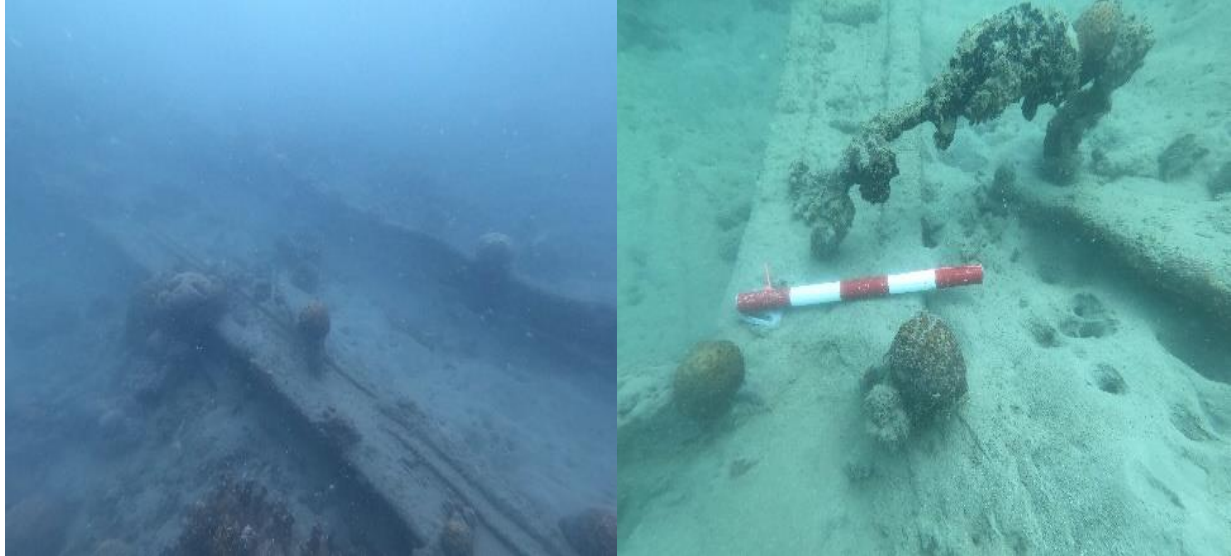
Figure 3-112 Large Metal Beams on Target 17 (Photos by AECOM)

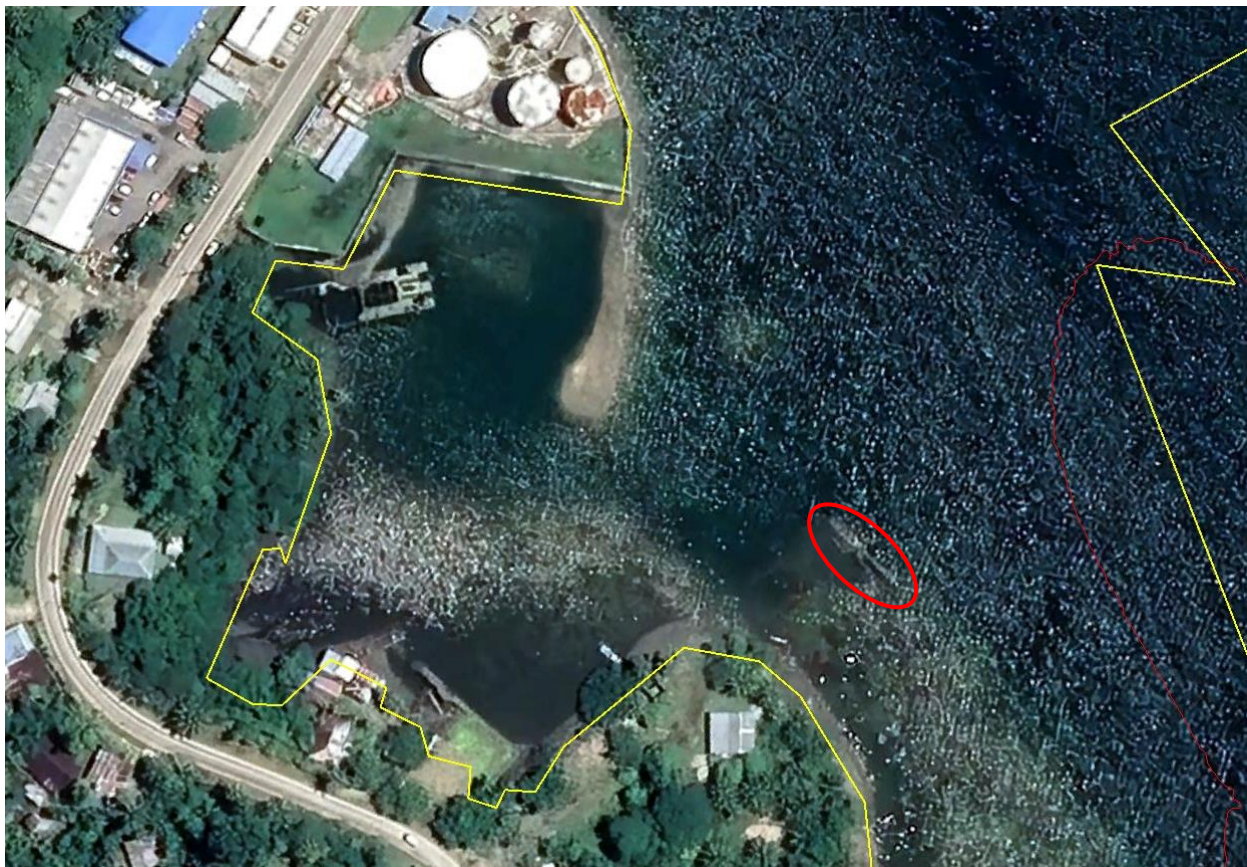
Target 21 was located in Yap Port–Southwest (Survey Area 5) and is denoted as kml_79 in the NOAA ENC shipwrecks database as a visible shipwreck, always dry. Target 21 was partially exposed and first appeared on aerial imagery in 2013, but was not visible in 2008 aerial imagery. Target 21 may correspond with a shipwreck identified on a 1981 U.S. Geological Survey map (USGS 1981) (Figure 3-114). While investigating Target 21, archaeologists noted that the target was completely submerged during high tide but became substantially exposed during low tide (Figure 3-114). Divers spent 42 minutes investigating Target 21 and identified the source as a rectangular barge, observing multiple ship construction elements including iron deck frames that support deck plating and are secured by a series of single riveting butt straps. The rivets measured 4 inches (10 centimeters) across (Figure 3-115). Divers measured Target 21 at 75 feet (23 meters) long and 16 feet (5 meters) wide. Target 21 contained other features such as 10-inch (25-centimeter) cleats and heavy-duty U-bolts (Figure 3-116). Observed construction elements were consistent with mid- to late-20th-century barge construction methodologies. Based on observed construction elements and vessel size, Target 21 was likely a barge. Based on observed characteristics and available data, Target 21 may retain the potential to yield important information regarding maritime shipping and industry practices significant to Yap and the FSM's history. It is recommended treating Target 21 as eligible for listing in the NRHP with an avoidance buffer of 164 feet (50 meters) from the defined site extents, pending additional information.

Figure 3-114 2013 Aerial Imagery of Target 21 (Google Earth)

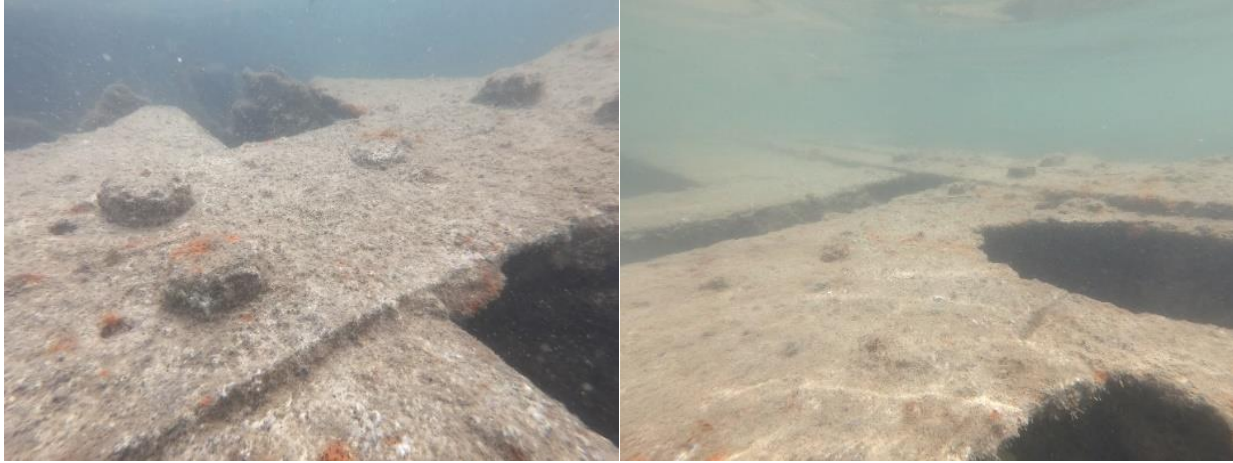
Figure 3-116 Single Riveting Butt Straps and Deck Plating (Photos by AECOM)

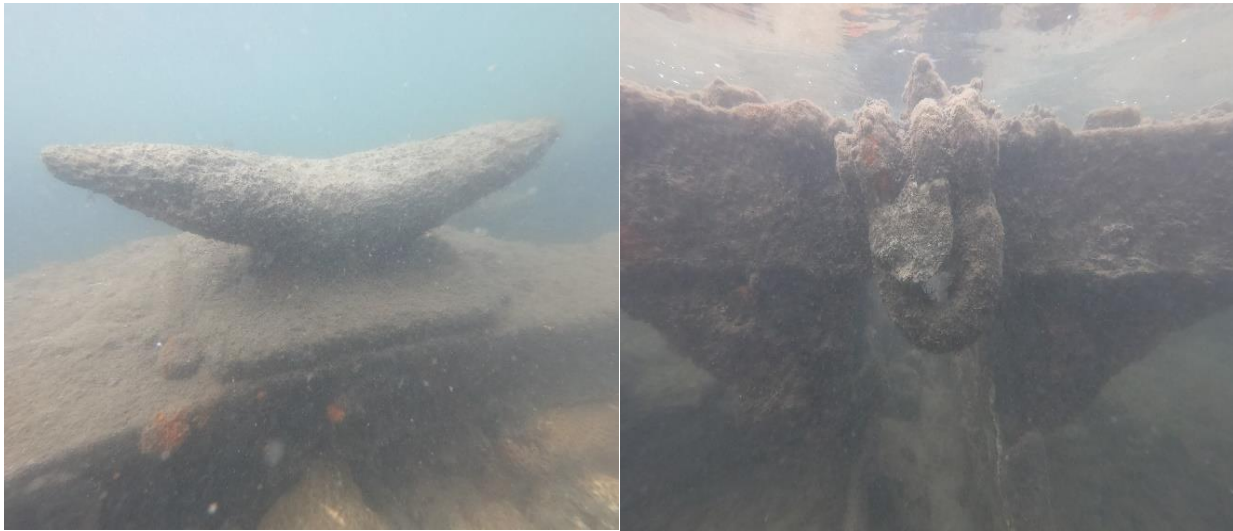
Figure 3-117 Cleat (Left) and U-bolt (Right) (Photos by AECOM)

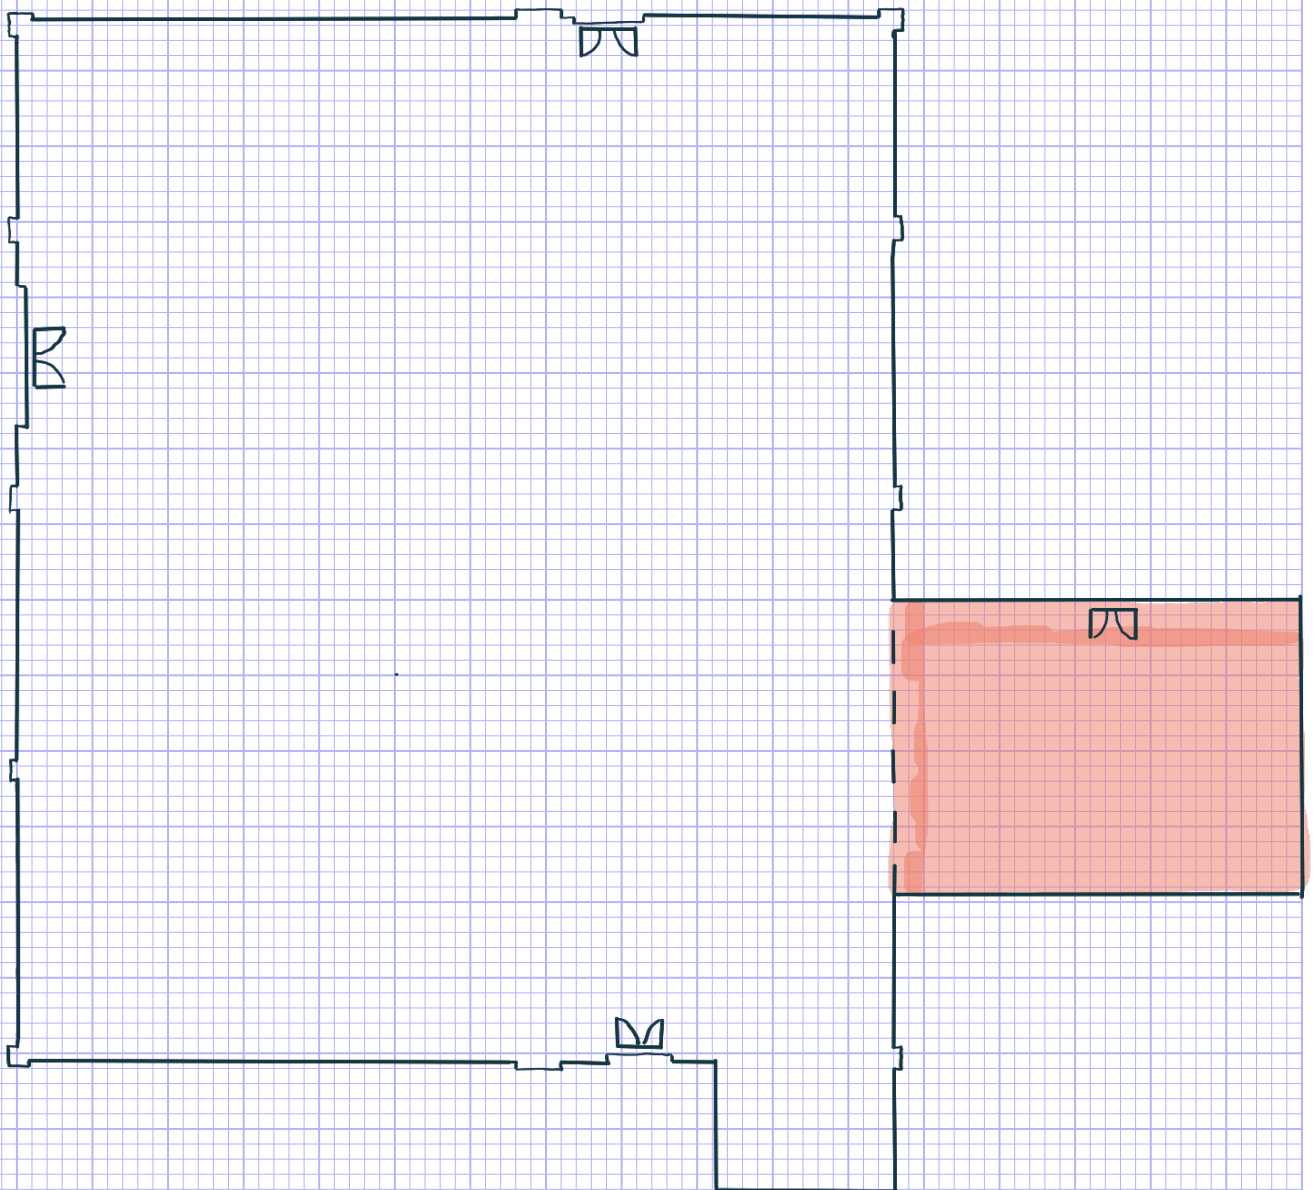
Modern wall-to-added building

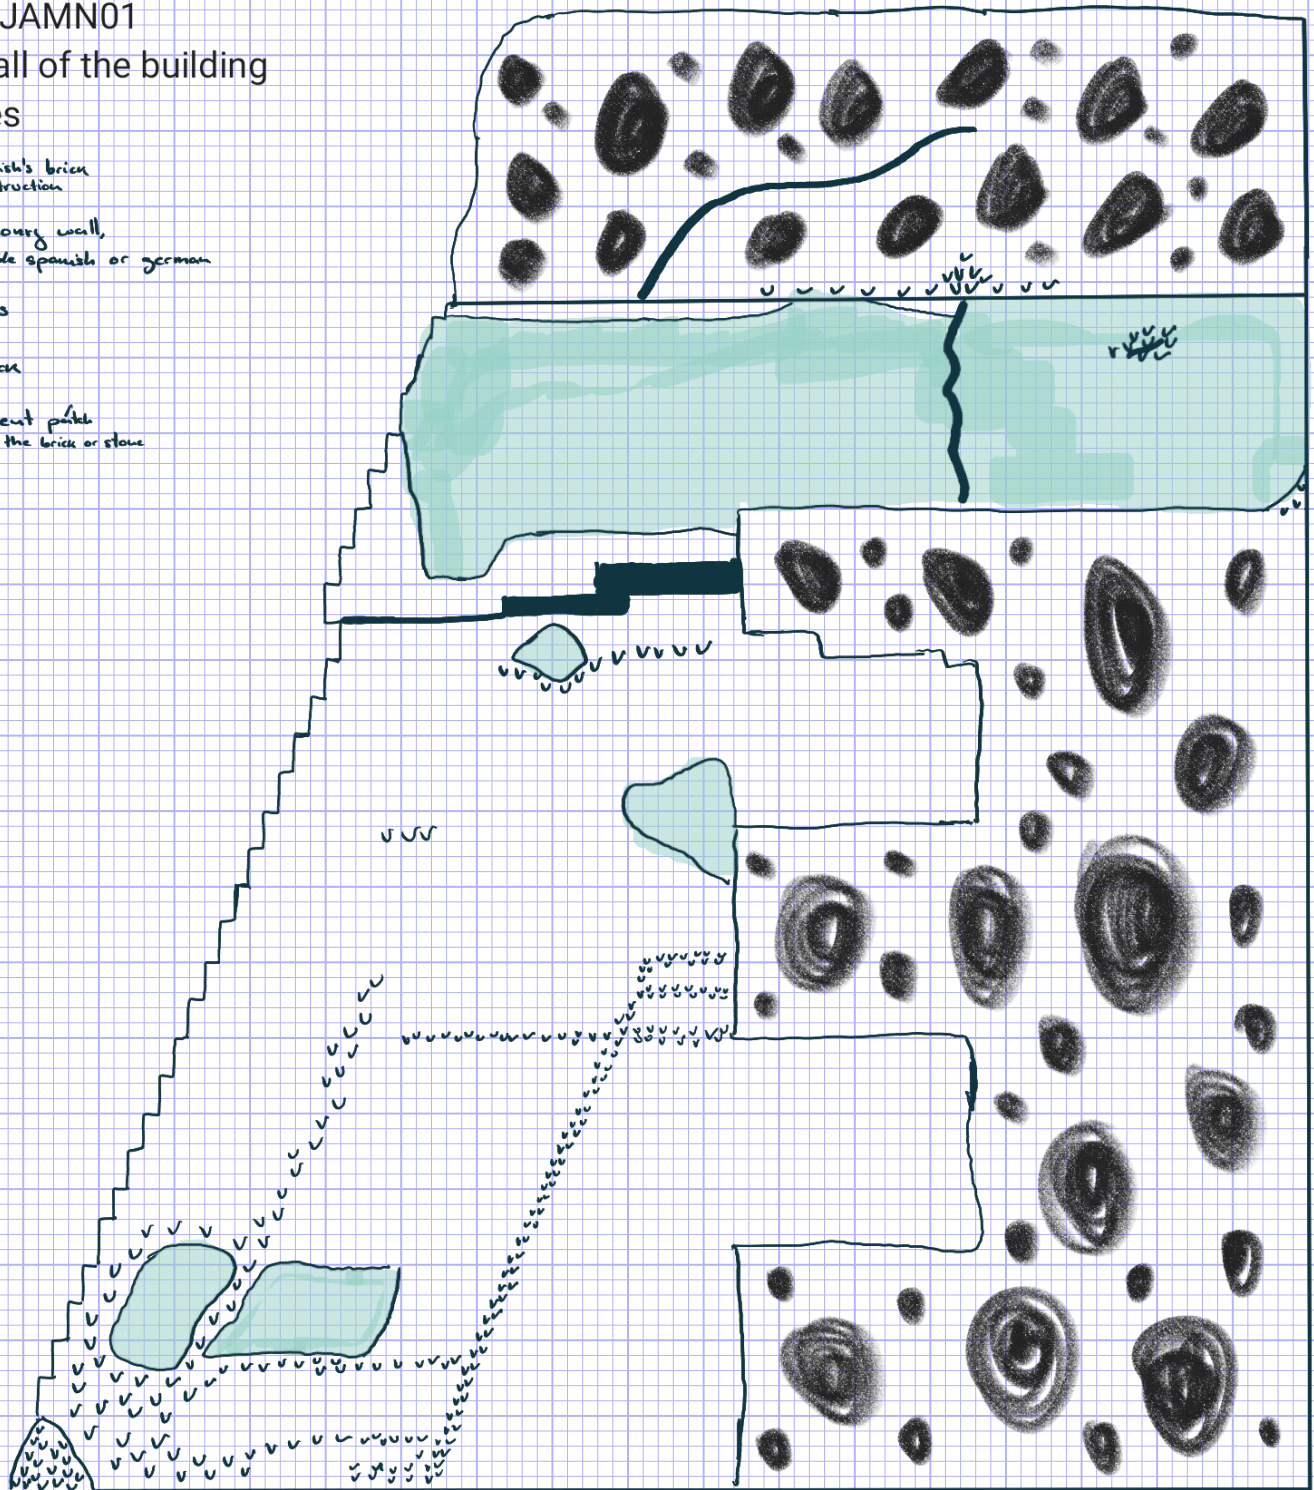
- Spanish's brick construction
- Masonry wall, probable spanish or german
- Grass
- Crack
- Cement patch over the brick or stone

Modern ground surface

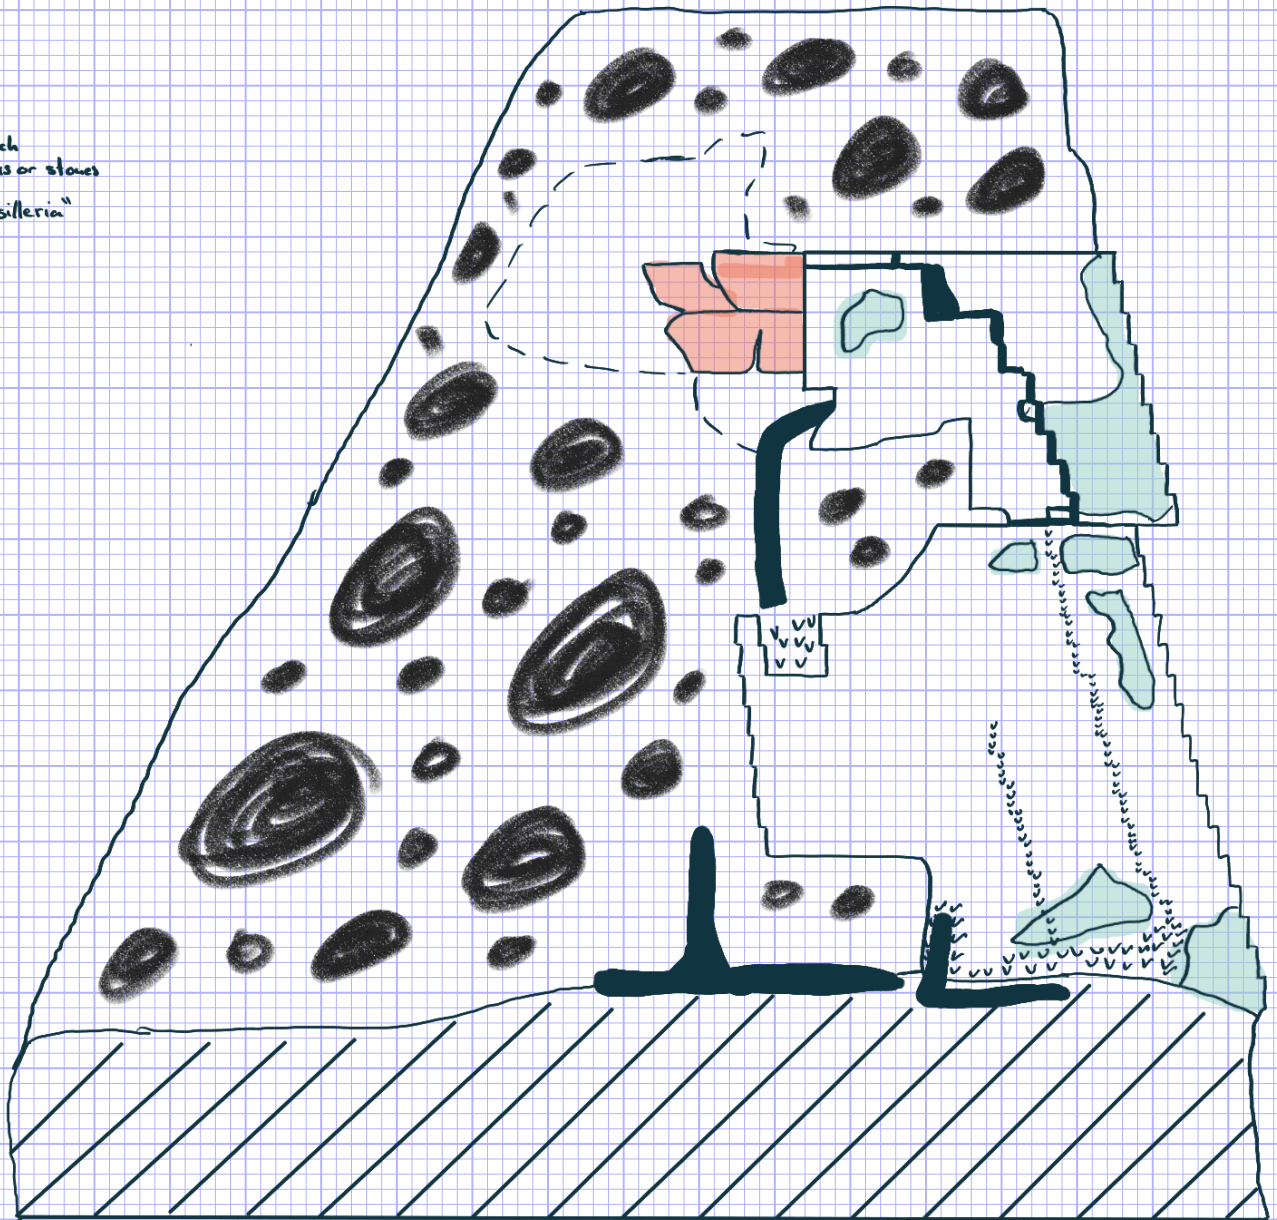
- Spanish's brick construction
- Masonry wall, probable "spanish or german"
- Grass
- Root or cracks
- Cement patch over the bricks or stones
- Spanish "silleria"
- Damage in the wall
- XX century addition

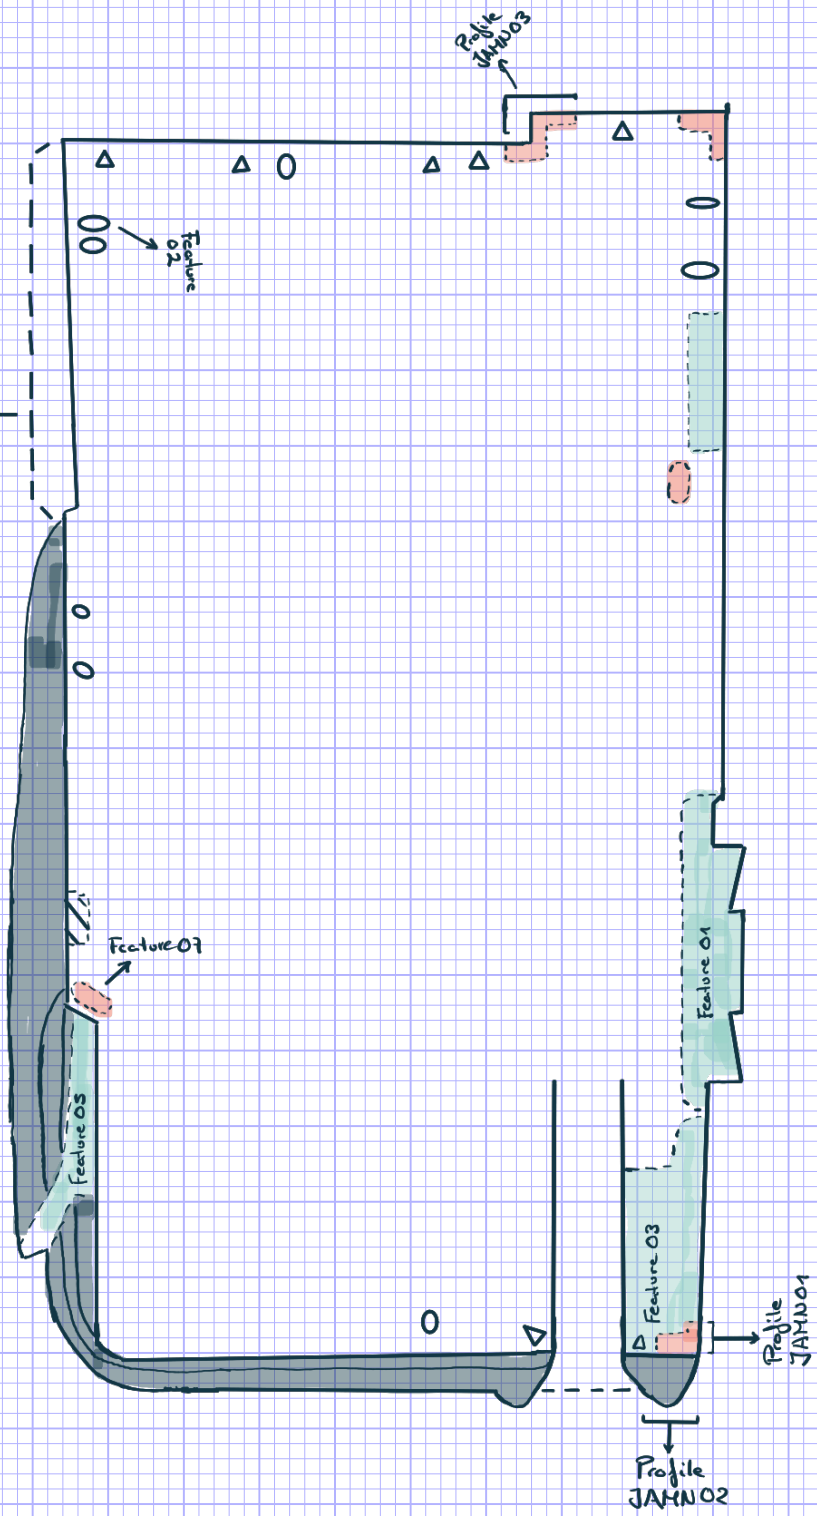
Masonry wall, probable Spanish or maybe German

Well conserved
probable Spanish
or German
part of the wall
