Final Field Report for Baseline Cultural Resources Surveys for the Sea Port in Yap, Federated States of Micronesia

Cardno GS – AECOM Pacific Joint Venture

October 2023

Project Name: Pacific Deterrence Initiative
Resource Surveys at Yap Port

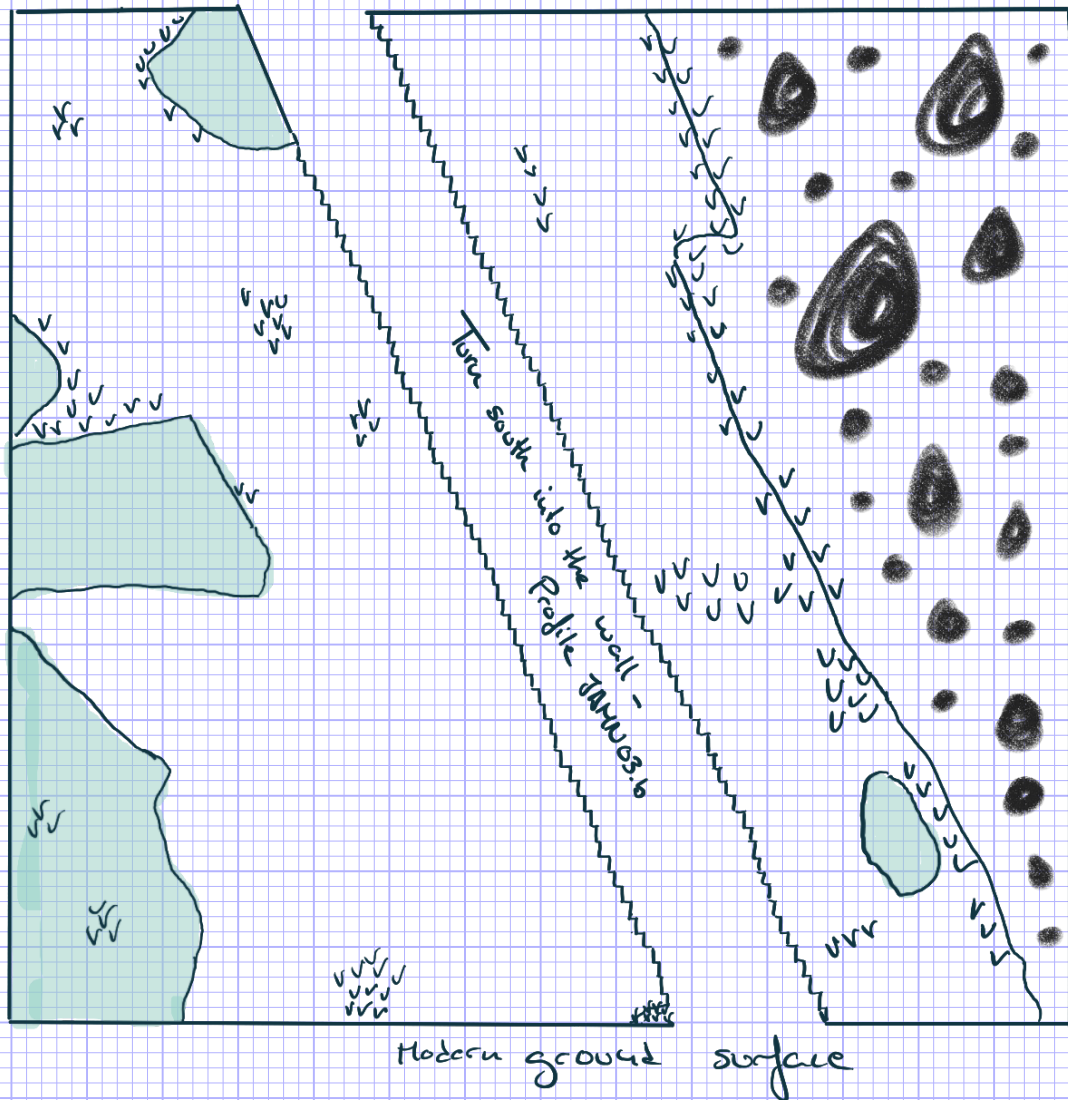
- Spanish's brick construction
- Masonry wall, probable spanish or german
- Vegetation
- Crack
- Cement patch over the brick or stone
