**Phase I Environmental Site**

**Assessment**

**Yap Seaport**

**May 2024**

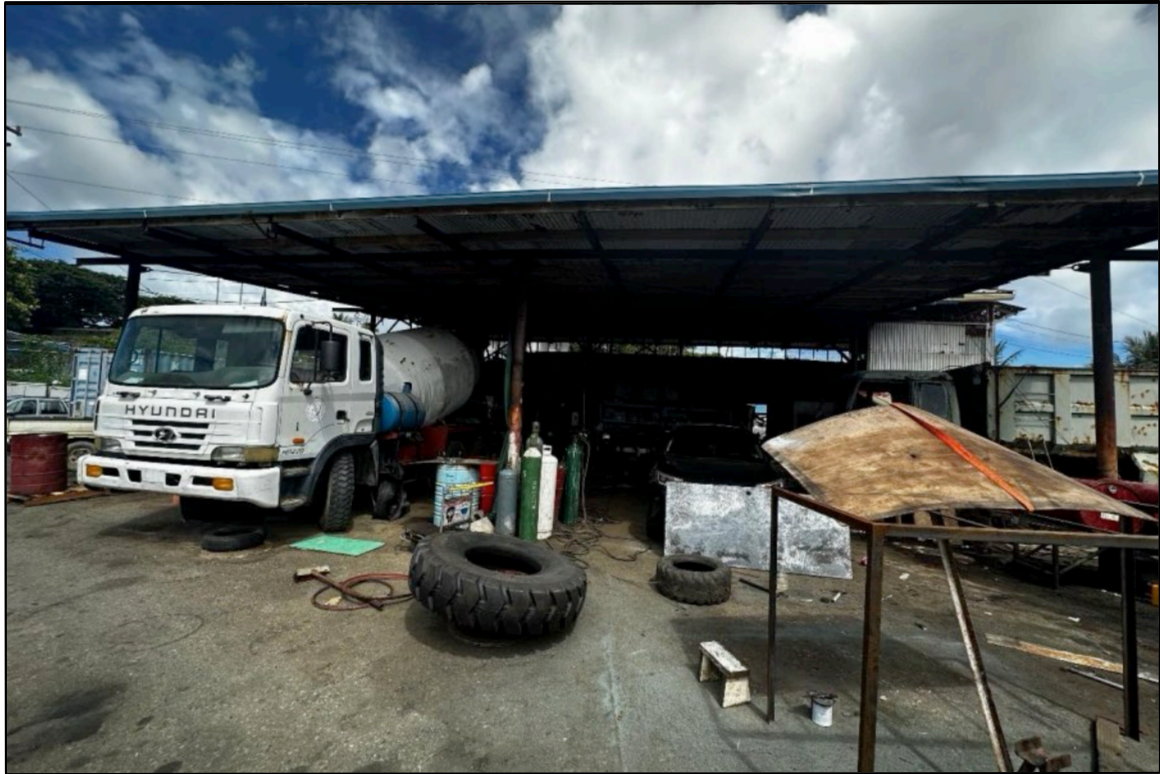
- Twenty drums located within the Division of Sea Transportation maintenance shop (Appendix A, Photos 5–7). With the exception of six 55-gallon drums that are utilized for daily maintenance and repair activities, the drums were observed to be empty. None of the drums were labeled and all were uncovered and on concrete pavement. Extensive oil staining, estimated to be approximately 200 square feet in total area, was observed on the pavement throughout maintenance shop. Spilled fluids have likely infiltrated floor and trench drains at the shop, which discharge to the ocean (Appendix A, Photos 8 and 9).

Photo 5: Overview of the Division of Sea Transportation maintenance shop. Photo is looking west.

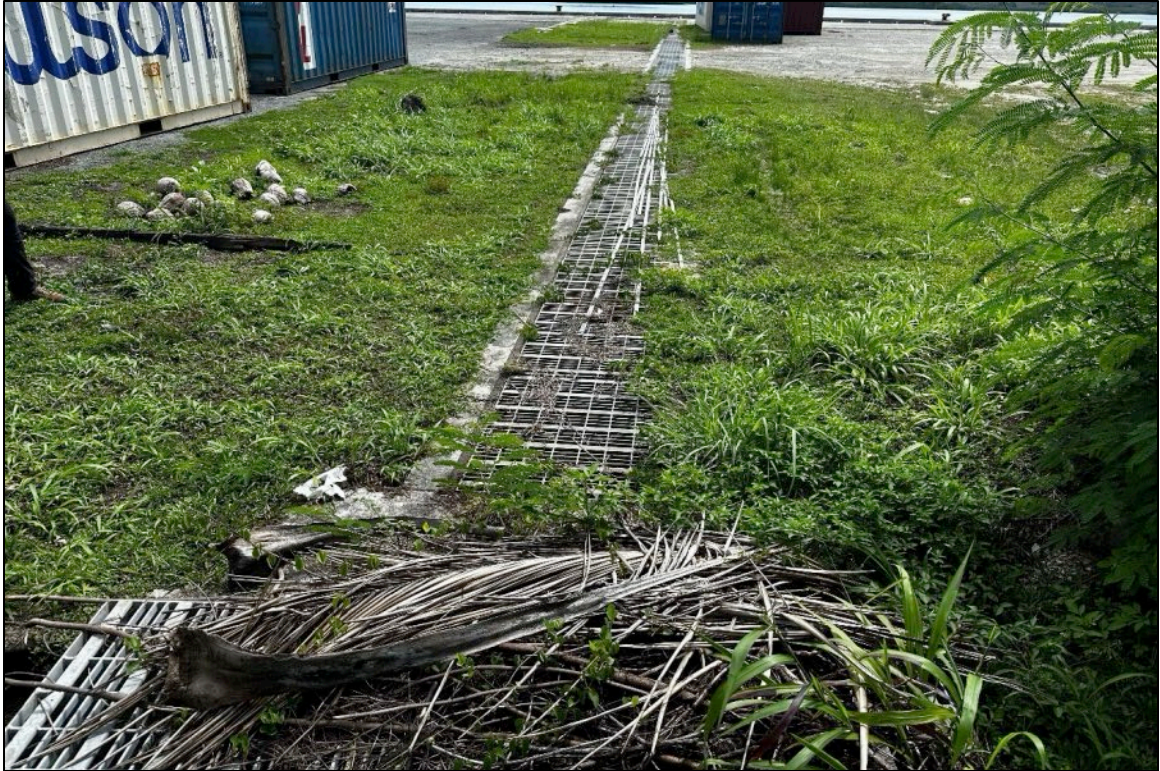
Photo 9: Drainage channel heading toward ocean. Photo is looking north.

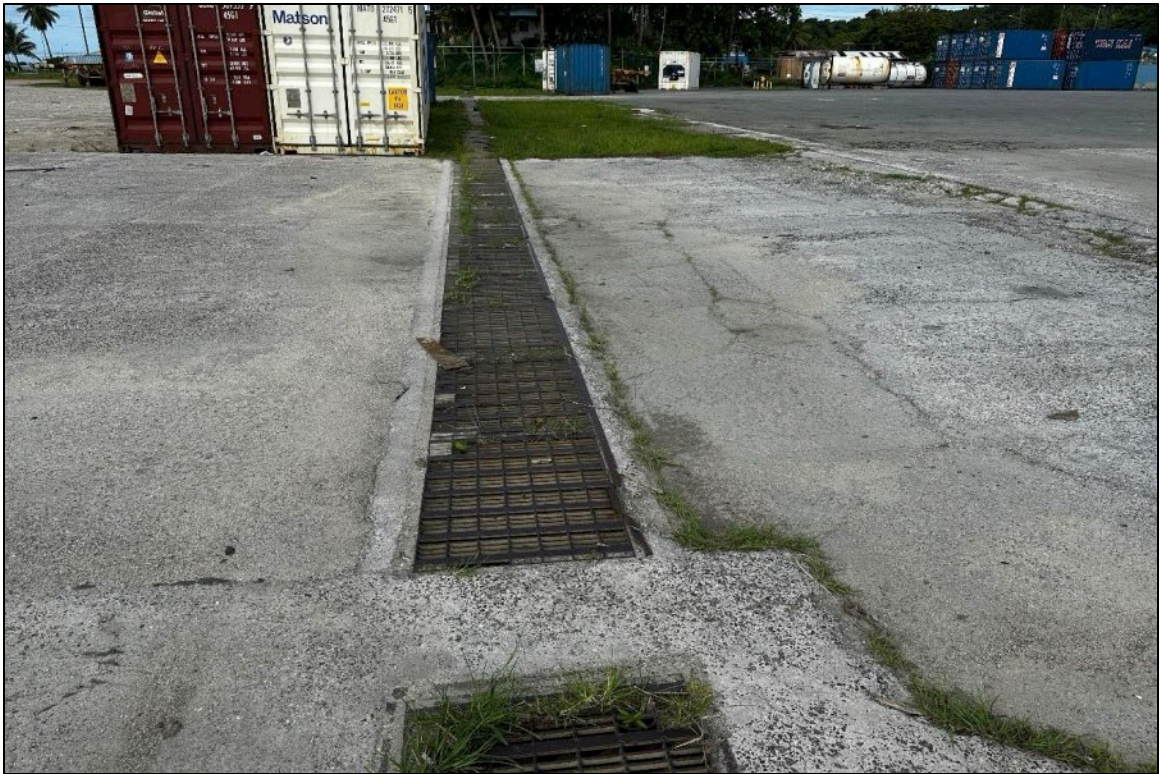
Photo 11: Storm drain channel which encircles the gated area within the port and leads toward the ocean. Photo is looking south.

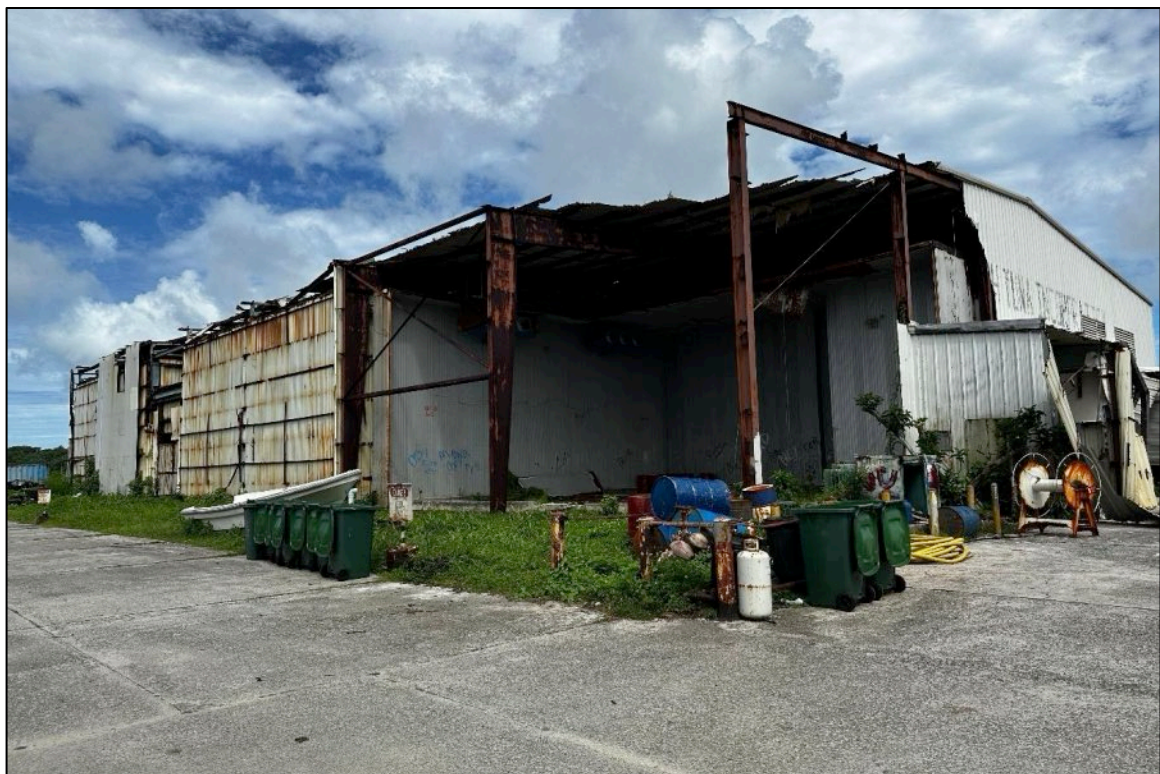
Photo 12: Overview of the former tuna canning facility's northeast corner. Photo is looking southwest.

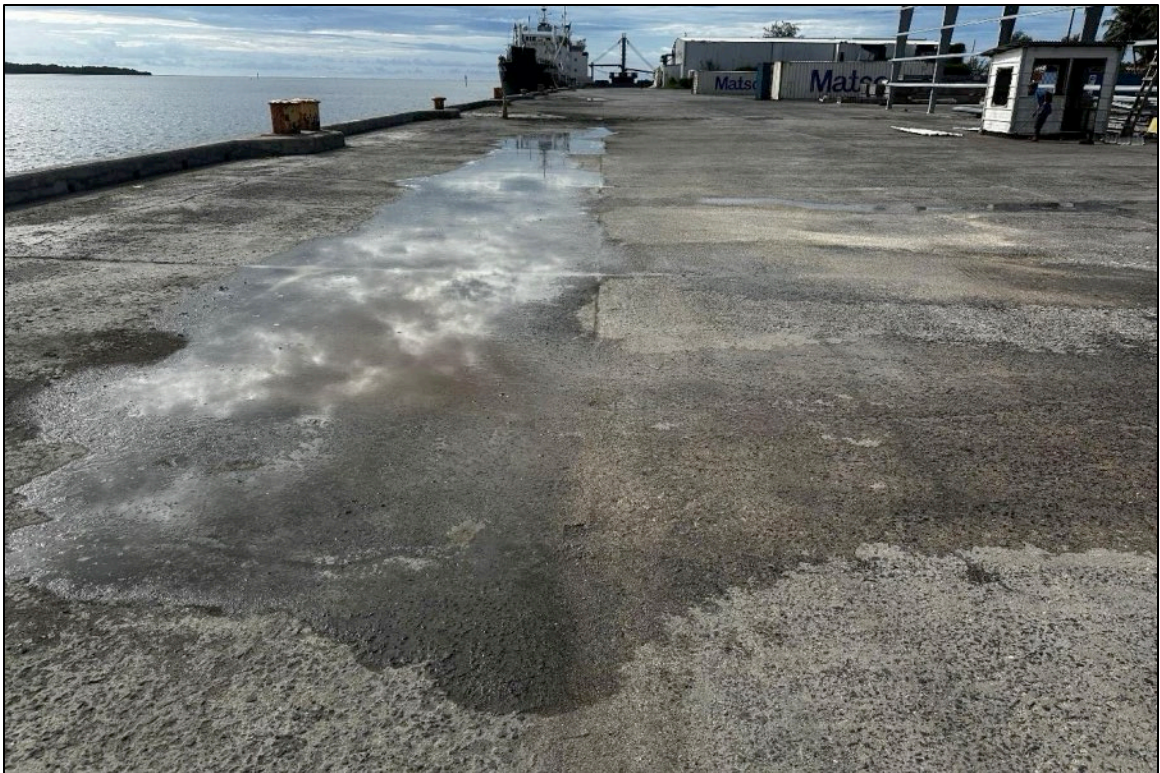
Photo 14: Overview of the main wharf at the seaport with the berths visible on the left side. Note: Natural water pooling is visible. Photo is looking southeast.

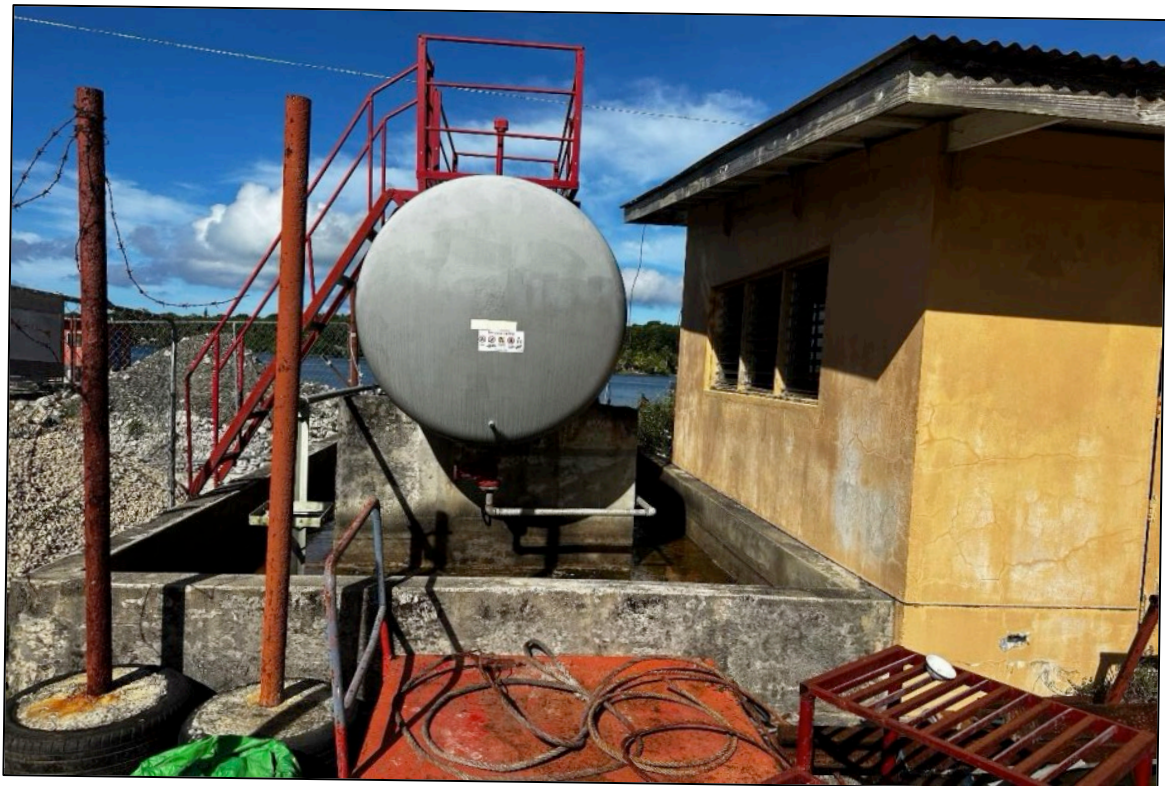
- A 10,000-liter diesel AST constructed of steel is present at the YFA facility (Appendix A, Photo 16). The AST is situated above a concrete containment basin. The installation date of the AST was unknown by YFA staff; however, the 1987 Yap Fishing Harbor Preparation Project drawings identify an “oil tank” would be installed (i.e., the AST was presumably installed after 1987). Mr. Yow and Ms. Falfen, the assistant general manager at YFA, indicated that other than a minor leak that was reported and repaired in 2022, no significant releases have been recorded from the AST. The 2022 leak was entirely contained within the concrete containment basin.

Photo 16: Overview of 10,000-liter diesel AST located at the YFA facility. Note: A concrete containment basin sits beneath the AST. Photo is looking south.

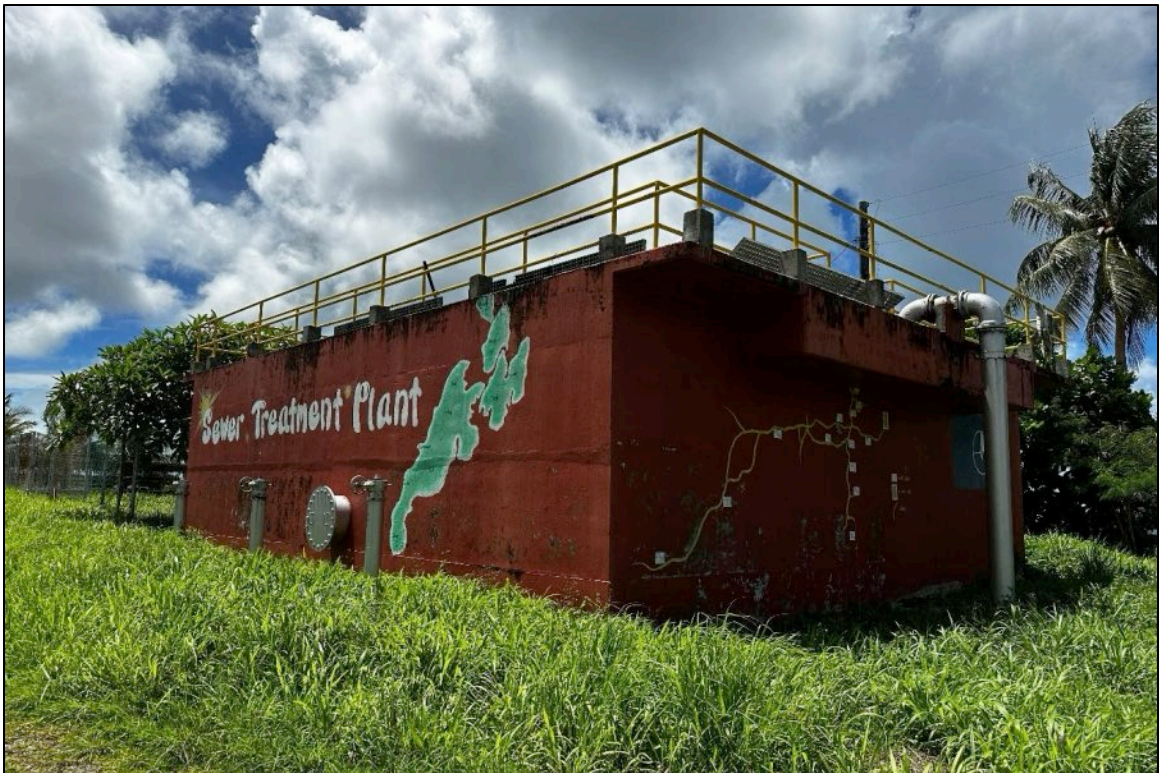
Photo 20: Overview of wastewater treatment plant located near the eastern boundary of the subject site. Photo is looking east.

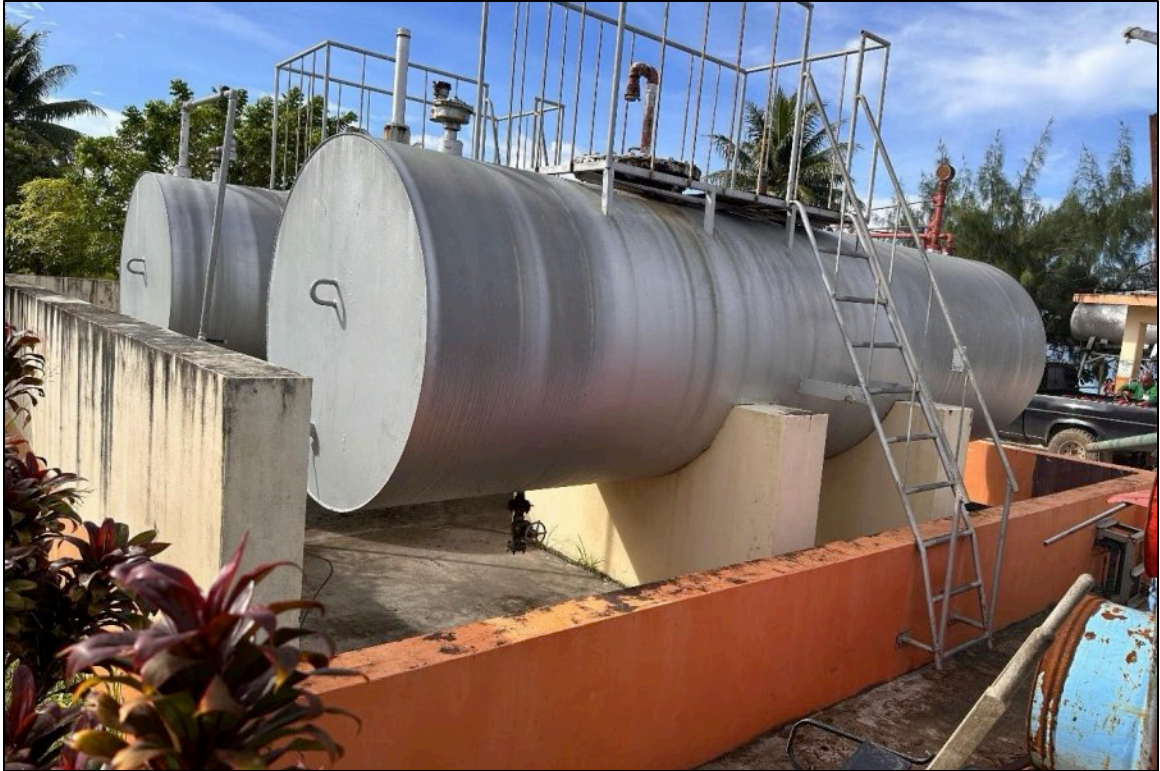
Photo 27: Overview of two steel ASTs containing diesel (3,700 gallons) and unleaded gasoline (4,010 gallons) in a concrete secondary containment observed at YCA Rufan Gas Station. Photo is looking north.

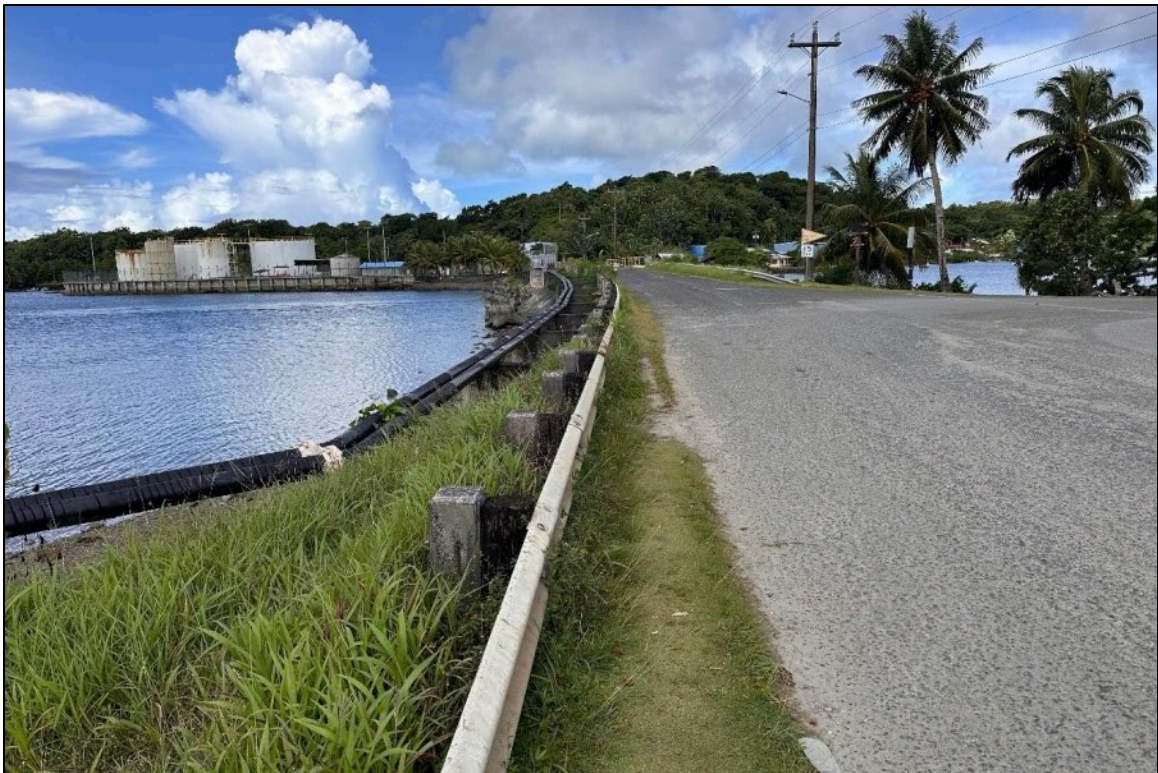
Photo 30: Small overpass leading to FSM Petroleum Corporation. Note: The subject property road is on the right and the fuel line is on the left. Photo is looking southwest.

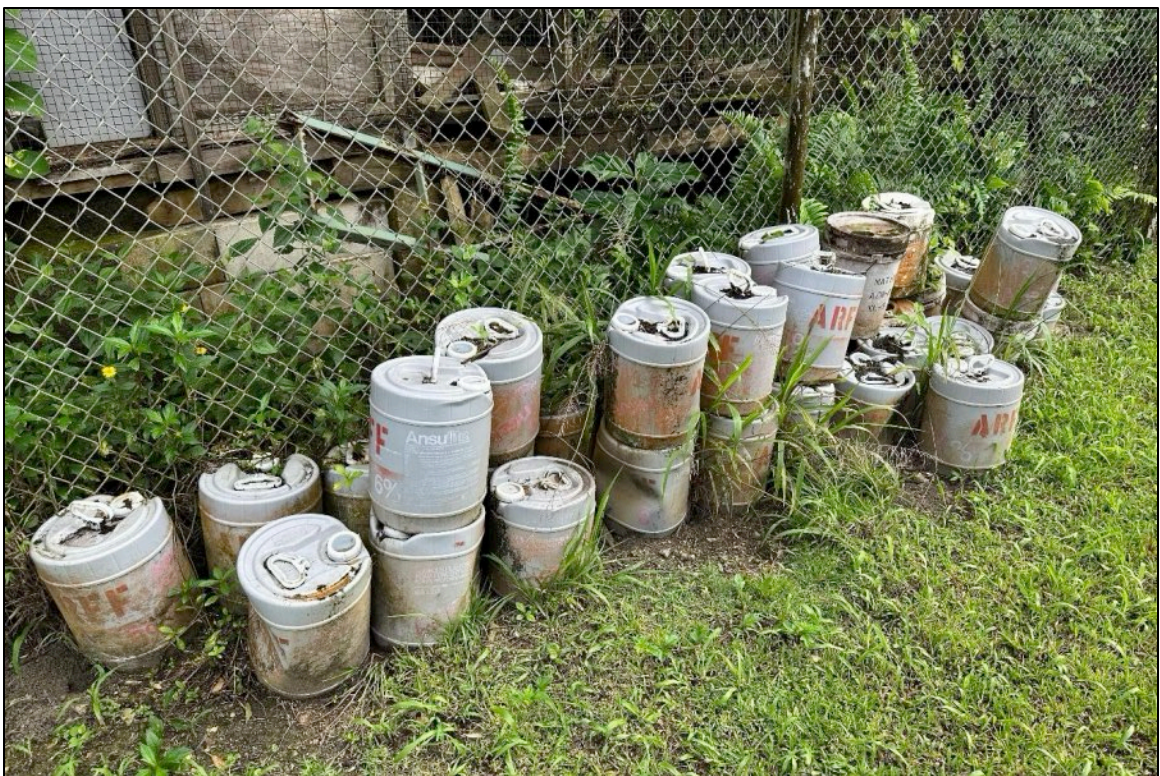
Photo 32: Close-up view of 55-gallon Ansolite buckets sitting on the lawn at the rear end of the fire department building.

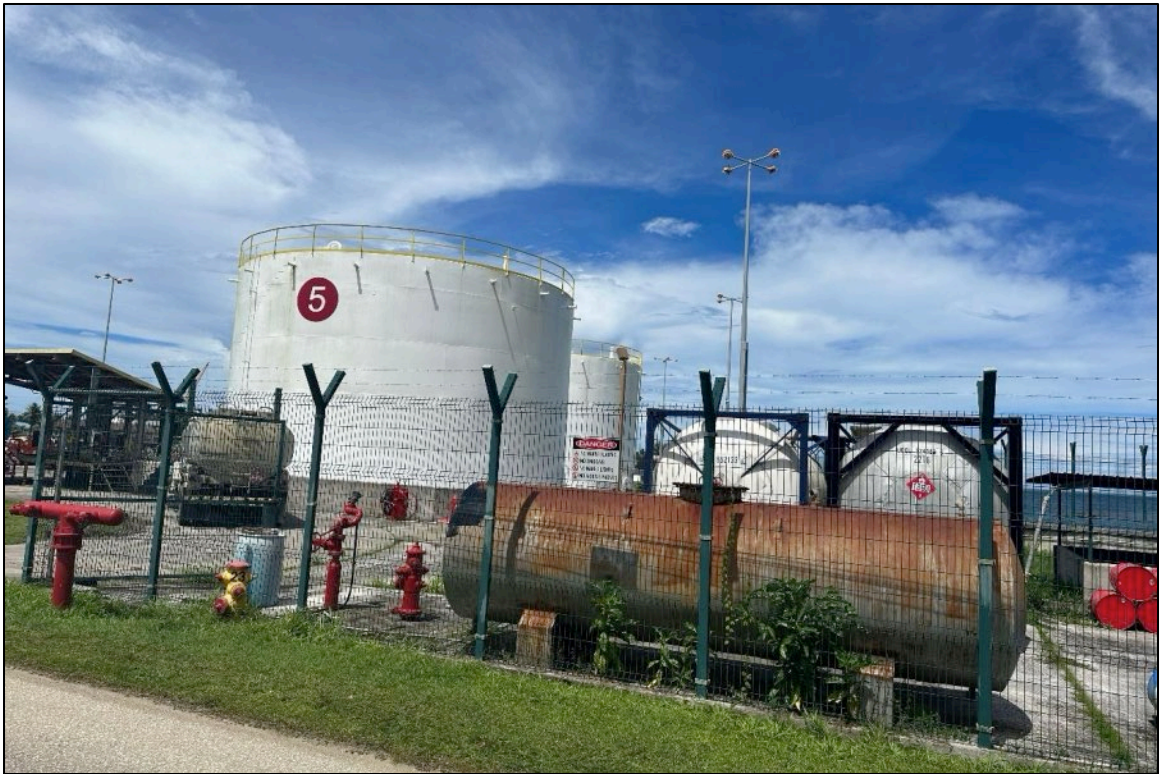
Photo 33: View of bulk fuel storage from outside the secured gates of FSM Petroleum Corporation. Photo is looking east.

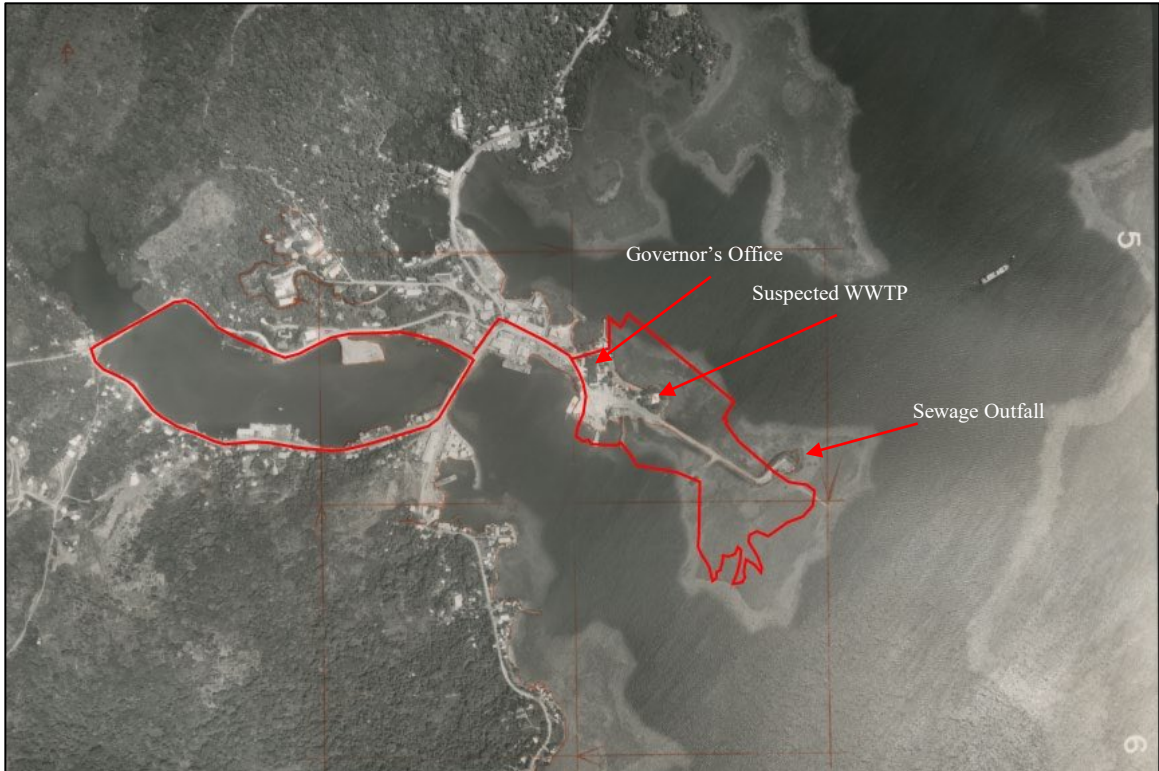
Historical aerial photographs indicate that the subject property, including the road encircling Chamorro Bay, was already partially developed by 1976. Visible structures include the Yap State Government and Administration Building, smaller structures in its vicinity, and the WWTP (Appendix B.1, Photo 1). The majority of the port area of the subject property is not yet in existence in the 1976 photo (i.e., the area is still ocean) and subsequently not illustrated in the 1983 topographic map. According to Mr. Yow, land reclamation and the construction of most of the port's buildings were completed in the 1980s. A review of the Yap Fishing Harbor Preparation Project at the Yap Fisheries Authority indicates that the FYA building was constructed after 1988.

Photo 1: 1976 – Subject property, Colonia. The majority of the subject property in the port area is undeveloped, with the exception of the governor's office and other features in the vicinity, including the suspected WWTP and its sewage outfall.

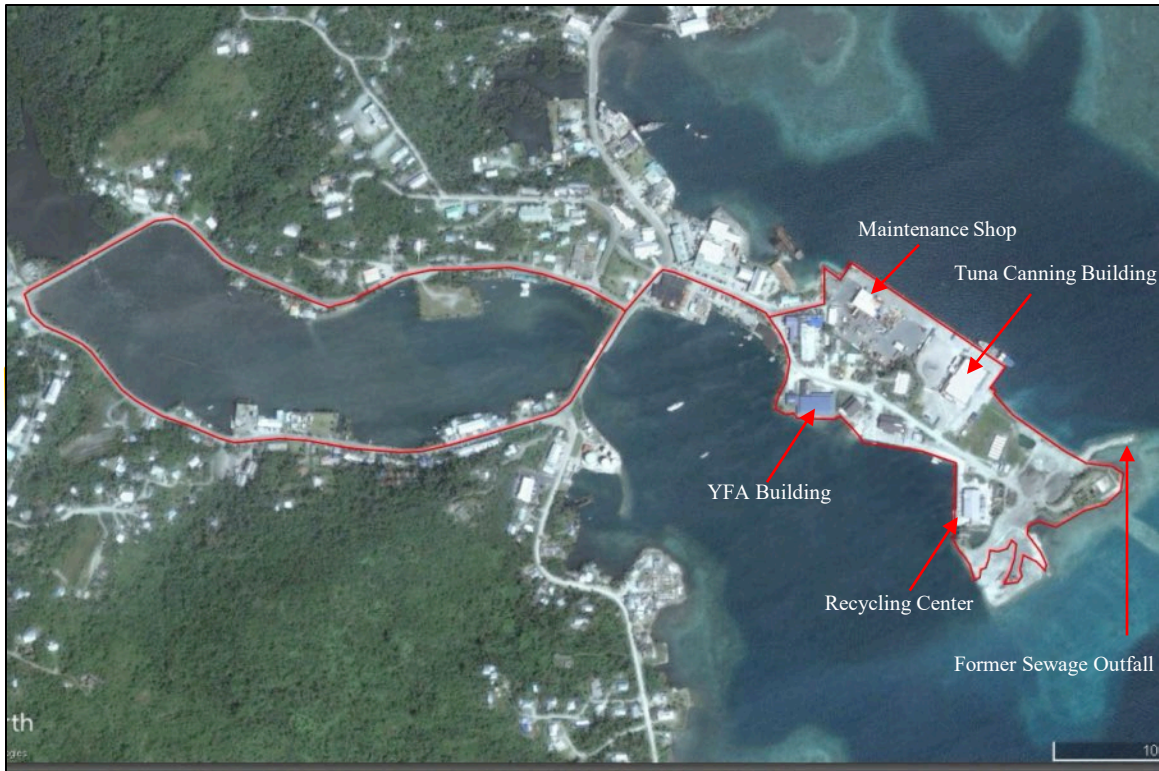
Photo 2: 2005 – Subject property, Colonia. The subject property appears fully developed. The wharf inside the gated area has been filled. The maintenance shop, YFA building, recycling center and tuna canning building are denoted by the red arrows. The majority of the former sewage outfall is now underwater.

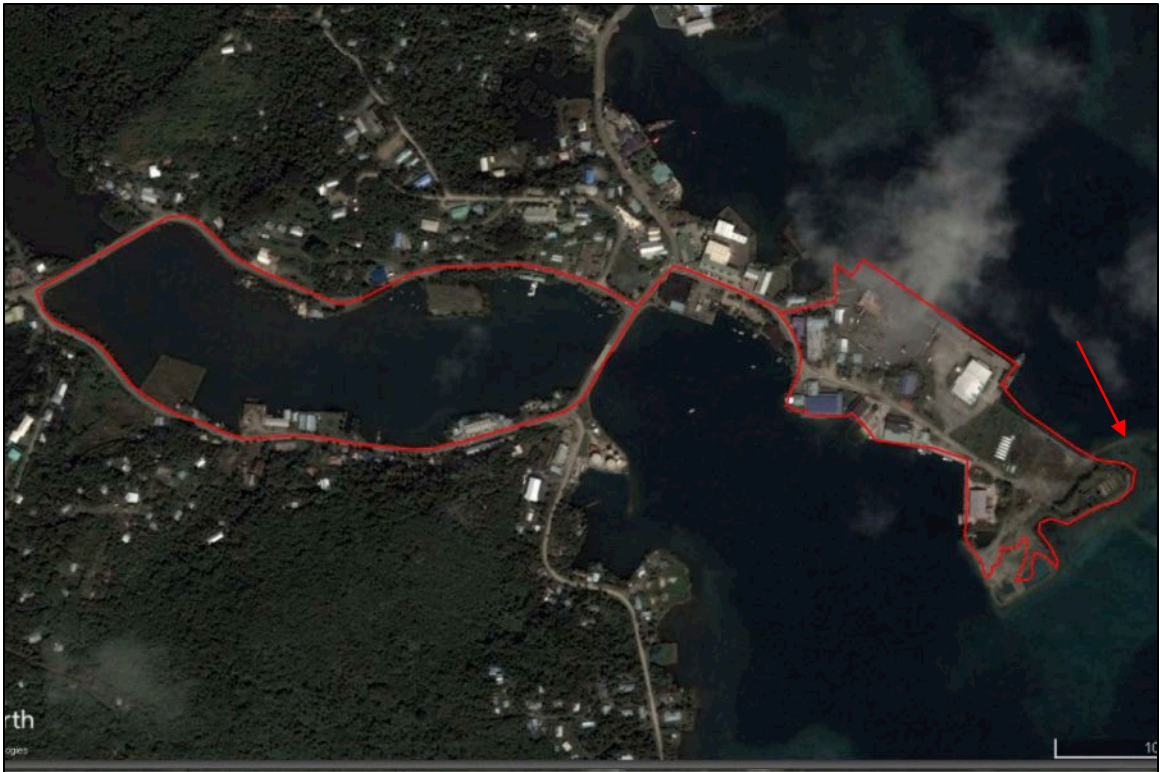
Photo 3: 2008 –Subject property, Colonia. The subject property looks generally the same from the last photo. Some portions of the easternmost point of the peninsula are now underwater. Red arrow points to the underwater strip of land associated with former sewage outfall

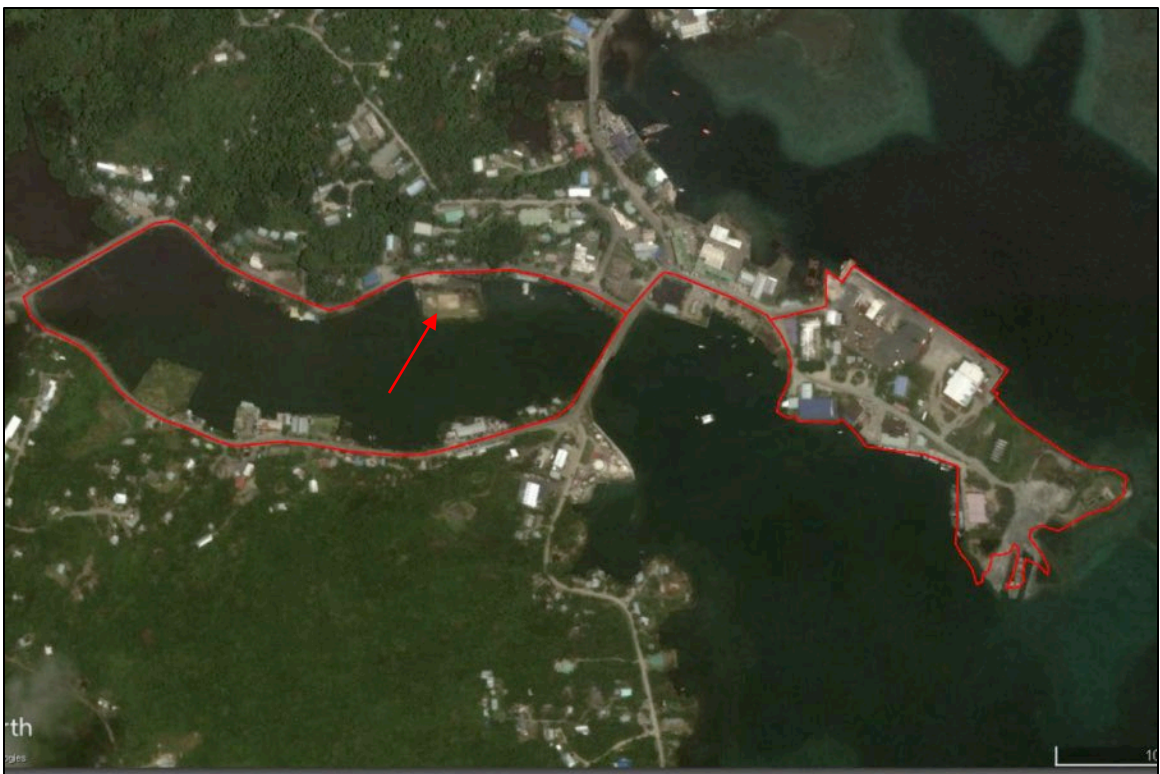
Photo 4: 2013 – Subject property, Colonia. The subject property looks generally the same from the last photo. There appears to be more shipping containers stored inside the gated area. There appears to be development in the adjacent area to the road denoted by the red arrow.

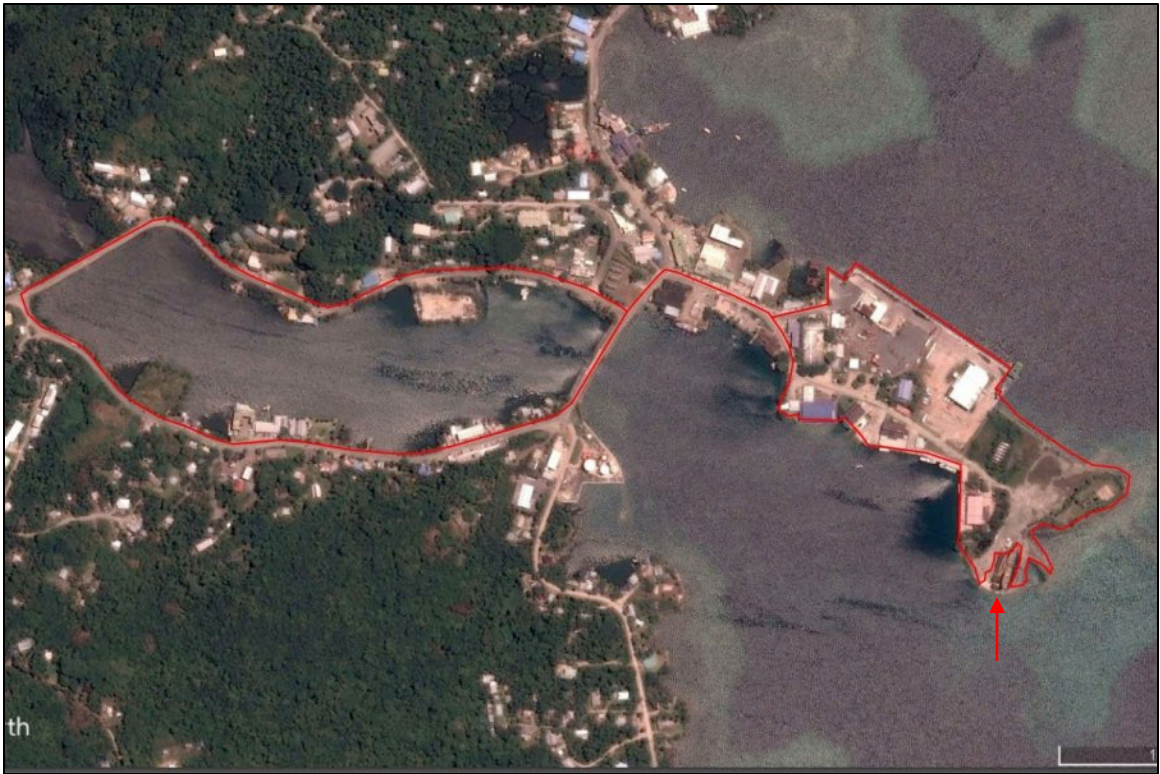
Photo 5: 2014 – Subject property, Colonia. The subject property looks generally the same from the last photo. The southeasternmost region of the subject property appears to be eroding. Red arrow points to region underwater.

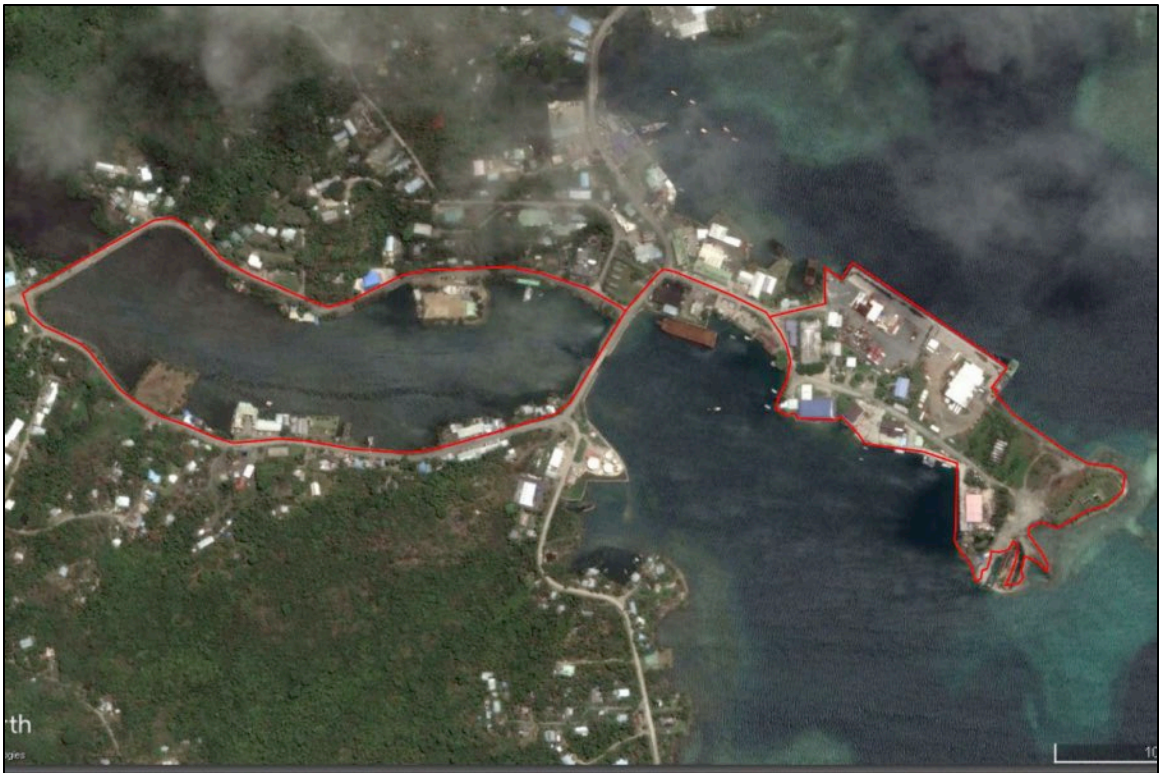
Photo 6: 2016 – Subject property, Colonia. The subject property looks generally the same from the last photo.

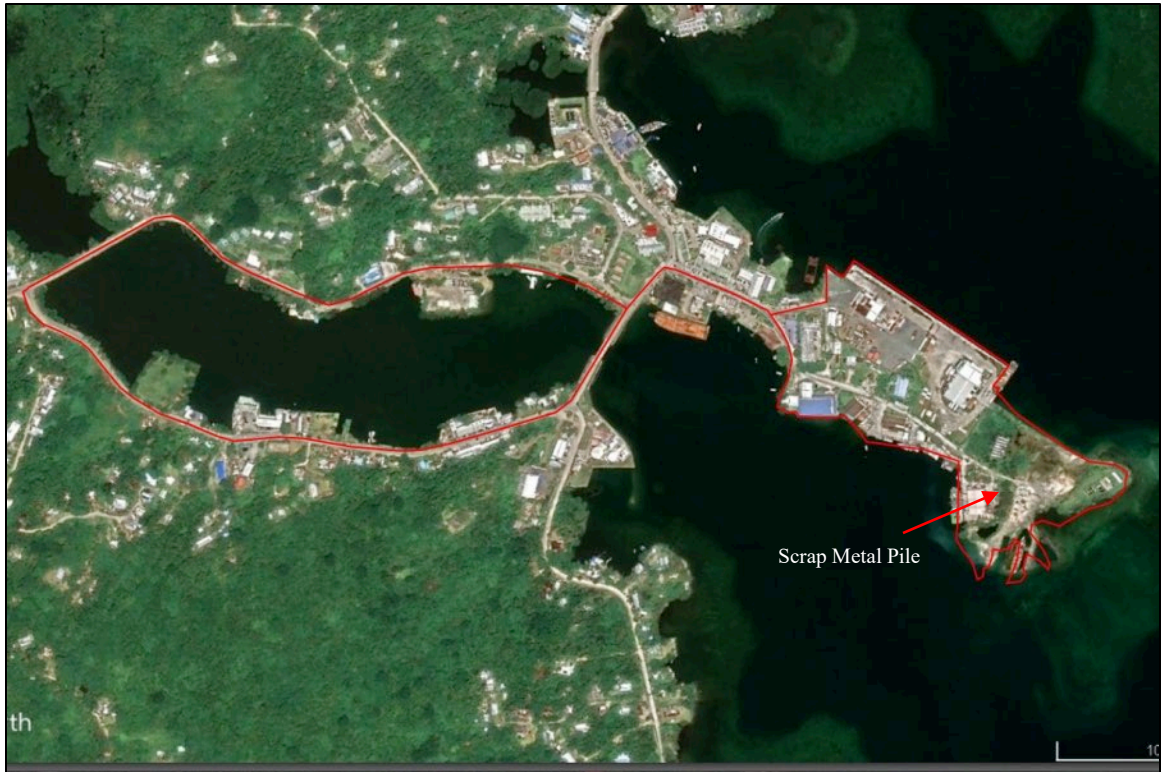
Photo 7: 2017 – Subject property, Colonia. The scrap metal pile adjacent to recycling center is now visible. Both piles are denoted by the red arrows.

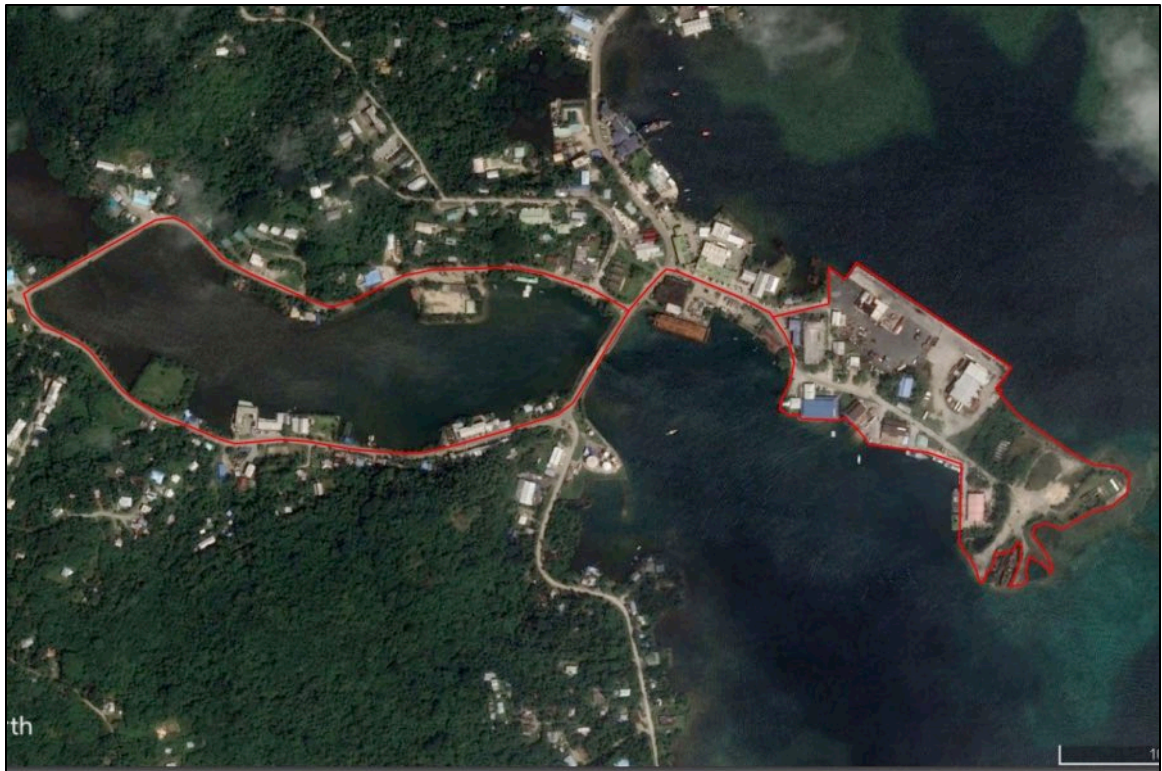
Photo 8: 2018 – Subject property, Colonia. The subject property looks generally the same from the last photo.

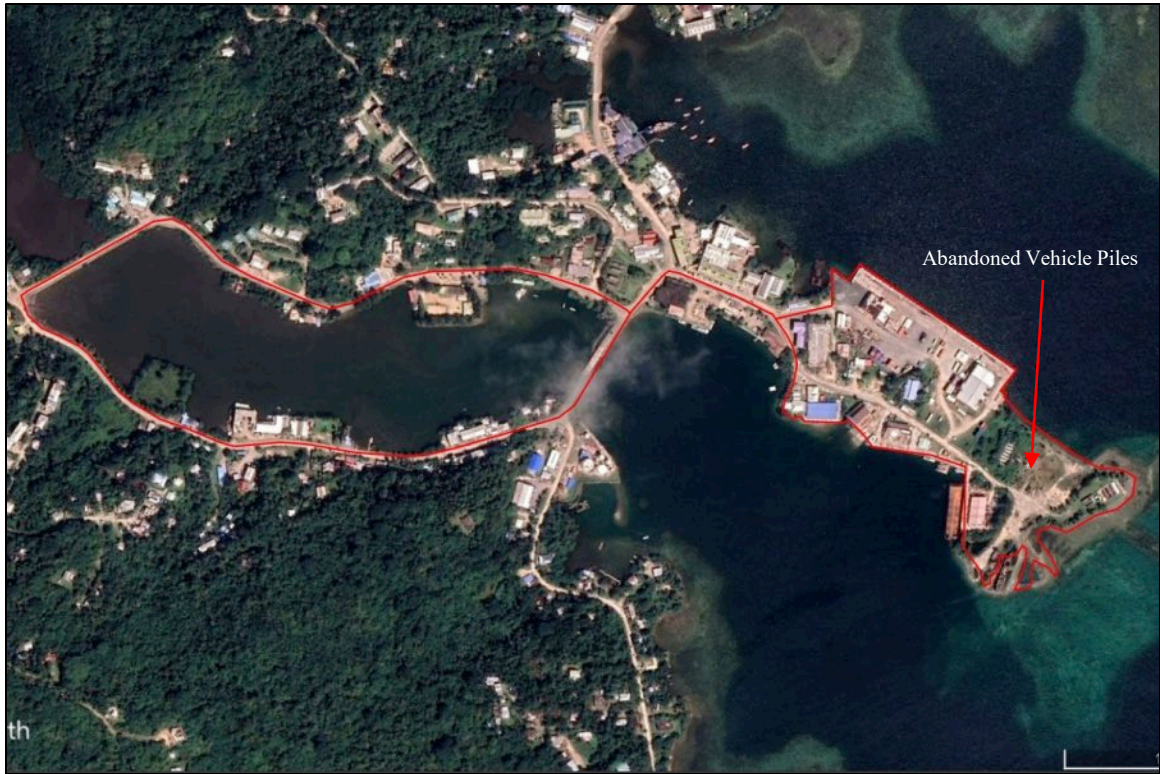
Photo 9: 2019 – Subject property, Colonia. The subject property looks generally the same from the last photo. The abandoned vehicle piles are beginning to accumulate (denoted by red arrow).

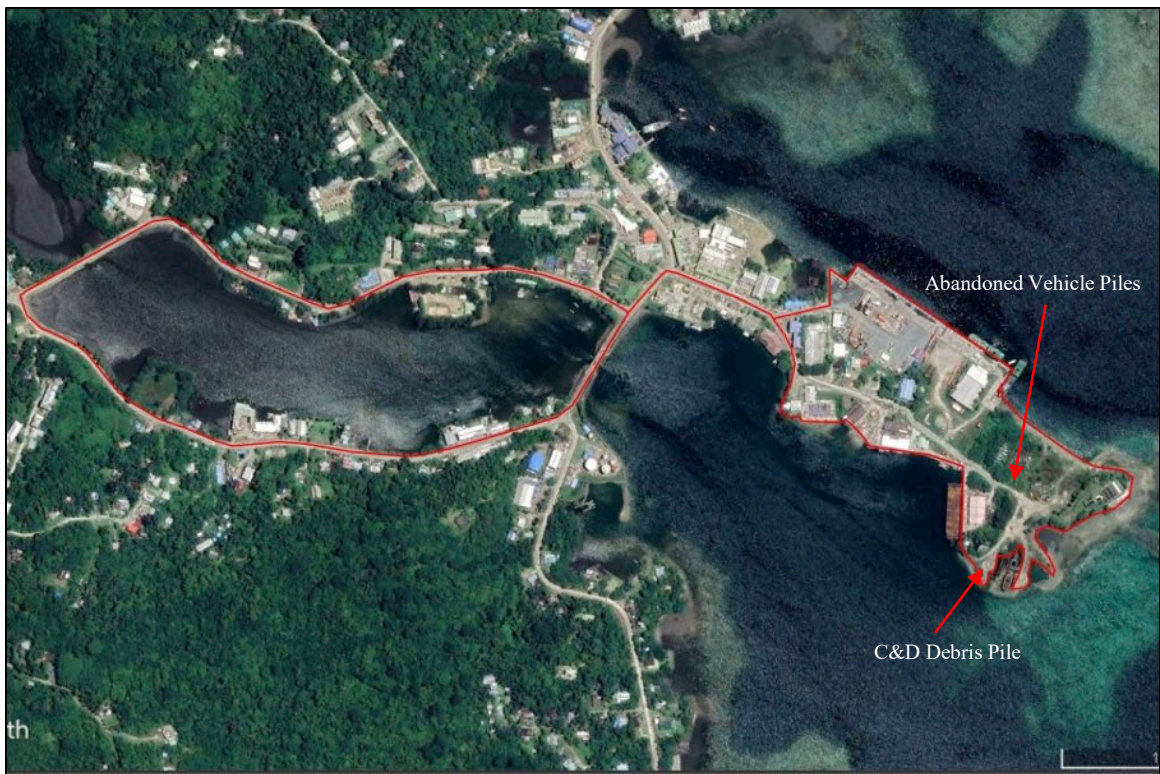
Photo 10: 2022 – Subject property, Colonia. The subject property looks generally the same from the last photo. More abandoned vehicles appear to be accumulated. Construction and demolition (C&D) debris pile is now visible (both areas denoted by red arrow).
