**Naval Facilities Engineering Systems Command Pacific
JBPHH HI**

Phase I Environmental Site

Yap Seaport

ISLAND OF YAP FEDERATED STATES OF MICRONESIA

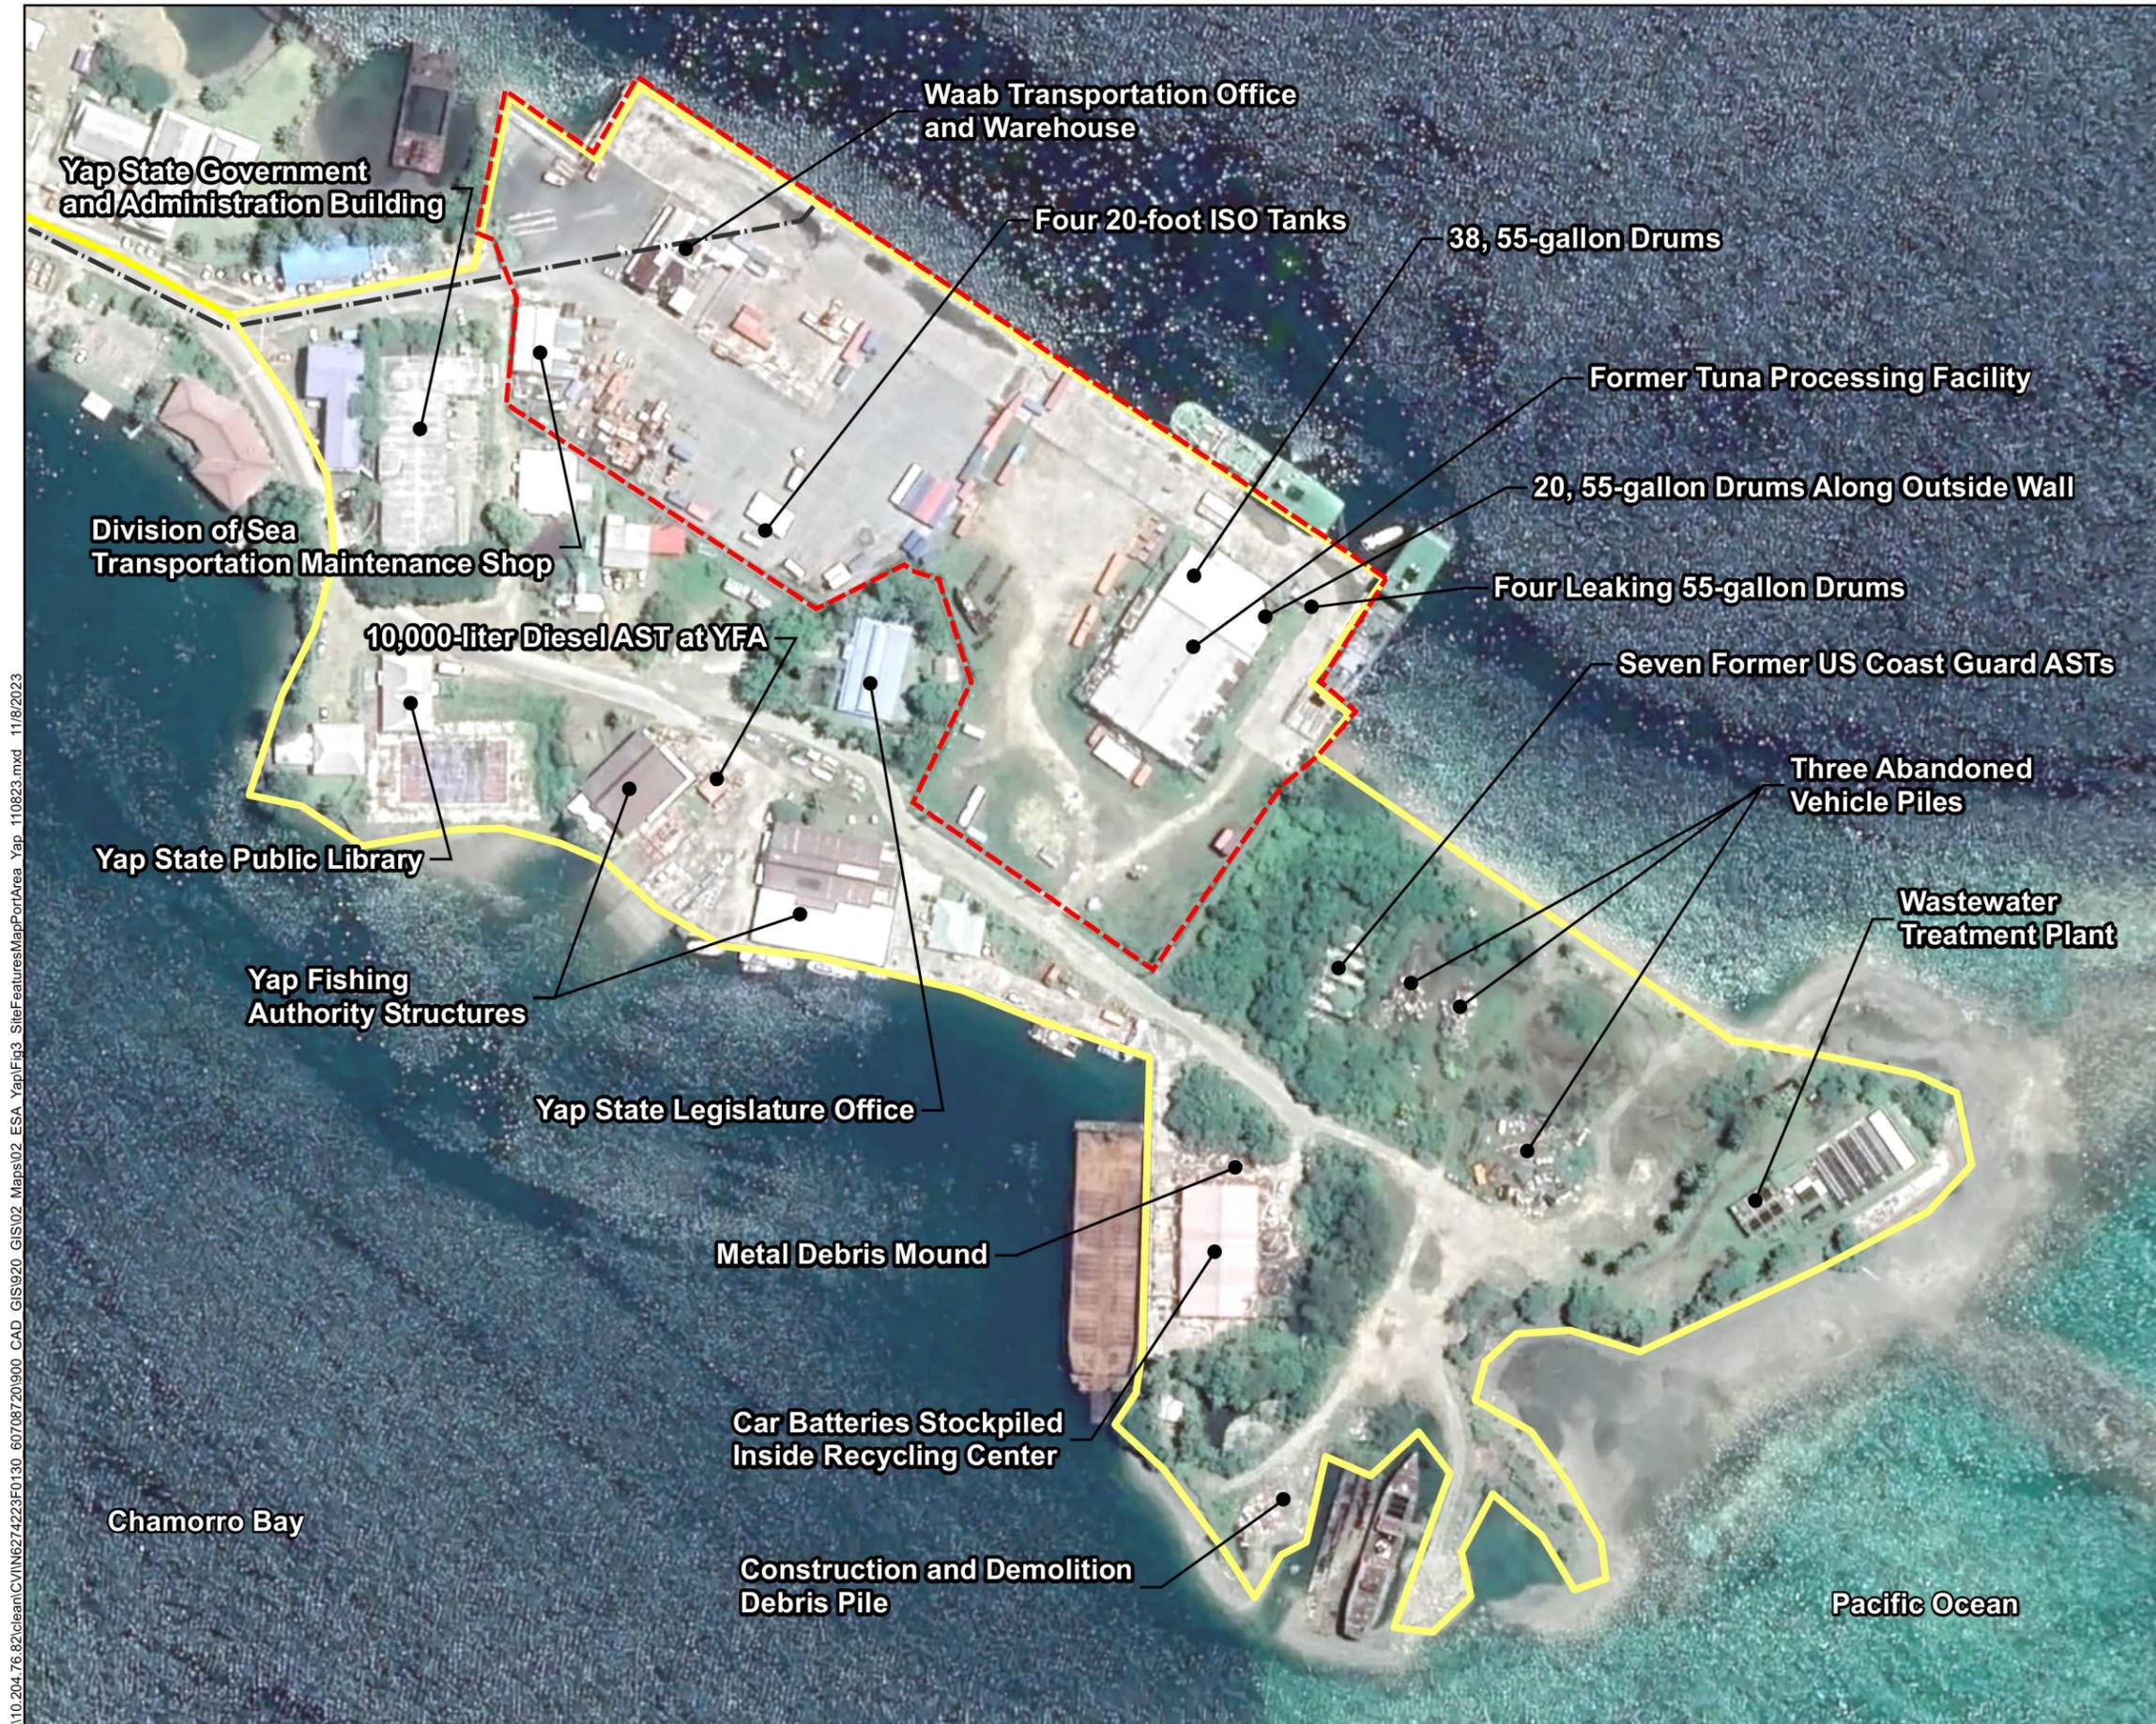
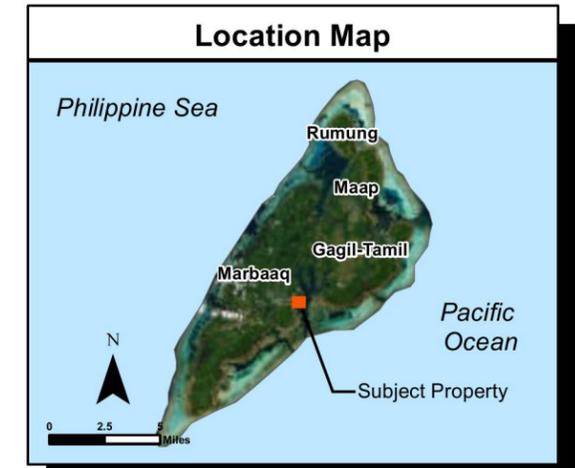
Figure 3
Site Features - Port Area
Environmental Site Assessment
Yap Port, Colonia, Yap Island,
Federated States of Micronesia

- An underground fuel pipeline is present within the port area of the subject property (Figure 3). The pipeline is used to transport mainly gasoline and diesel fuel offloaded by tanker barges at the port to the Vital PetroCorp fuel farm, located approximately 200 feet to the southeast of the Chamorro Bay road portion of the subject property. Mr. Rumwol, the officer in charge, was unaware of any releases from the pipeline. It could not be determined whether the pipeline is regularly leak tested, the leak testing methods, and testing results. Based on this lack of information, the pipeline represents a material threat of a potential future release. A monitoring well was observed in a parking lot adjacent to the fuel pipeline. Mr. Mautaman was unaware of the purpose of the monitoring well and whether it is associated with the fuel pipeline.

- Four 20-foot ISO tanks containing liquified petroleum gas were observed inside the fenced area of the port area portion of the subject property (Figure 3). The ISO ASTs are managed by the Sea Transportation Office. Mr. Siugwemal indicated the ASTs are temporarily stored at the port pending their subsequent transportation. Mr. Siugwemal was uncertain of the specific duration of time the ASTs have been in storage. During the site inspection, the tanks appeared in good condition without evidence of corrosion and no evidence of leaks or releases were observed below the tanks.

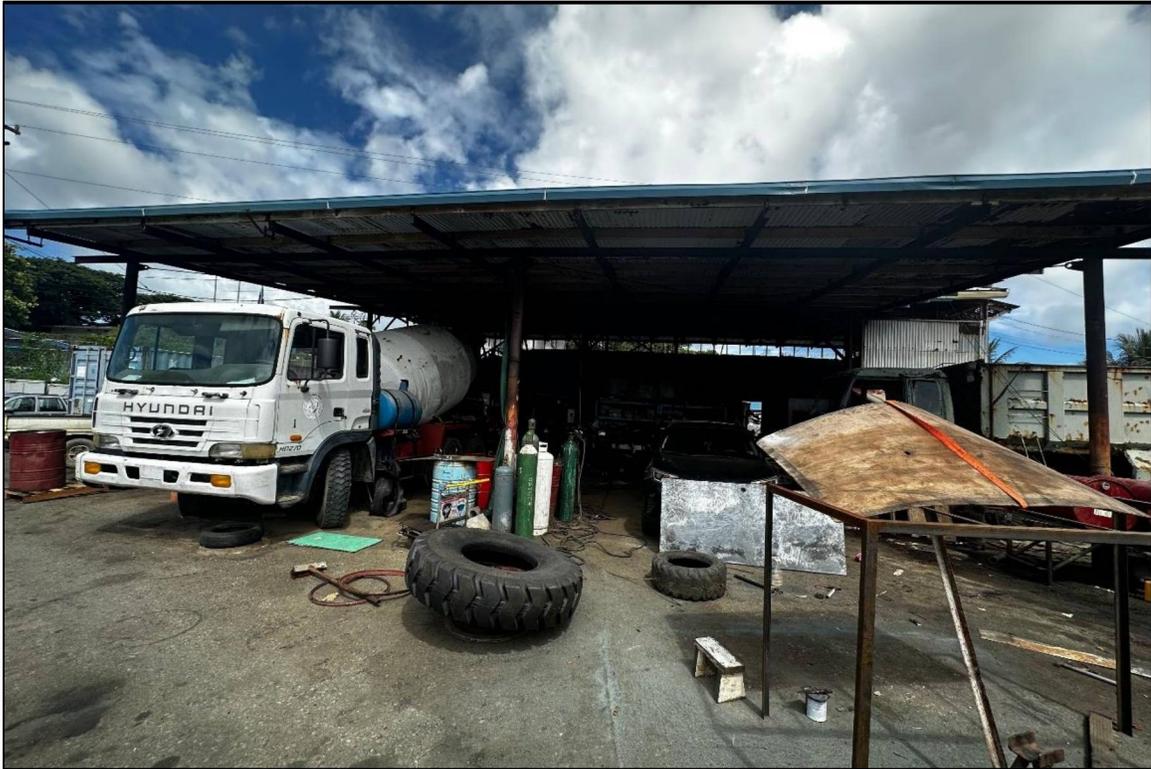
- Twenty drums located within the Division of Sea Transportation maintenance shop (Appendix A, Photos 5–7). With the exception of six 55-gallon drums that are utilized for daily maintenance and repair activities, the drums were observed to be empty. None of the drums were labeled and all were uncovered and on concrete pavement. Extensive oil staining, estimated to be approximately 200 square feet in total area, was observed on the pavement throughout maintenance shop. Spilled fluids have likely infiltrated floor and trench drains at the shop, which discharge to the ocean (Appendix A, Photos 8 and 9).

Photo 5: Overview of the Division of Sea Transportation maintenance shop. Photo is looking west.

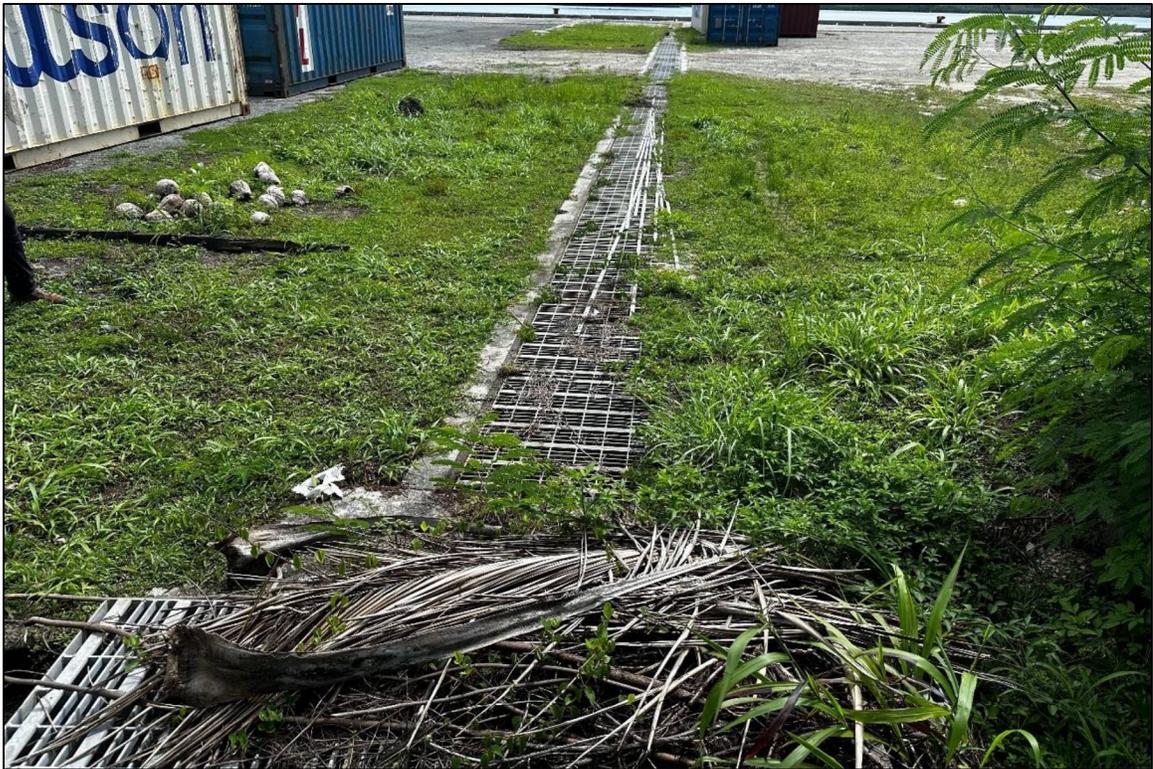
Photo 9: Drainage channel heading toward ocean. Photo is looking north.

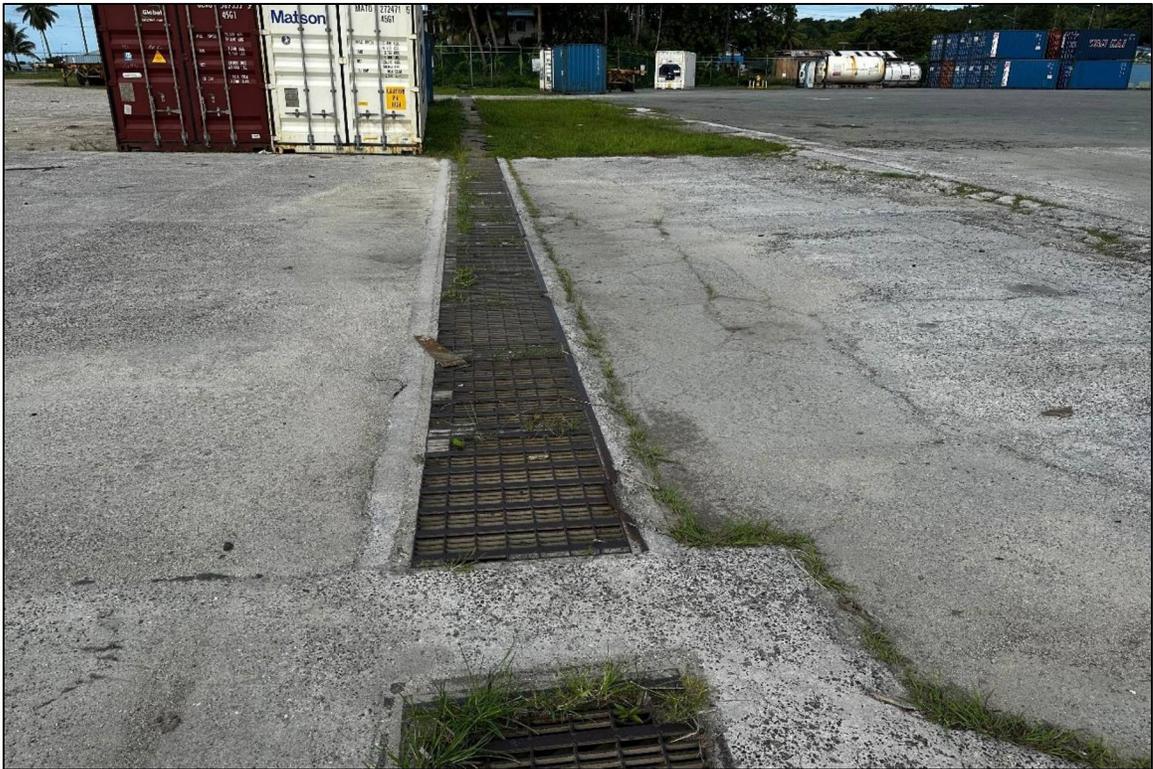
Photo 11: Storm drain channel which encircles the gated area within the port and leads toward the ocean. Photo is looking south.

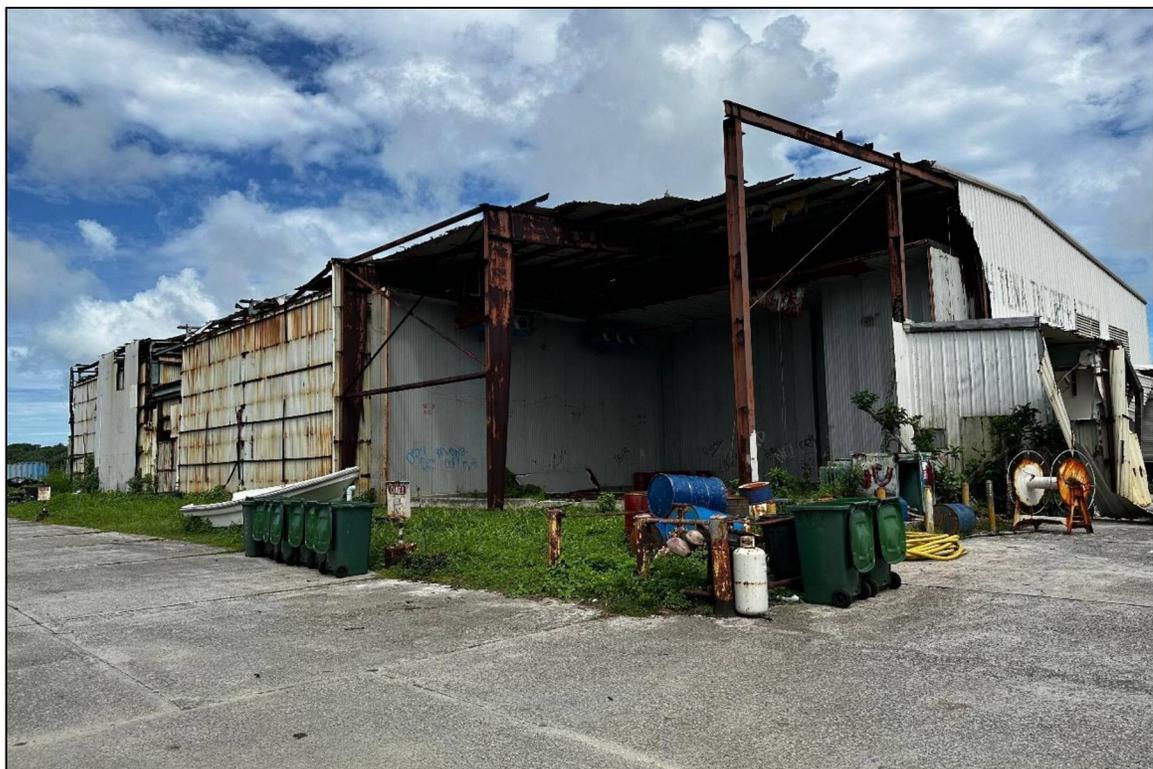
Photo 12: Overview of the former tuna canning facility's northeast corner. Photo is looking southwest.

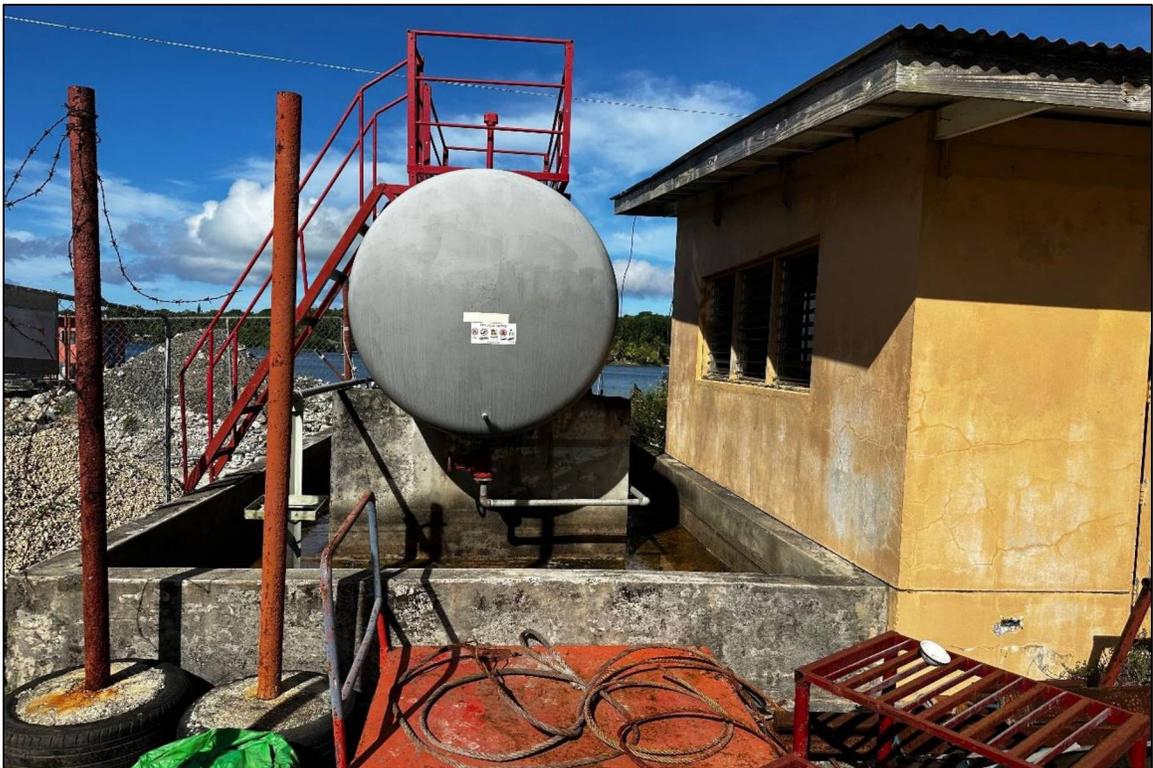
- A 10,000-liter diesel AST constructed of steel is present at the YFA facility (Appendix A, Photo 16). The AST is situated above a concrete containment basin. The installation date of the AST was unknown by YFA staff; however, the 1987 Yap Fishing Harbor Preparation Project drawings identify an “oil tank” would be installed (i.e., the AST was presumably installed after 1987). Mr. Yow and Ms. Falfen, the assistant general manager at YFA, indicated that other than a minor leak that was reported and repaired in 2022, no significant releases have been recorded from the AST. The 2022 leak was entirely contained within the concrete containment basin.

Photo 16: Overview of 10,000-liter diesel AST located at the YFA facility. Note: A concrete containment basin sits beneath the AST. Photo is looking south.

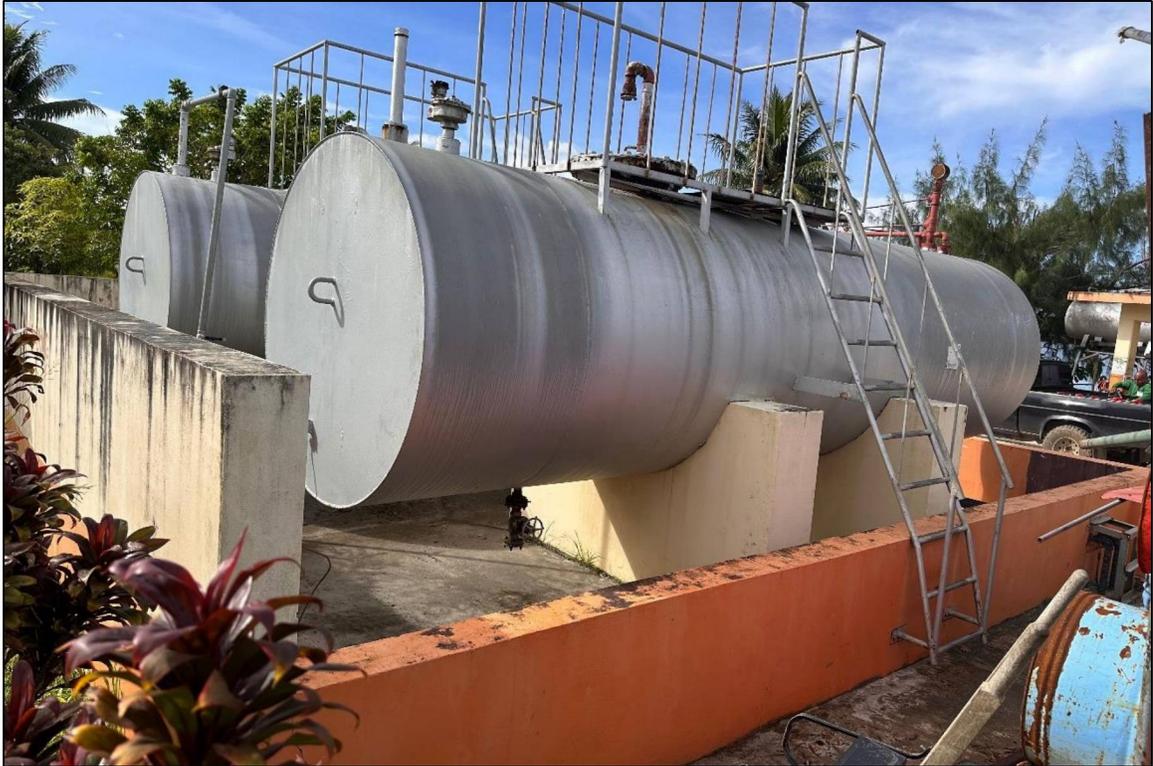
Photo 27: Overview of two steel ASTs containing diesel (3,700 gallons) and unleaded gasoline (4,010 gallons) in a concrete secondary containment observed at YCA Rufan Gas Station. Photo is looking north.

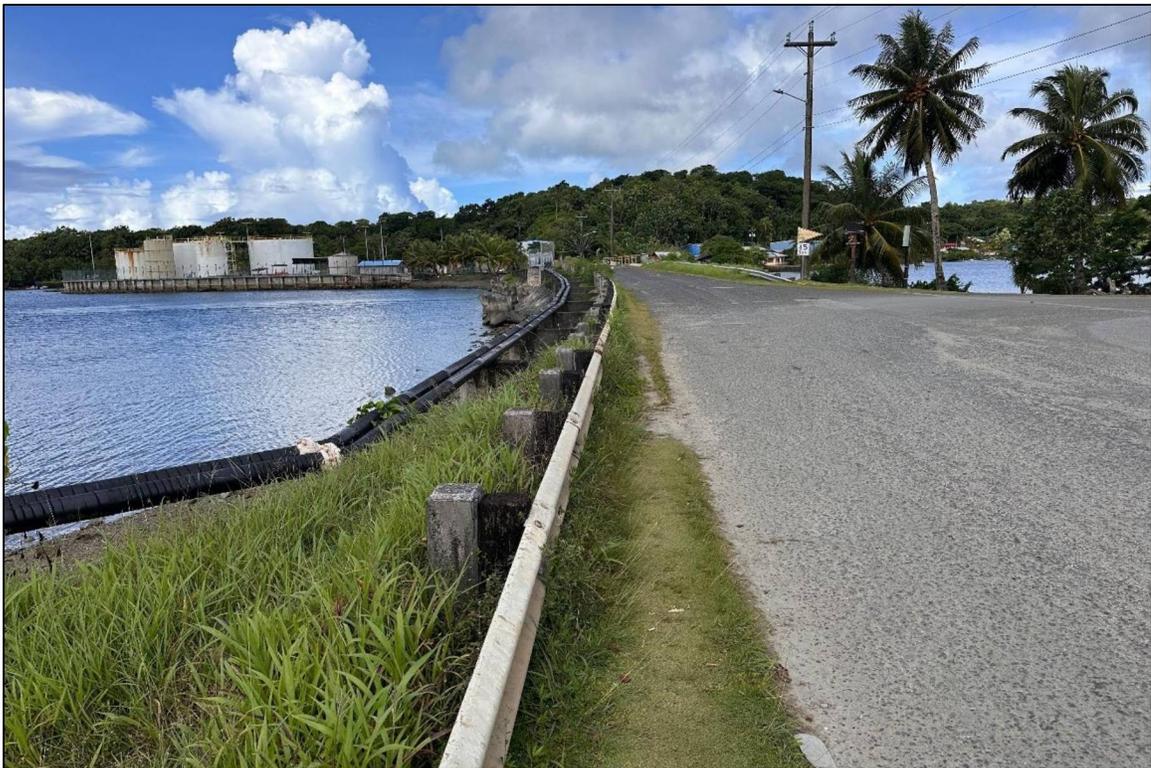
Photo 30: Small overpass leading to FSM Petroleum Corporation. Note: The subject property road is on the right and the fuel line is on the left. Photo is looking southwest.

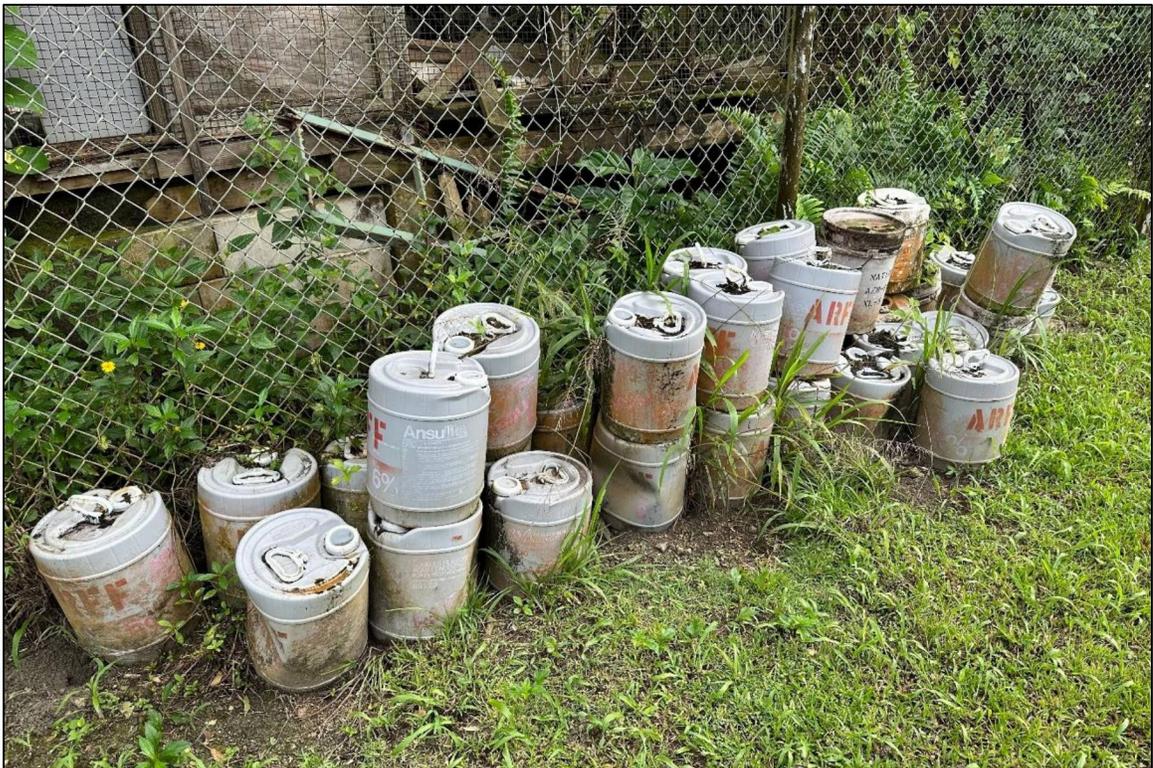
Photo 32: Close-up view of 55-gallon Ansolite buckets sitting on the lawn at the rear end of the fire department building.

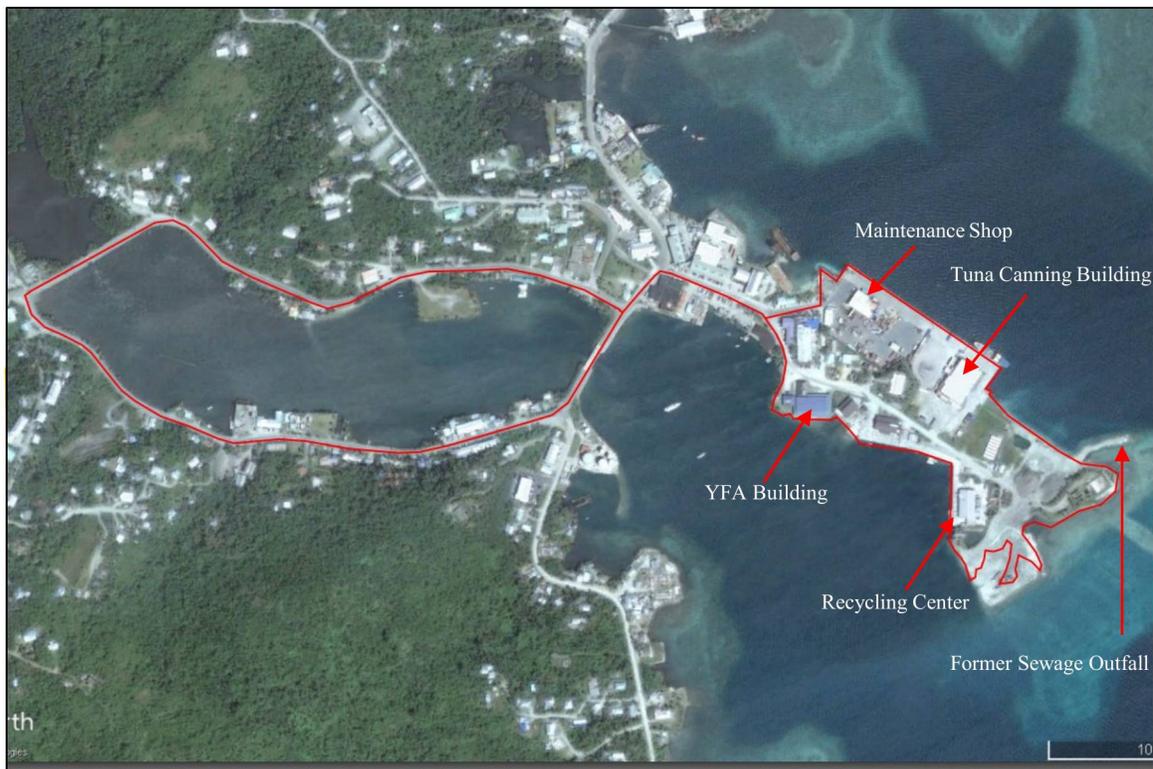
Photo 2: 2005 – Subject property, Colonia. The subject property appears fully developed. The wharf inside the gated area has been filled. The maintenance shop, YFA building, recycling center and tuna canning building are denoted by the red arrows. The majority of the former sewage outfall is now underwater.

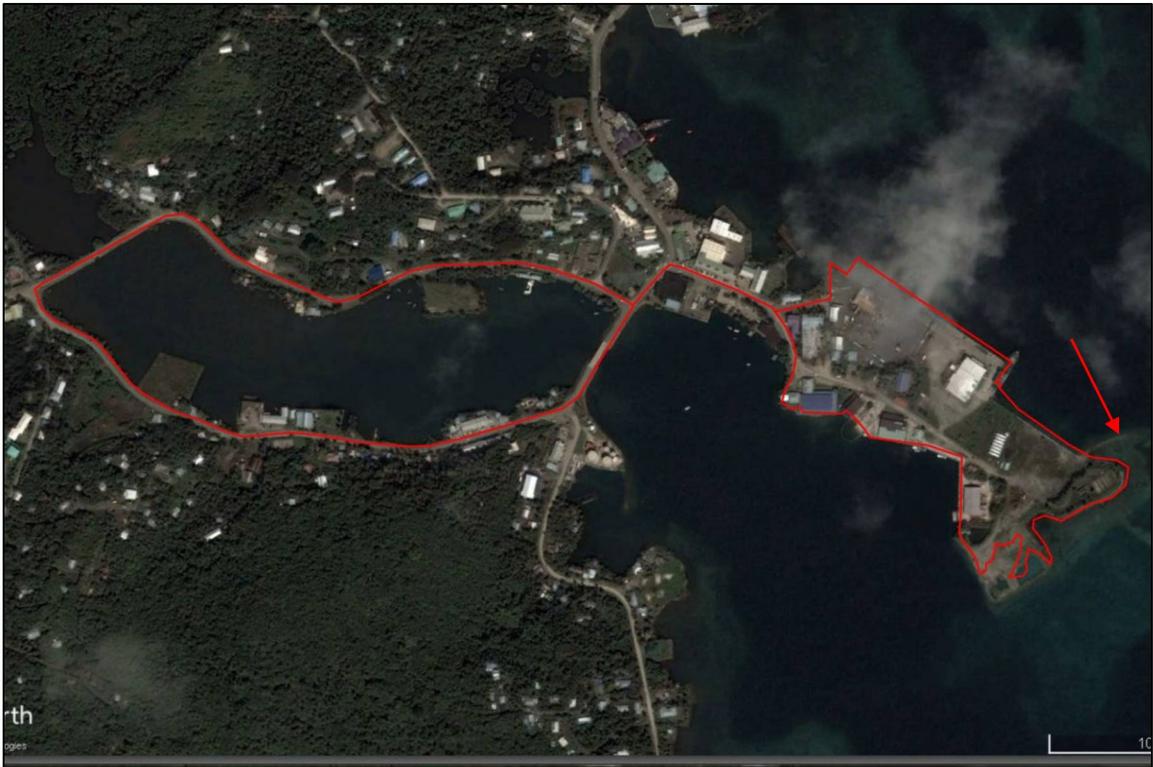
Photo 3: 2008 –Subject property, Colonia. The subject property looks generally the same from the last photo. Some portions of the easternmost point of the peninsula are now underwater. Red arrow points to the underwater strip of land associated with former sewage outfall

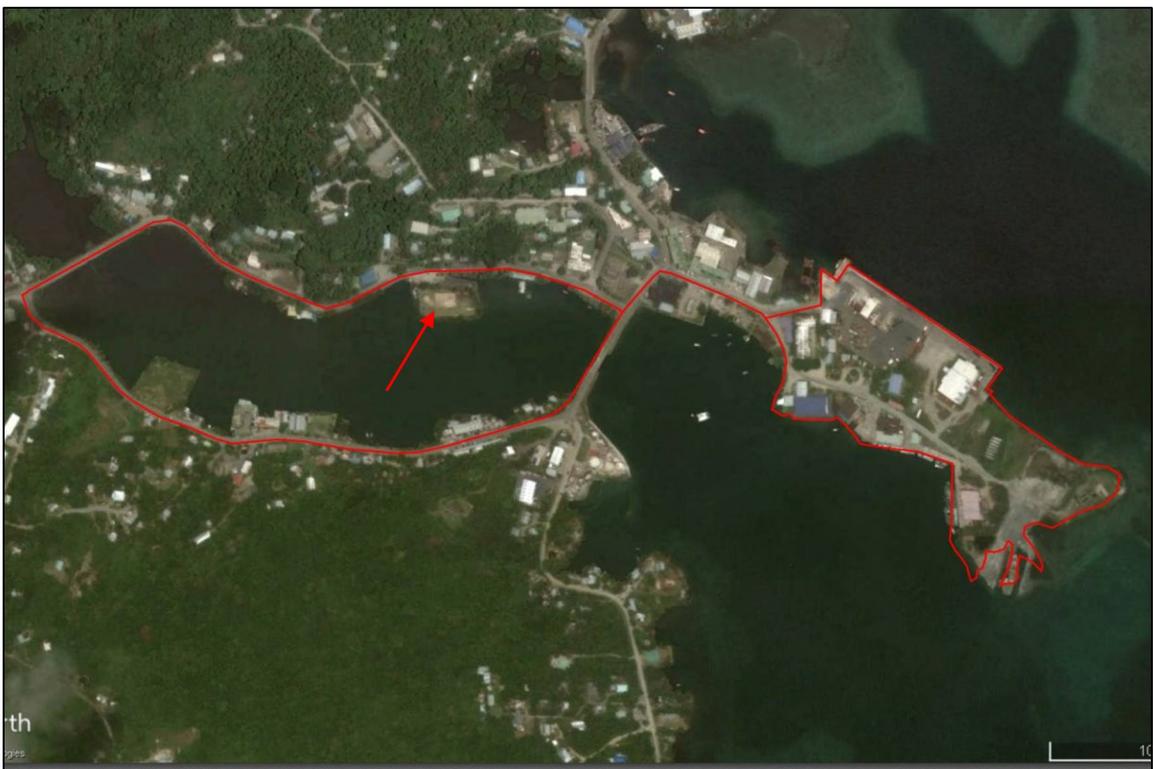
Photo 4: 2013 – Subject property, Colonia. The subject property looks generally the same from the last photo. There appears to be more shipping containers stored inside the gated area. There appears to be development in the adjacent area to the road denoted by the red arrow.

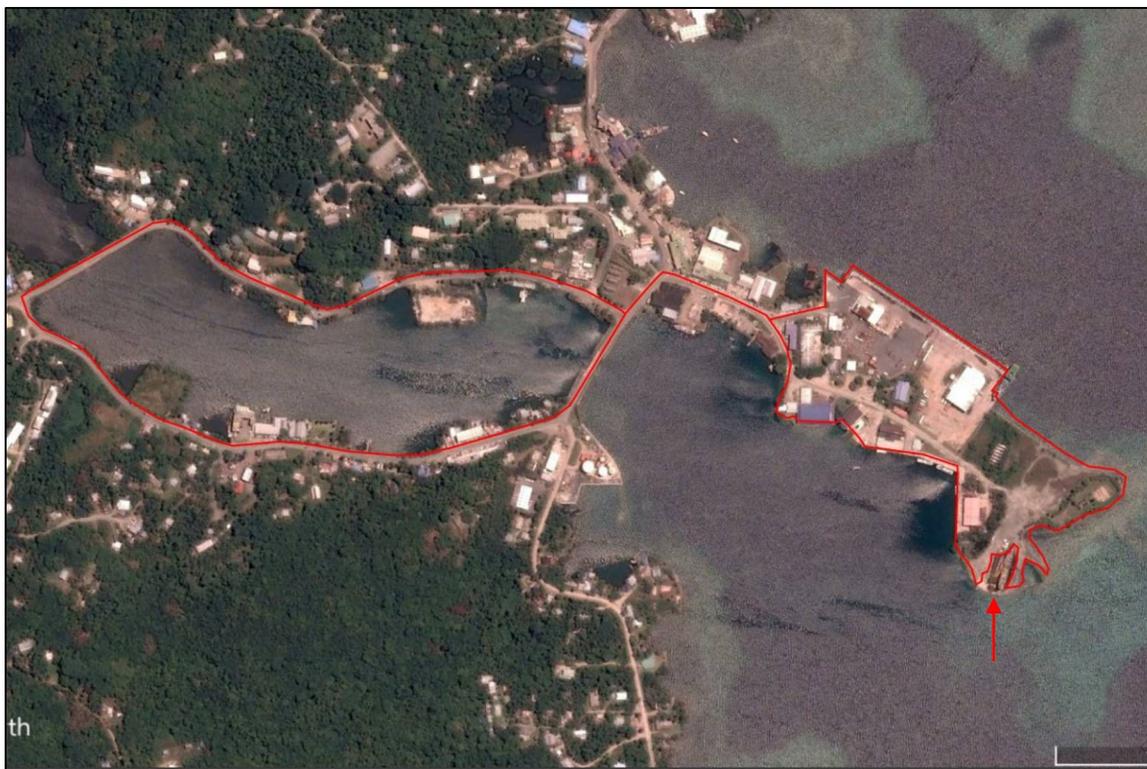
Photo 5: 2014 – Subject property, Colonia. The subject property looks generally the same from the last photo. The southeasternmost region of the subject property appears to be eroding. Red arrow points to region underwater.

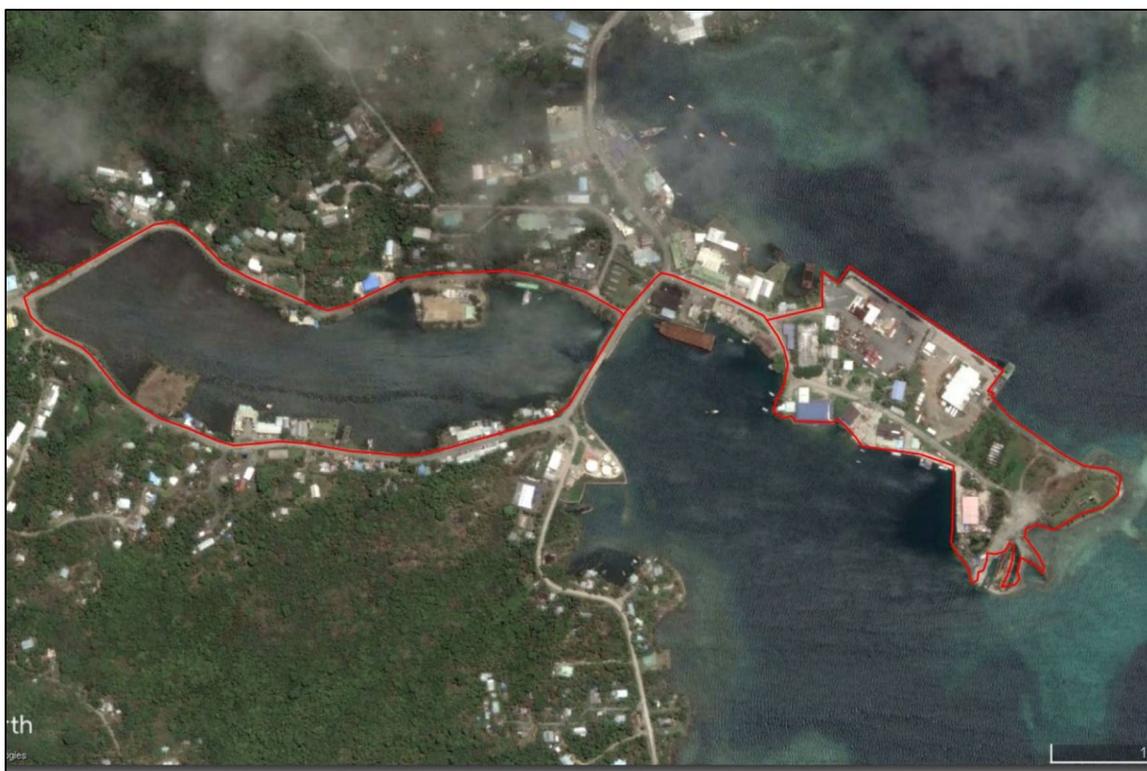
Photo 6: 2016 – Subject property, Colonia. The subject property looks generally the same from the last photo.

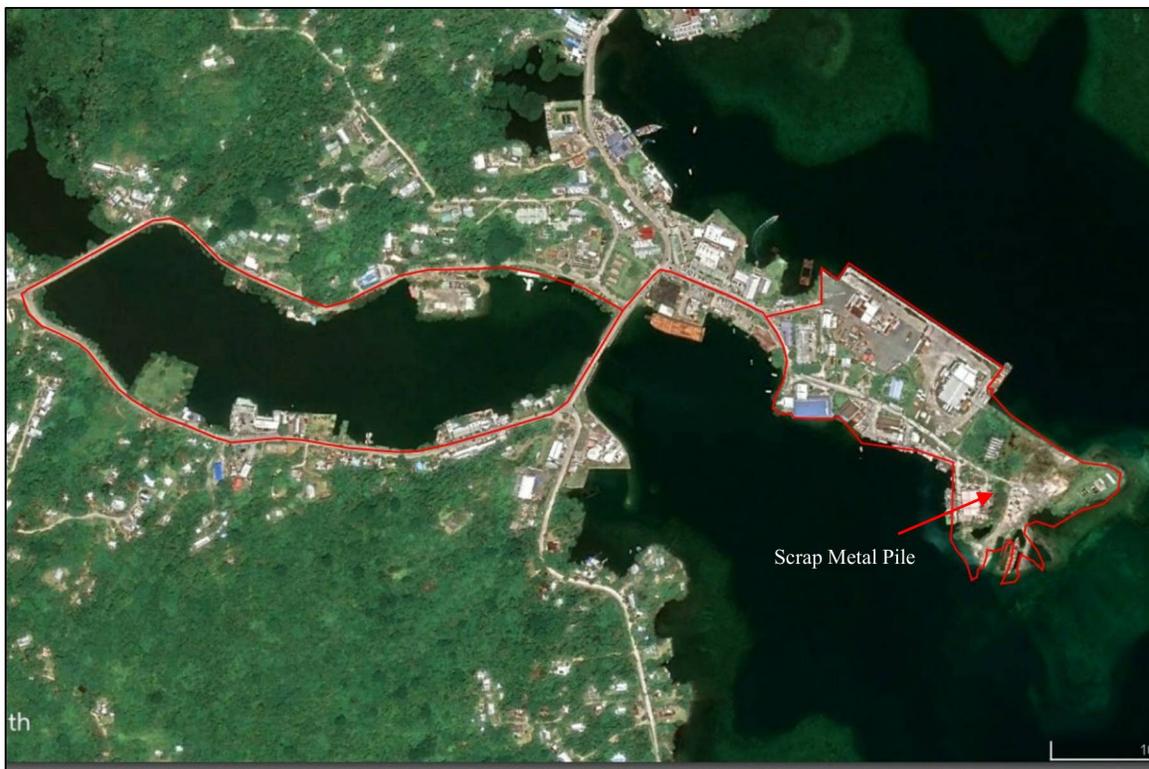
Photo 7: 2017 – Subject property, Colonia. The scrap metal pile adjacent to recycling center is now visible. Both piles are denoted by the red arrows.

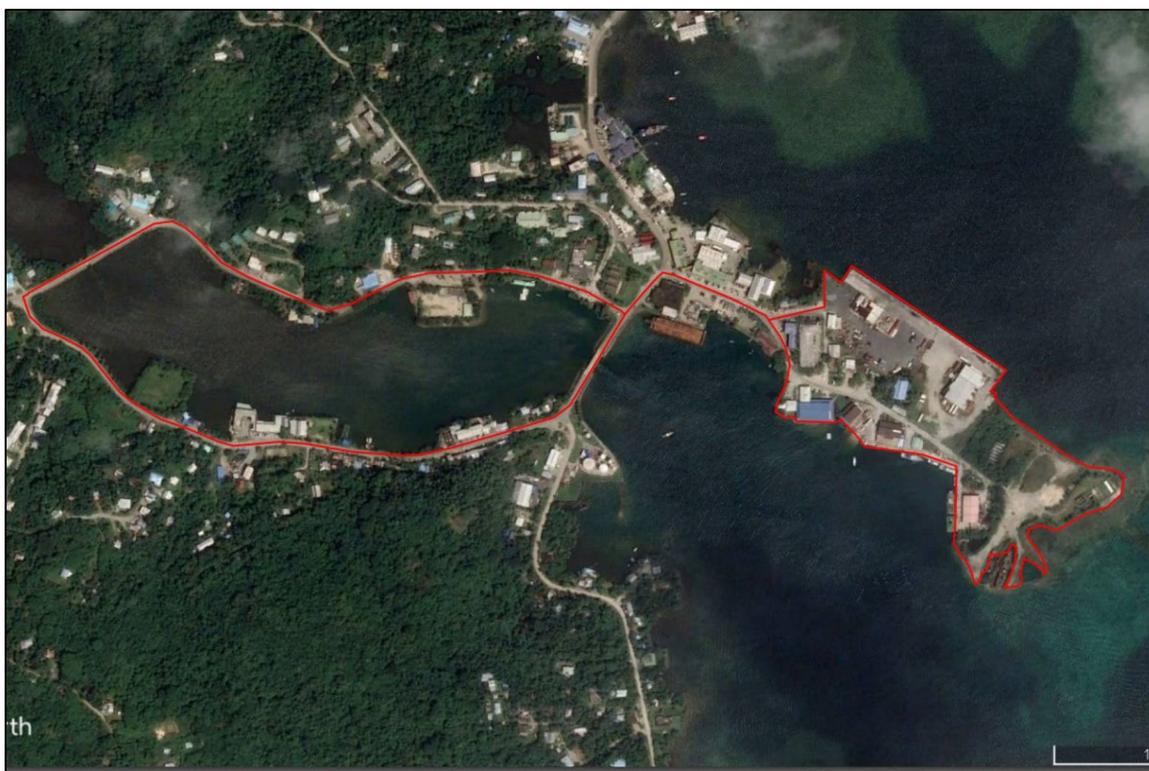
Photo 8: 2018 – Subject property, Colonia. The subject property looks generally the same from the last photo.

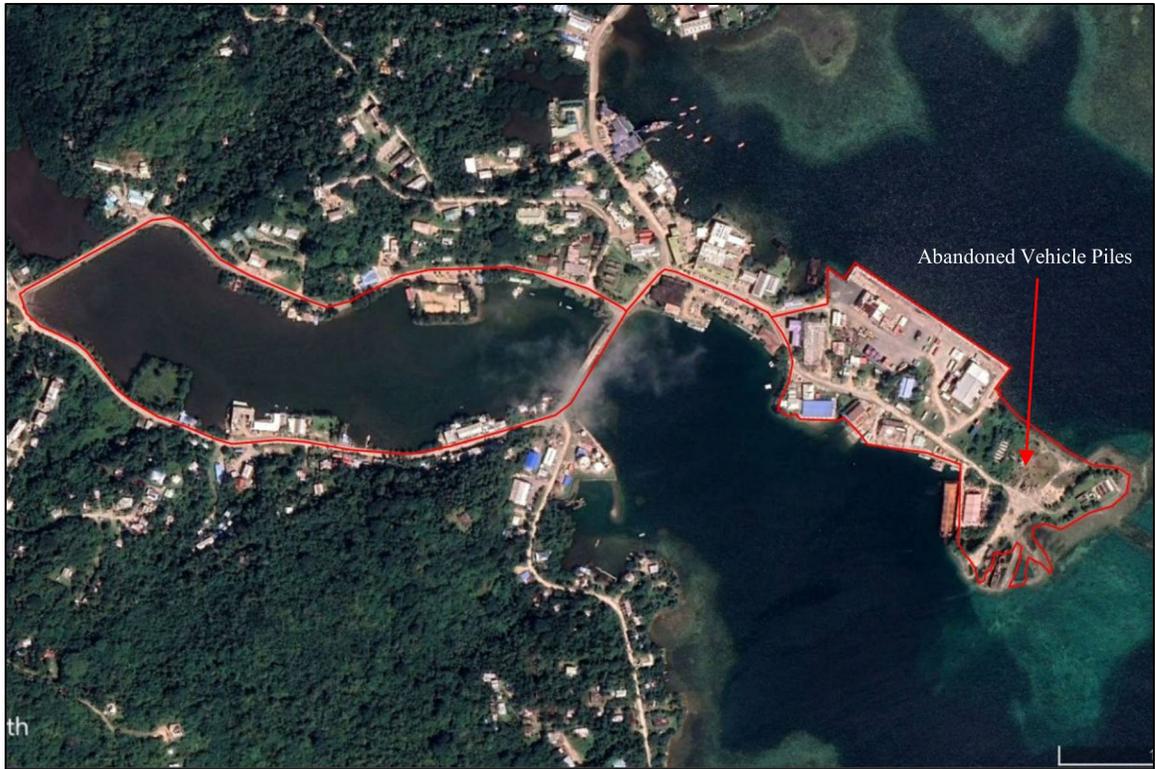
Photo 9: 2019 – Subject property, Colonia. The subject property looks generally the same from the last photo. The abandoned vehicle piles are beginning to accumulate (denoted by red arrow).

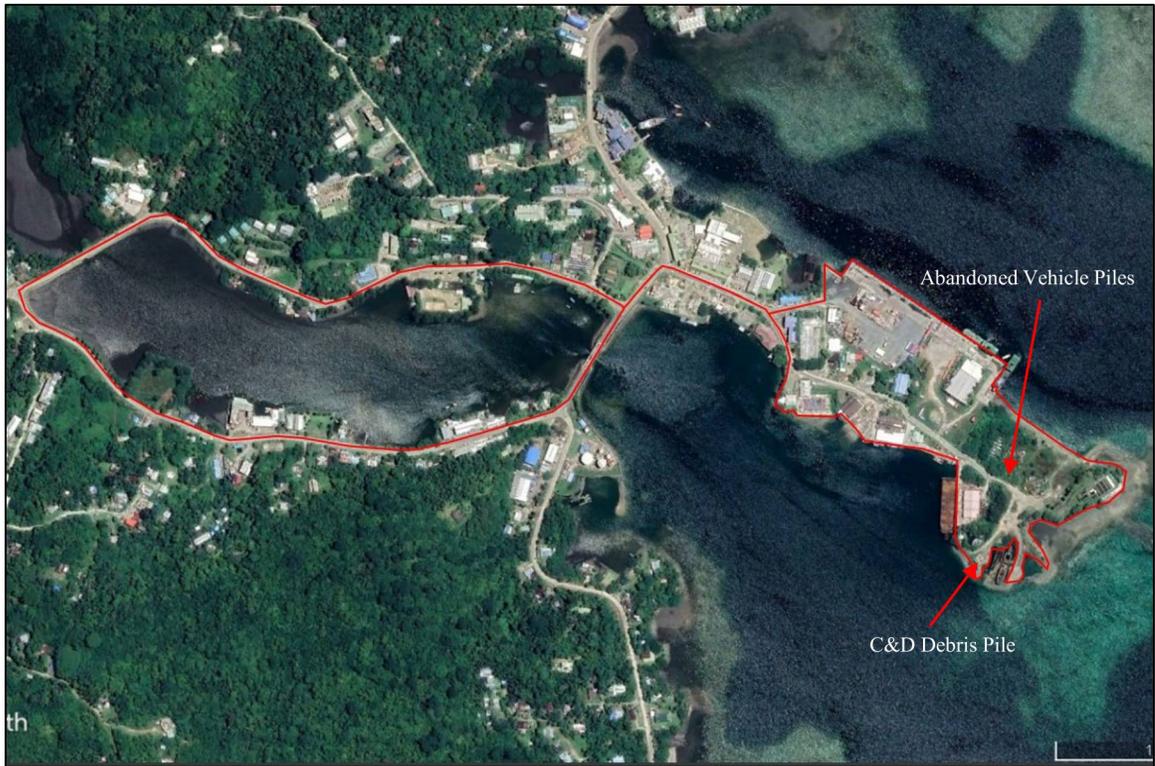
Photo 10: 2022 – Subject property, Colonia. The subject property looks generally the same from the last photo. More abandoned vehicles appear to be accumulated. Construction and demolition (C&D) debris pile is now visible (both areas denoted by red arrow).
